## BLUEBIRD CANYON LANDSLIDE, LAGUNA BEACH, CALIFORNIA

Robert Sydnor, County of Orange

Sydnor, Robert H., 1979, Bluebird Canyon Landslide, Laguna Beach, California, in Fife, D.L., editor, Geologic Guide of San Onofre Nuclear Generating Station and adjacent regions of southern California: American Association of Petroleum Geologists, Pacific Section AAPG Guidebook #46, p. 25-37.

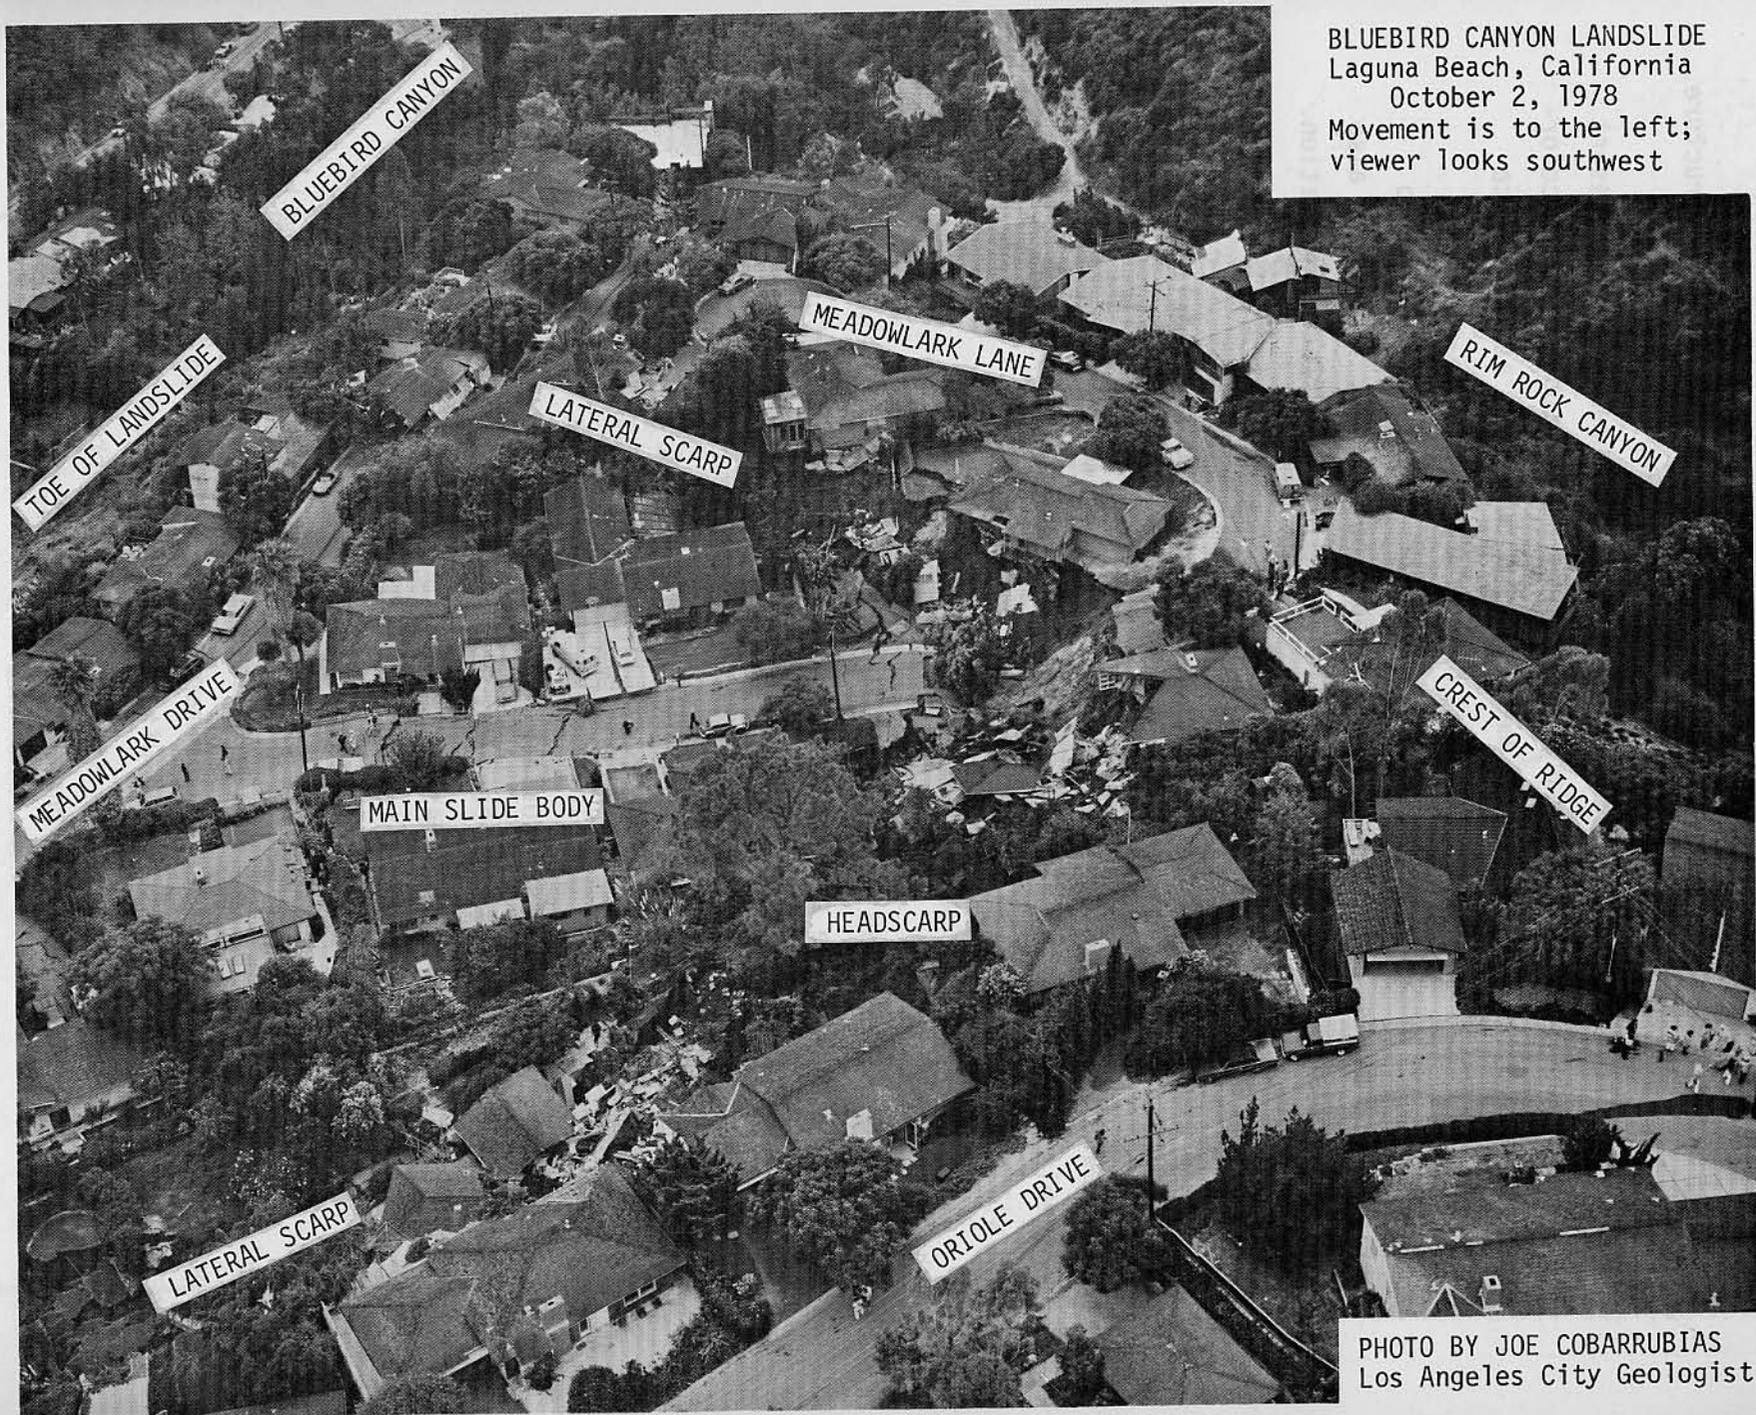
BLUEBIRD CANYON LANDSLIDE  
Laguna Beach, California  
October 2, 1978  
Movement is to the left;  
viewer looks southwest

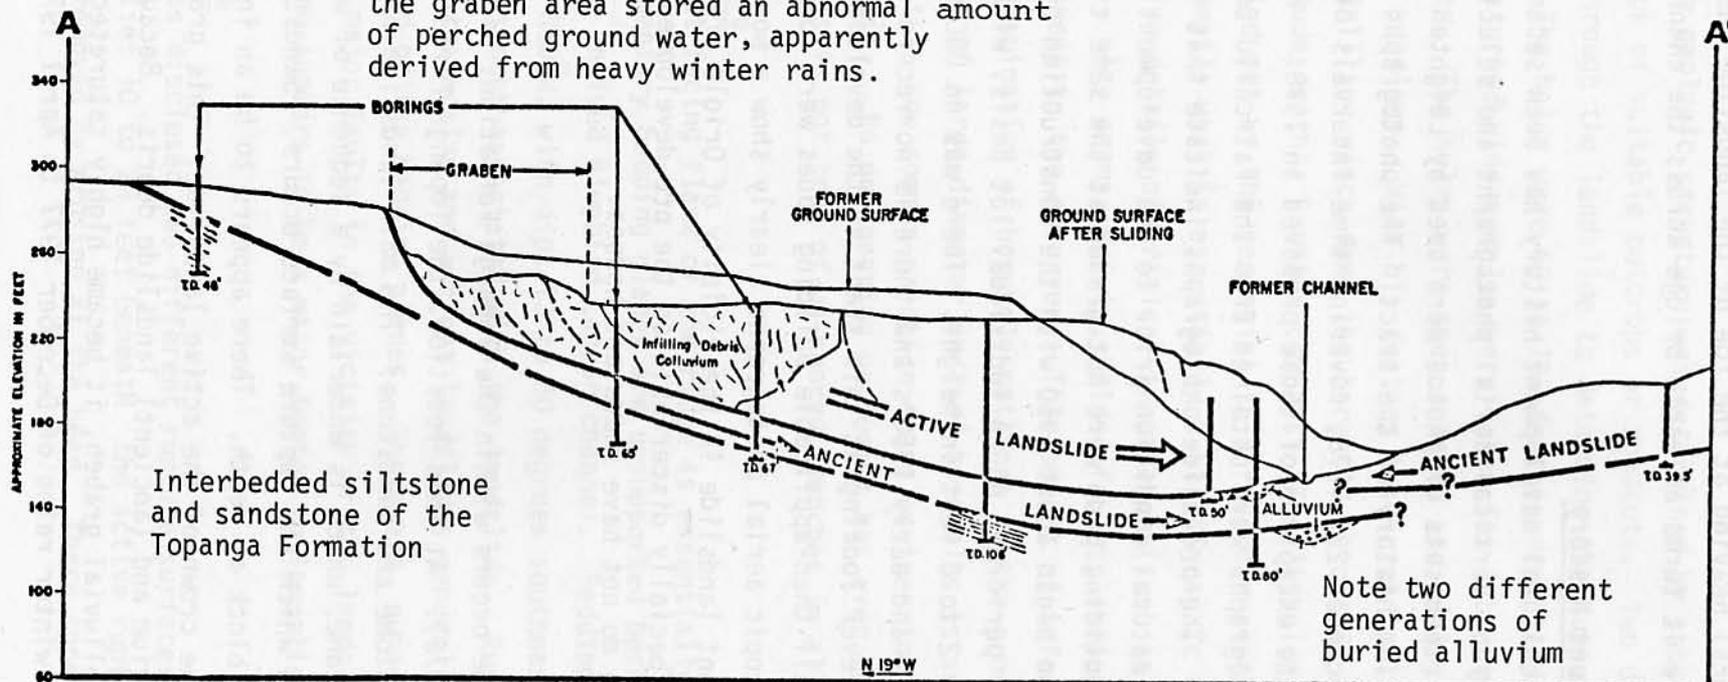
SCHEMATIC CROSS-SECTION A-A'

SCHEMATIC GEOLOGIC CROSS SECTION THROUGH THE AXIS OF THE BLUEBIRD CANYON LANDSLIDE

Borehole data indicates that the graben area stored an abnormal amount of perched ground water, apparently derived from heavy winter rains.

There was some local heaving at the toe of the landslide in the vicinity of Oriole Drive where it forms an earth bridge across the channel.

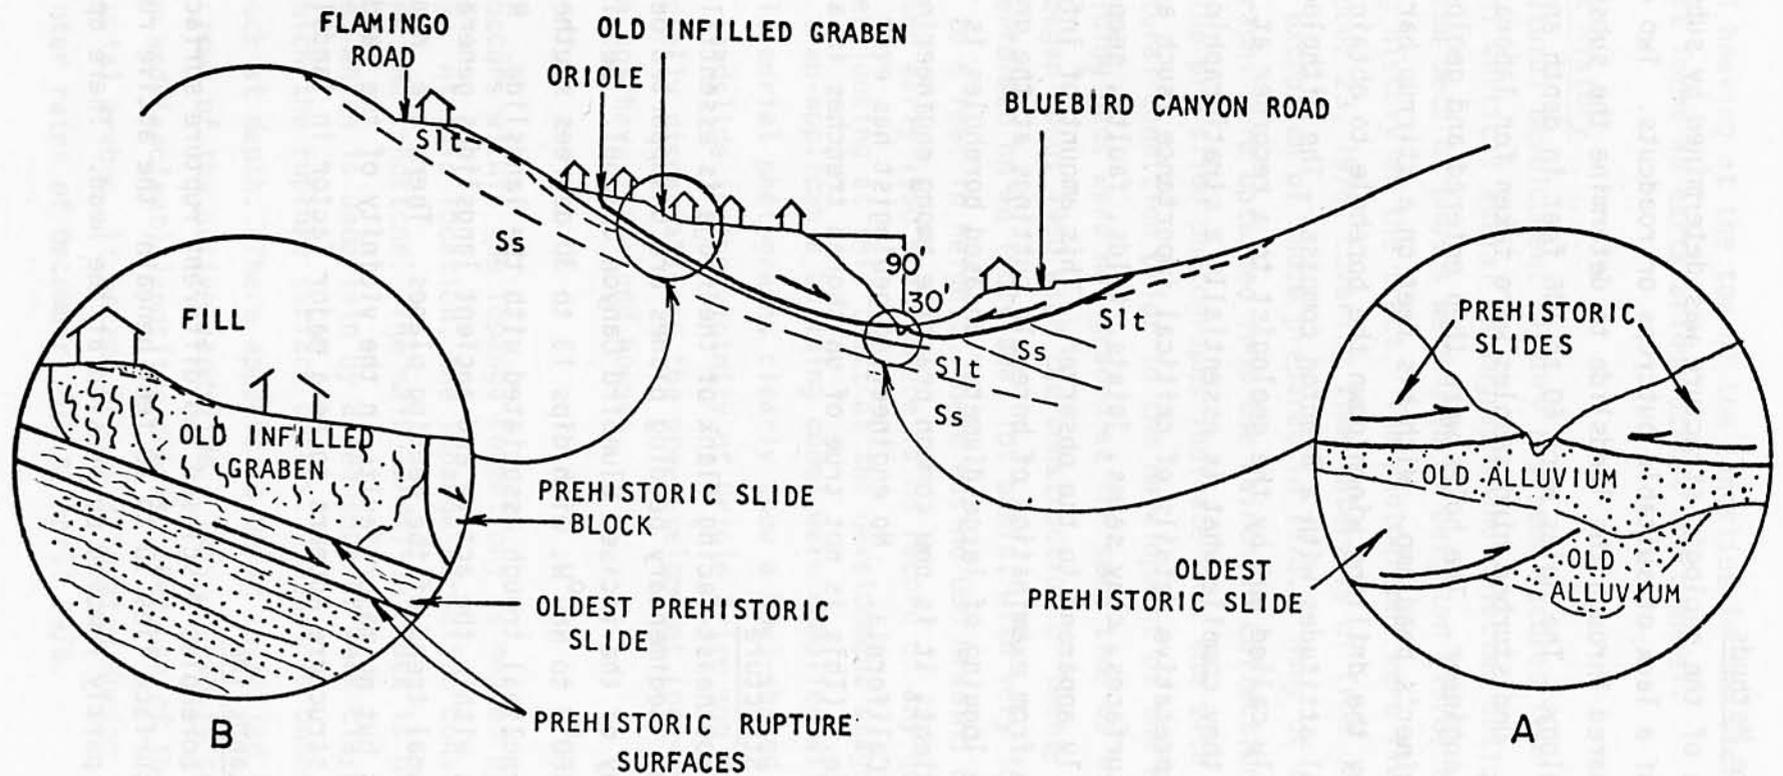
A-32

# KEY LANDSLIDE RELATIONSHIPS PRIOR TO OCTOBER 2, 1978 SLIDING

Schematic cross section from  
Leighton and Associates (1978)

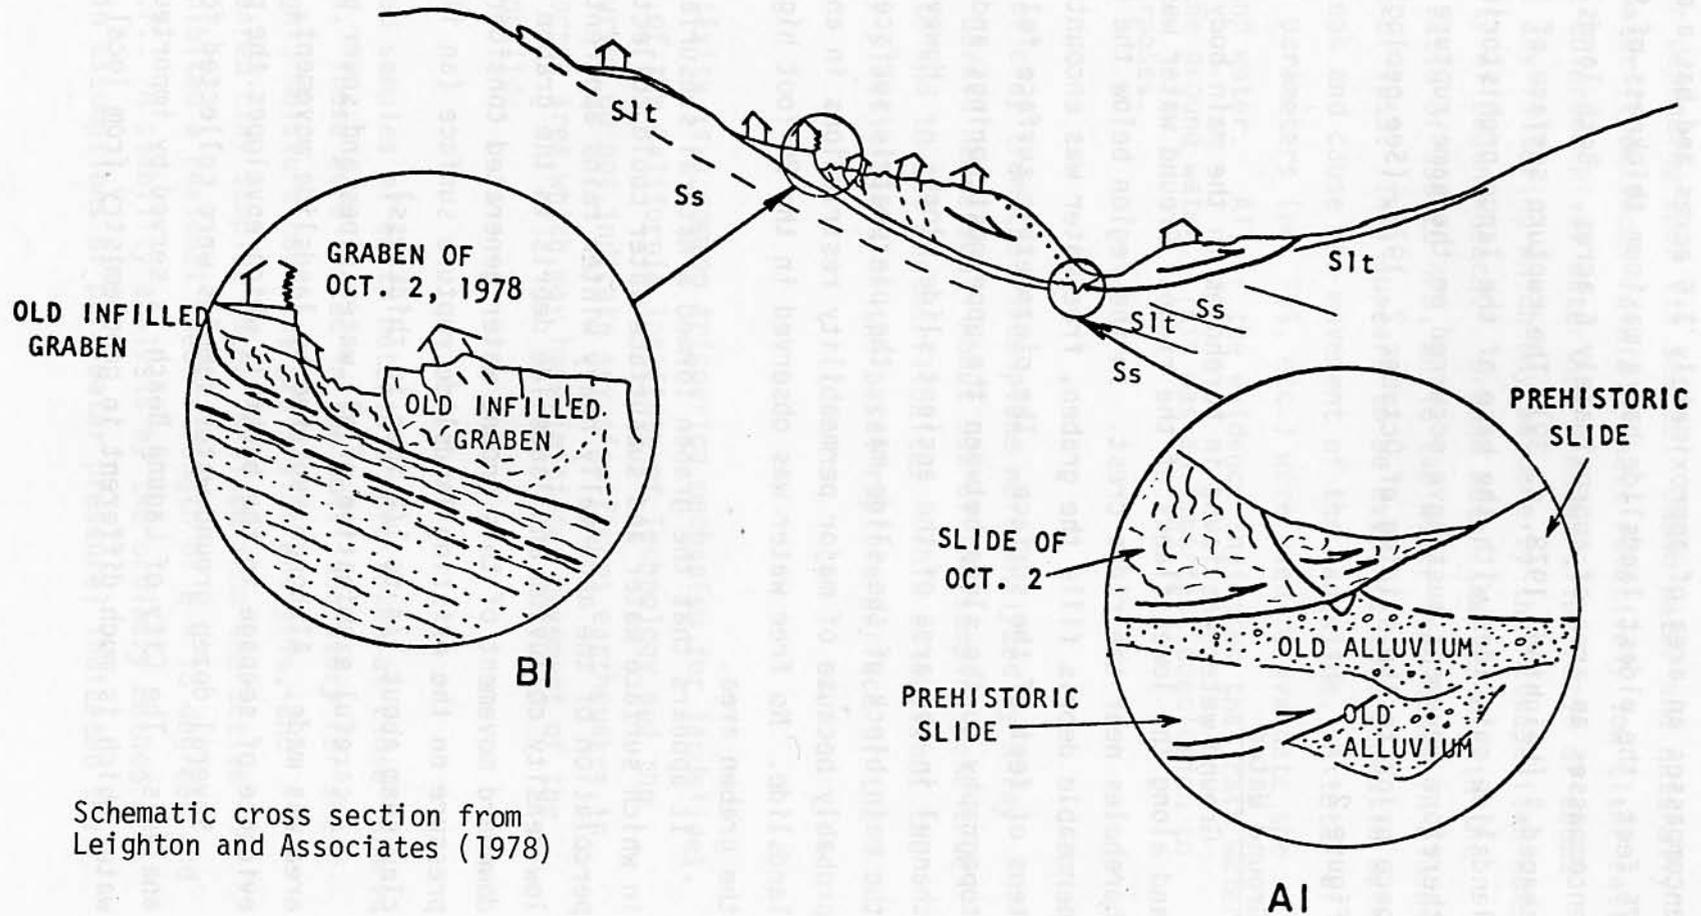
A-33

# KEY LANDSLIDE RELATIONSHIPS AFTER OCTOBER 2, 1978 SLIDING

Schematic cross section from  
Leighton and Associates (1978)
