DEBRIS-FLOW RESPONSE OF BASINS BURNED BY THE 2002 COAL SEAM AND MISSIONARY RIDGE FIRES, COLORADO

in Boyer, D.D., Santi, P.M., and Rogers, W.P., eds., Engineering Geology in Colorado—Contributions, Trends, and Case Histories: Association of Engineering Geologists Special Publication 14, Colorado Geological Survey Special Publication 55, on CD-ROM.

Key Terms: Debris flow, Wildfire, Rainfall thresholds, Hazard assessments

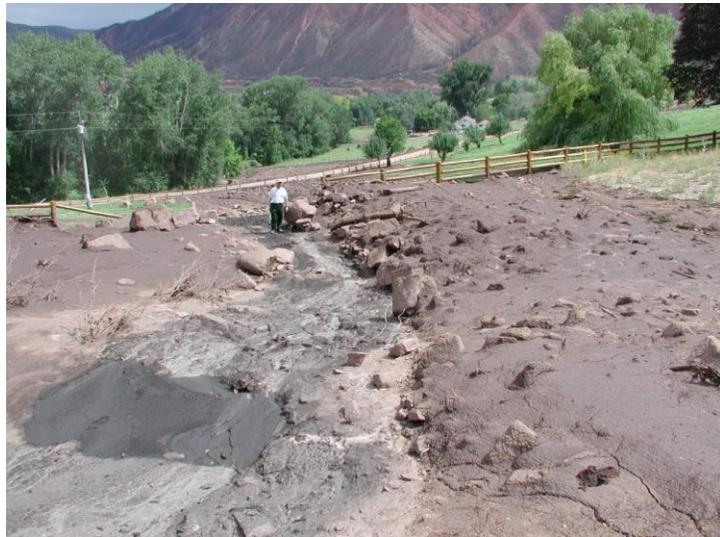
Figures 3A and B. Photographs of A) debris-flow paths and B) deposits produced during August 5, 2002 storm from Basins B and C, Coal Seam Fire.

August 5, 2002 - Debris flows were first produced from basins burned by the Coal Seam Fire in response to the first heavy rain fall of the monsoon season. Field reconnaissance immediately following the event indicated that at least 15 basins produced debris flows in response to this storm (Figure 2A). The road along Mitchell Creek was blocked with an estimated several hundred cubic meters of debris-flow material in numerous places, and a 6-ft (2-m) diameter culvert was completely blocked by debris produced from Basin A. The debris flows spread over the fan surfaces, leaving deposits approximately 1 ft (0.3 m) thick that consisted of isolated clasts up to 1.5 ft (0.5 m) in diameter in abundant mud and ash (Figures 3A and B). The channels of Basins B, C, and D were flushed of the pre-existing dry-ravel deposits and eroded as much as about 2 ft (0.6 m) in depth, exposing bedrock in many places along their lengths. Debris flows were also produced from basins above the Fish Hatchery (Figure 4), from basins that supply the Red Mountain fan (Figure 5), and from Basin A. The debris flows produced from the basins above the Fish Hatchery deposited levees up to 2.0 ft (0.6 m) high lining the channels and lobes of material up to 5 ft (1.6 m) high at the flow terminus. The debris-flow materials consisted primarily of gravel and cobbles in a muddy matrix.

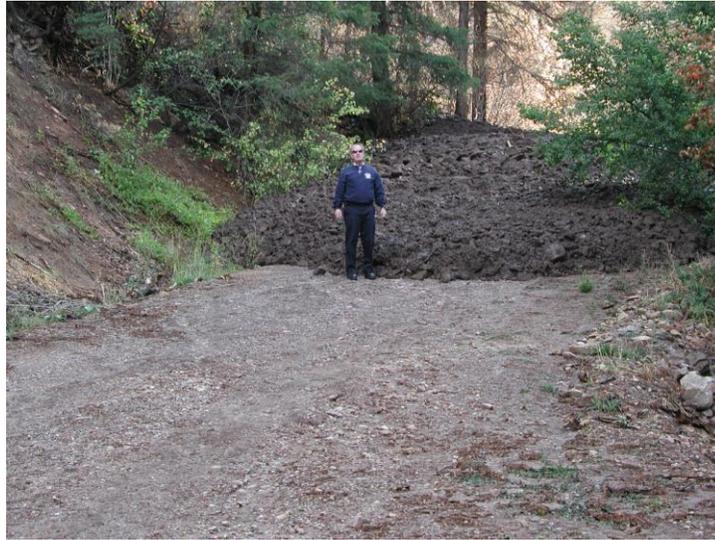
Figure 4. Debris-flow deposit produced during August 5, 2002, storm from Basin H, Coal Seam Fire.

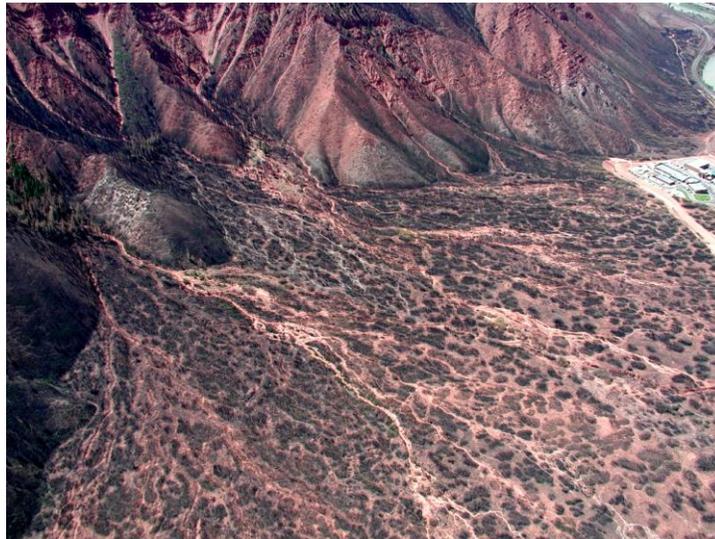
Figure 5. Debris-flow paths (lighter colored material) from the August 5, 2002, storm on the Red Mountain Fan. Buildings in upper right for scale.

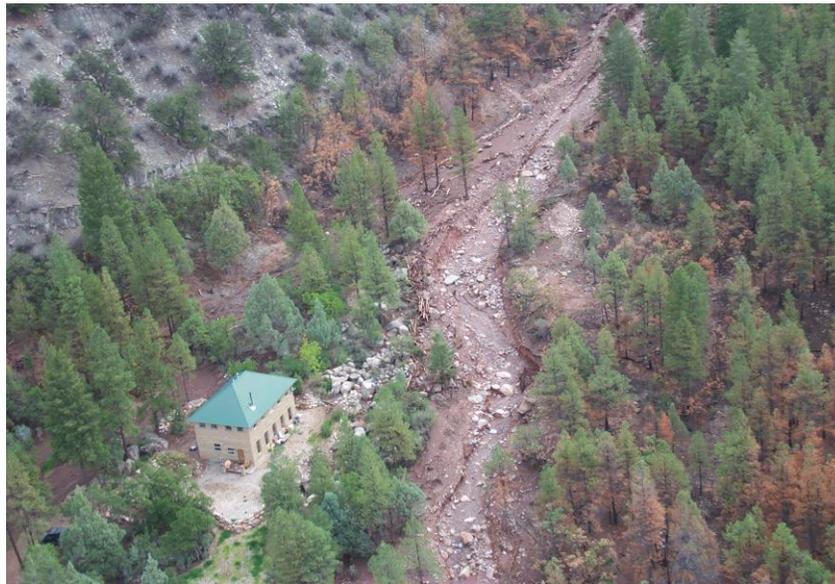
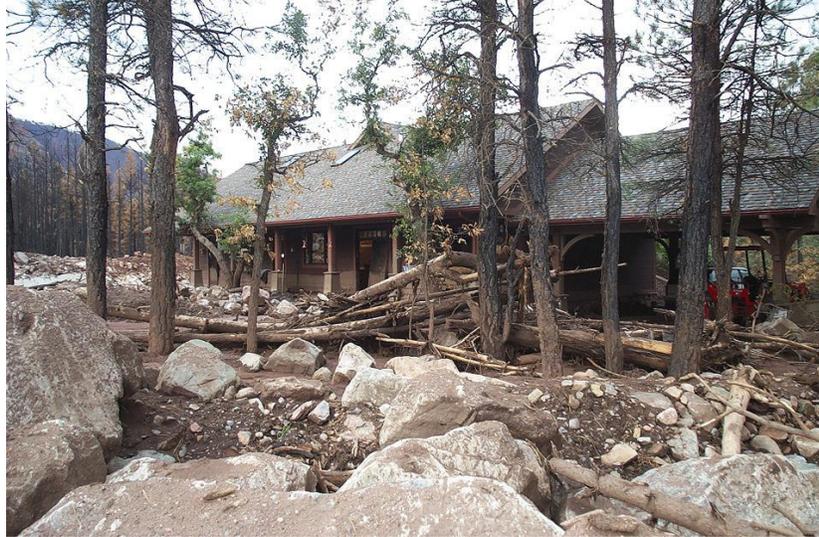
Figures 6A and B. Photographs of A) debris-flow path near apex of Stevens Creek Fan, and B) debris-flow deposits on fan, Missionary Ridge Fire. Debris flows occurred during September 7, 2002, storm.
