EFFECTIVENESS OF DEBRIS FLOW MITIGATION METHODS IN BURNED AREAS

Abstract: The fire-flood sequence, in which recently burned areas generate debris flows and floods in response to relatively small rainstorms, is common in the Western United States. To reduce the likelihood and magnitude of these debris flows, hillslopes and channels are often treated by mulching, seeding, and construction of erosion barriers and fences. The effectiveness of these treatment methods in reducing debris-flow volume has not been thoroughly evaluated; therefore, the goal of this study was to quantify the effectiveness of post-fire debris flow mitigation techniques. Debris volumes were measured and sediment sources were identified for 46 recent debris-flow events. Graphs of debris flow volume accumulation along the length of the flowpath were generated to identify sources of debris and to develop a predictive model to estimate expected debris-flow volumes. Extensive field observations and interpretations of surveys of wildfire emergency response personnel provided additional information on effectiveness and applicability of various treatment methods. Based on this information we conclude that hillslope tre

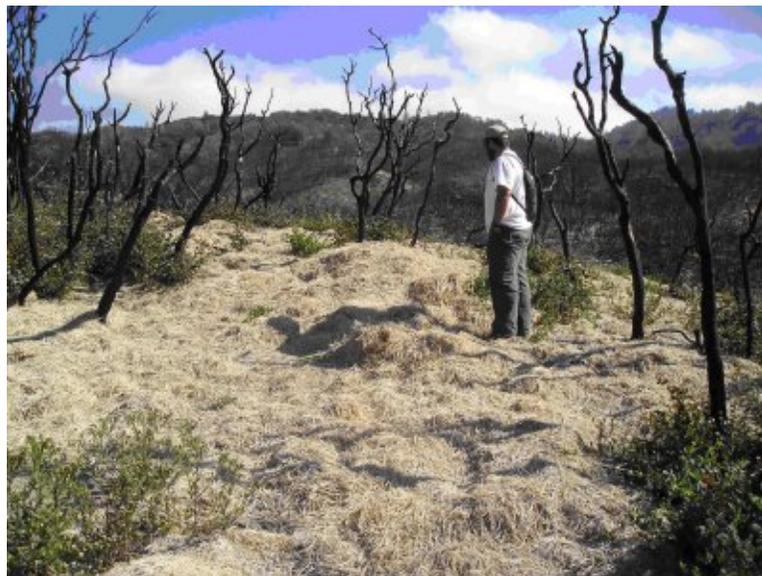
Figure 3. Poorly dispersed mulch applied by helicopter on burned slopes near Silverwood, CA. Note how clumping has prevented vegetation growth.

Mulch was effective at reducing surface runoff and enhancing infiltration, but only when placed properly. If evenly spread, as is usually done by hand, the mulch protects most of the soil. If spread by helicopter, the mulch was often clumped, providing poor coverage and preventing plant growth (Figure 3). Mulch was frequently redistributed by wind, which also resulted in clumping around trees and bushes and creating large areas with no coverage. Crimping of mulch into the soil, discussed in the next section, greatly improved its effectiveness.

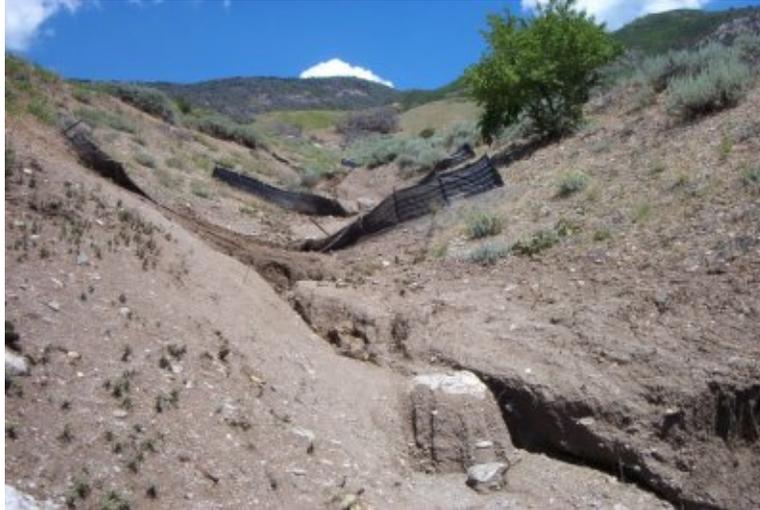
Figure 4. Failed silt fences near Farmington, UT.

Silt fences were ineffective for erosion control as the fine mesh of the geotextile trapped fine sediment and water as well as coarse debris, causing them to be quickly filled and overwhelmed (Figure 4).

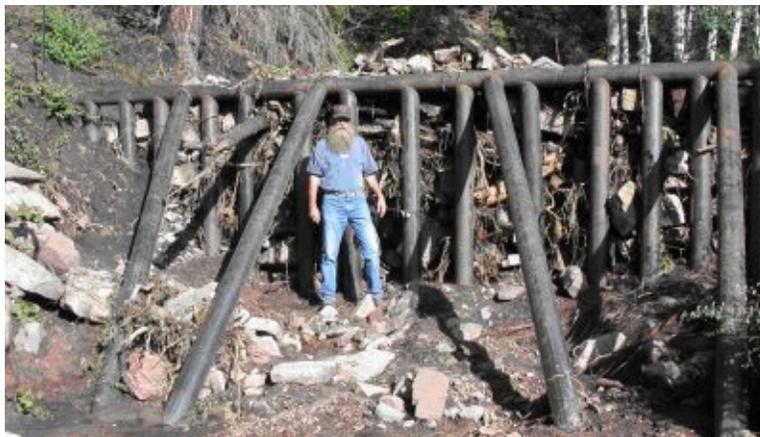
Figure 5. Debris rack installed near Lemon Dam, CO.

Debris racks are less likely to be filled and overrun because their large size allows finer material and water to pass (Figure 5). Although limited observations were made, they performed well, as described in the next section.

Five debris racks were constructed between October and December 2002. Only one rack was located in a channel that produced a debris-flow, intercepting ~130 m³ of a debris-flow measured to be about 445 m³ in total volume (Figure 7). The design of this debris rack prevented failure and allowed the fine material to continue down channel, where it was partially trapped by a second debris rack. Only muddy water reached the Florida River.

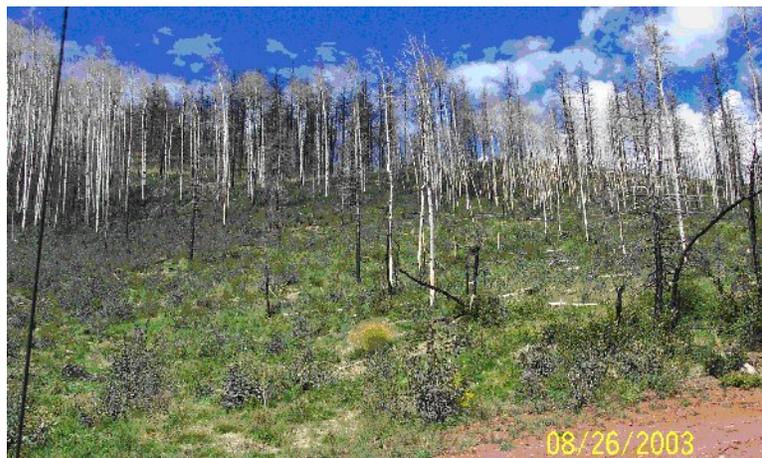
Figure 6. Natural and seeded revegetation near Lemon Dam, CO.

Critical areas near Lemon Dam were seeded at a rate of 67-84 kg/hectare (typical application concentrations are around 45 kg/hectare). Observations of those slopes show that spreading this concentration among crimped mulch helped re-establish a vegetative cover during the first growing season (Figure 6). We postulate that the mulch and LEBs reduced hillslope erosion and held the seeds in place until germination.

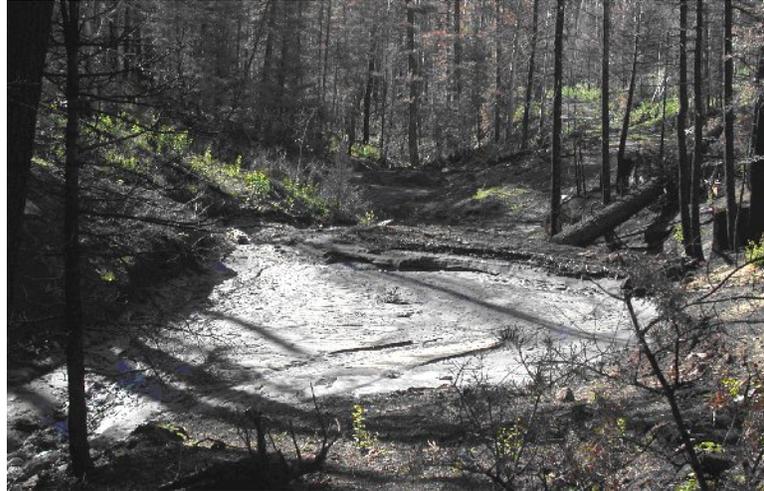
Figure 7. Check dam that captured ash/mud runoff following a rainstorm near Lemon Dam, CO.

Thirteen earthen check dams were constructed in the main channel of Knight Canyon above Lemon Dam. Figure 7, taken on September 9th, 2003 (14 months after the fire, approximately 2-year recurrence interval storm), shows a check dam filled with an ash/mud deposit during a heavy rain in the watershed. In the background, another check dam can be seen in the series. The dams were monitored by the FWCD and cleaned out after such erosional events. The dams were properly constructed and sized, and effectively reduced both the volume of debris that reached the canyon mouth and the potential growth of the debris flow within the canyon (deWolfe et al., in review).
