Significant Landslide Events in the United States

*by Lynn M. Highland and Robert L. Schuster
Graphic presentation by Margo L. Johnson*

Abstract

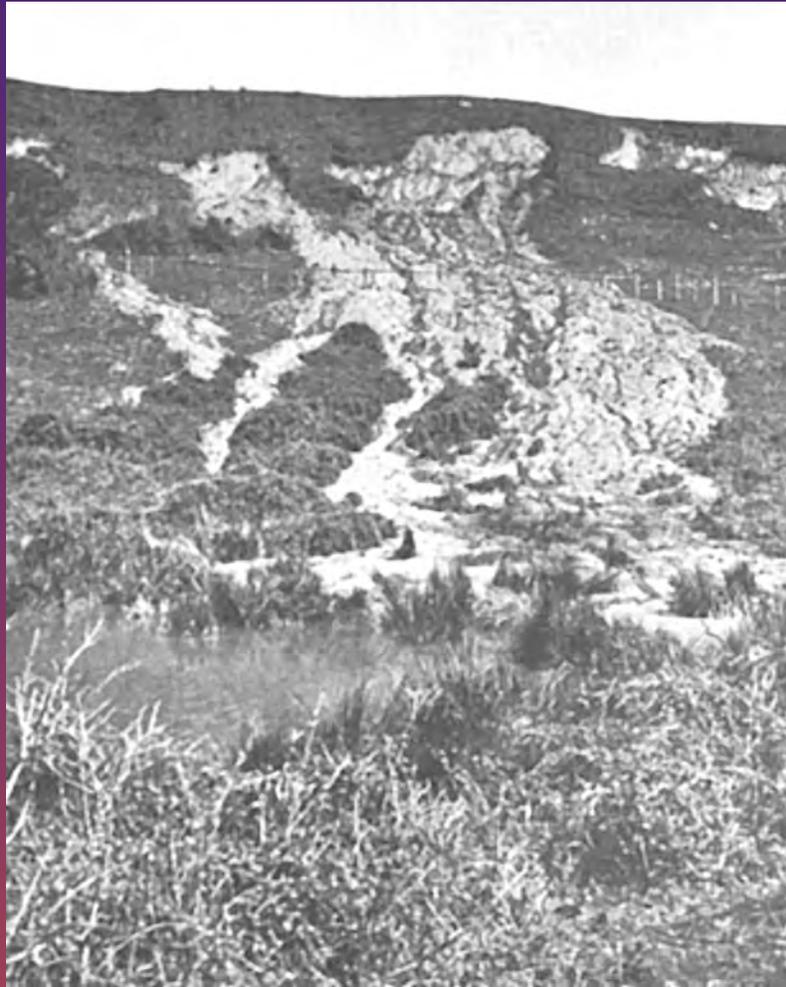
Landslide caused by the San Francisco, California, earthquake of 1906, located 2.5 miles northwest of Bolinas Lagoon. *Photograph by G.K. Gilbert, U.S. Geological Survey.*

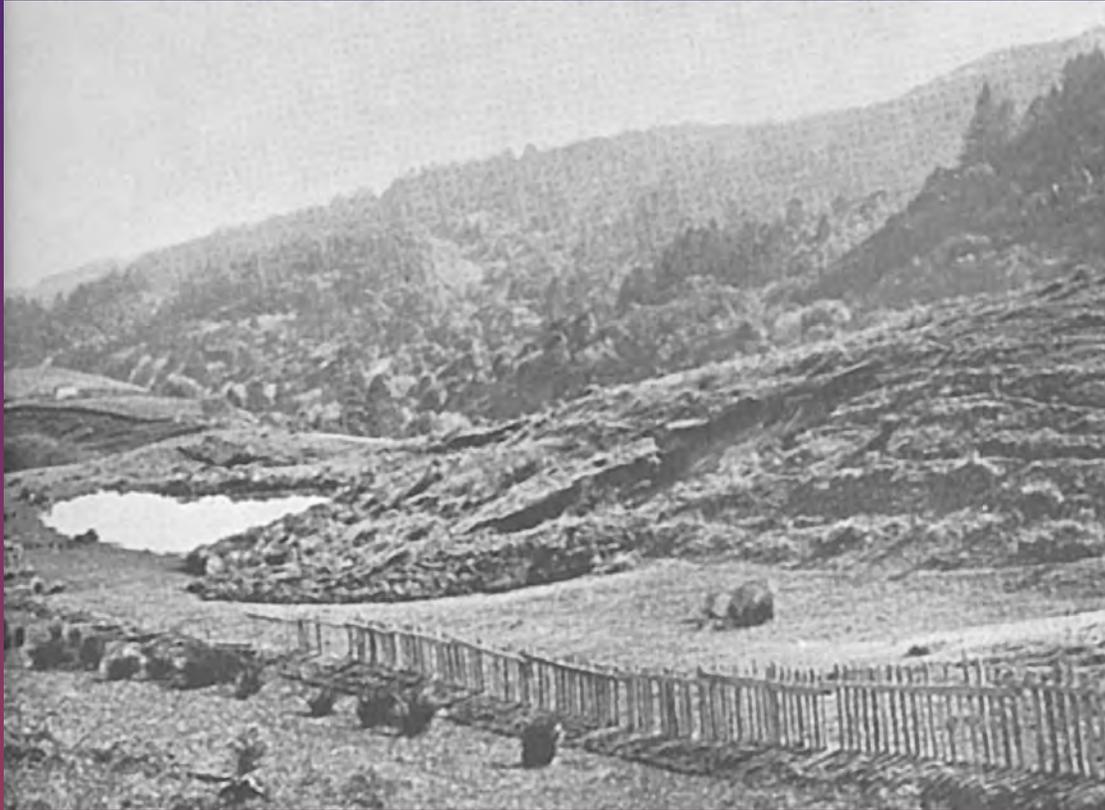
This landslide, caused by the San Francisco, California, earthquake of 1906, is located 4 miles northwest of Bolinas Lagoon. Observer is looking south-southwest.
Photograph by G.K. Gilbert, U.S. Geological Survey.

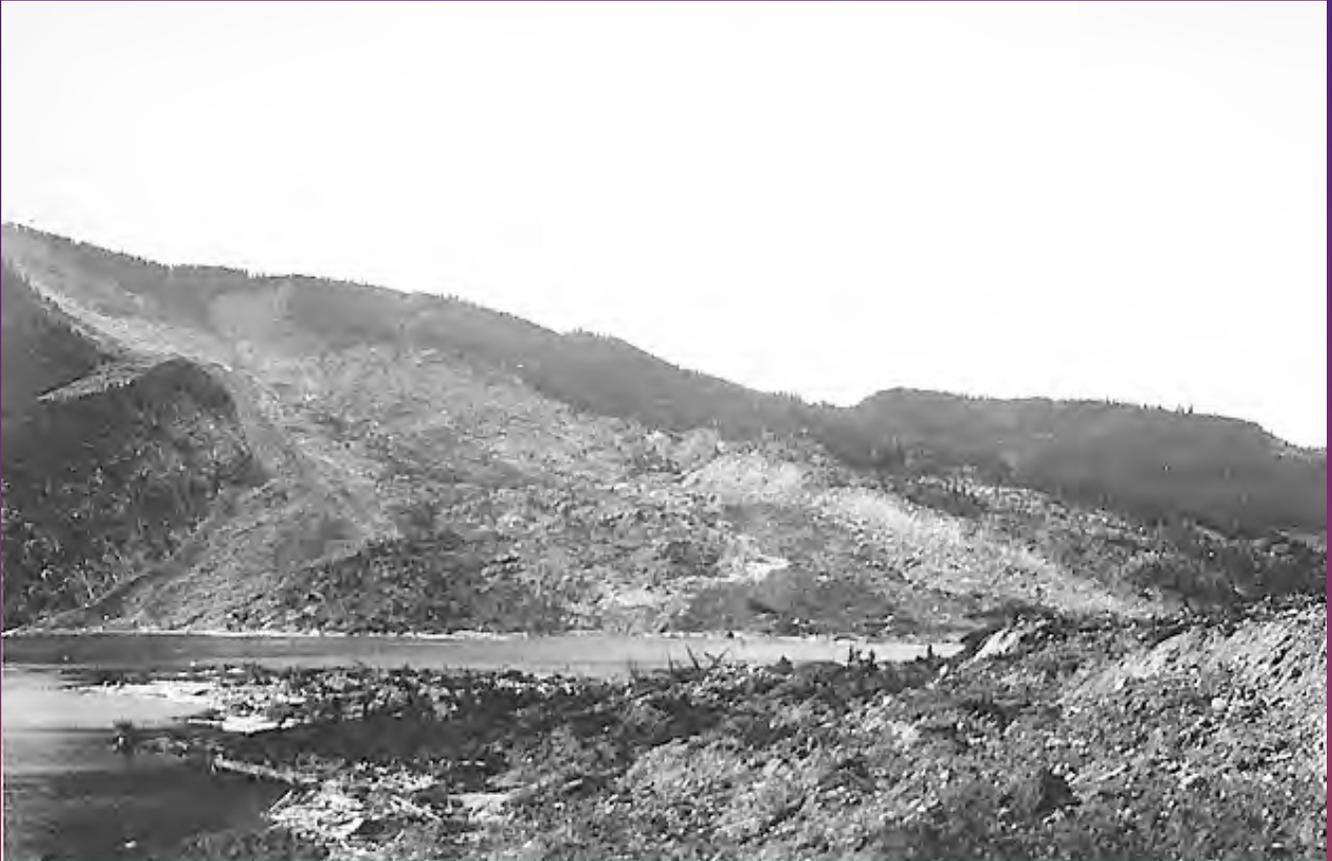
Gros Ventre landslide, Lincoln County, Wyoming, June 6, 1925, twenty-five people were killed and the landslide destroyed the town of Kelly. The view is south across foot of the lake created when the Gros Ventre River was dammed. Slumped surface of inner side of the dam in right foreground.

Thirty-eight million cubic-yard slide dammed the Gros Ventre River on June 23, 1925. In 1927, the landslide dam failed and the resulting flood destroyed the small town of Kelly, Wyoming. Six people drowned in the floodwaters. The slide location is approximately 40 miles south of Yellowstone National Park.

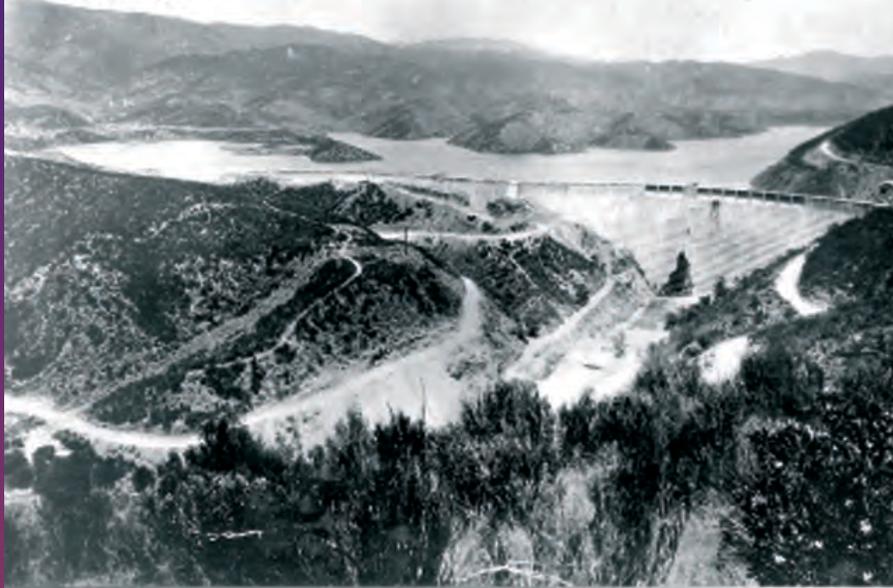
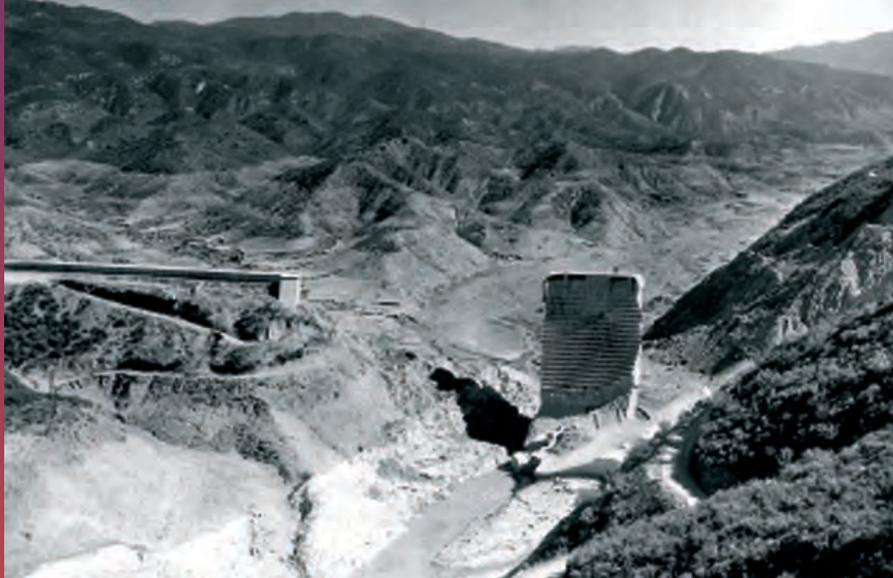
St. Francis dam failure, March 12, 1928—Los Angeles County, California. The bottom photo was taken March 17, 1928, and shows destroyed dam.

St. Francis Dam failure

Los Angeles County, California. The dam gave way on March 12, and its waters swept through the Santa Clara Valley toward the Pacific Ocean, about 54 miles away. Sixty five miles of valley was devastated, and over 500 people were killed. Damages were estimated at \$672.1 million (year 2000 dollars).

History: The dam was built in San Francisquito Canyon, a short distance north of the now heavily populated San Fernando Valley. The plan was to store aqueduct water behind the dam and distribute it by gravity to local storage reservoirs and eventually to users in the San Fernando Valley and the Los Angeles basin. The St. Francis Dam was a massive gravity dam; that is, it was designed to hold back water by its sheer weight alone, rather than with the support of an arch to distribute stresses into the foundation rock. The dam failed because of a pre-existing landslide in the east abutment that became soaked by water from the reservoir. It is now agreed that this paleo-landslide on the abutment moved, causing failure of the dam.

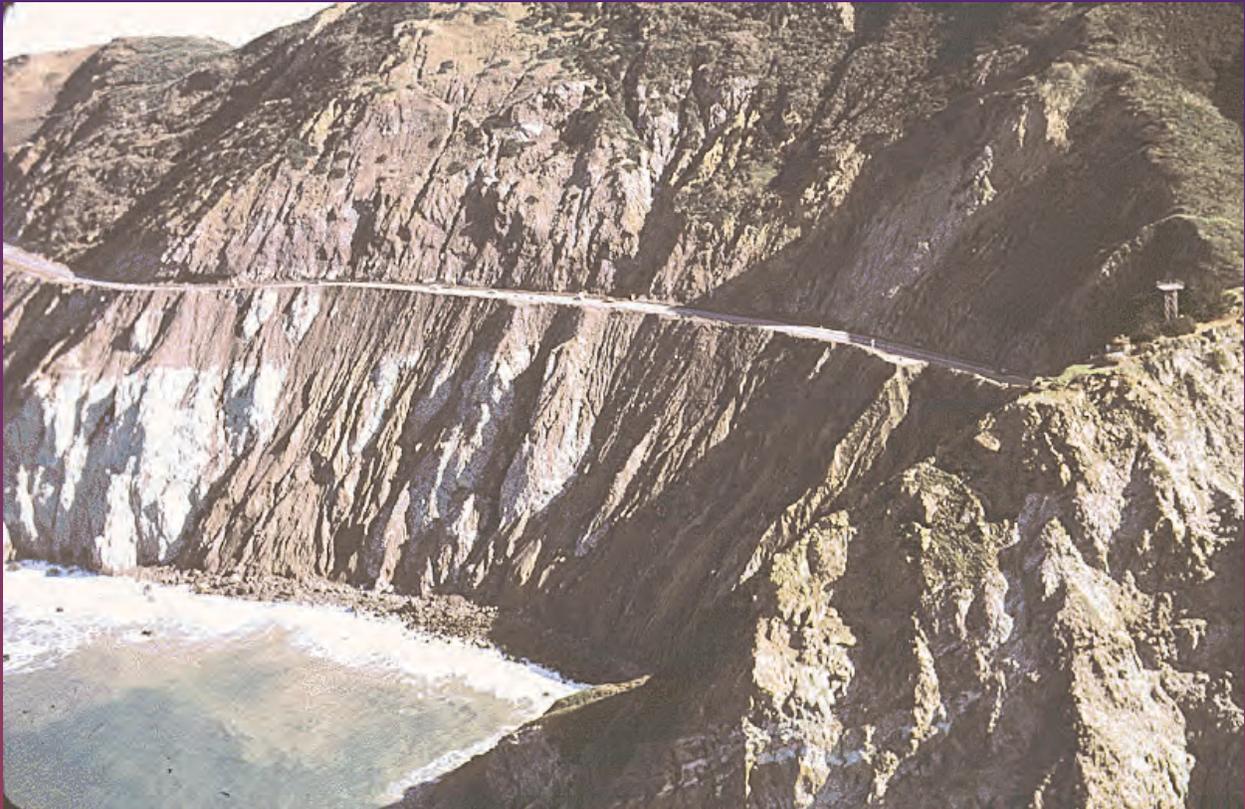
Devil's landslide along U.S. Highway 1 in San Mateo County, California. The landslide first began in 1937 and was reactivated as recently as 1996.

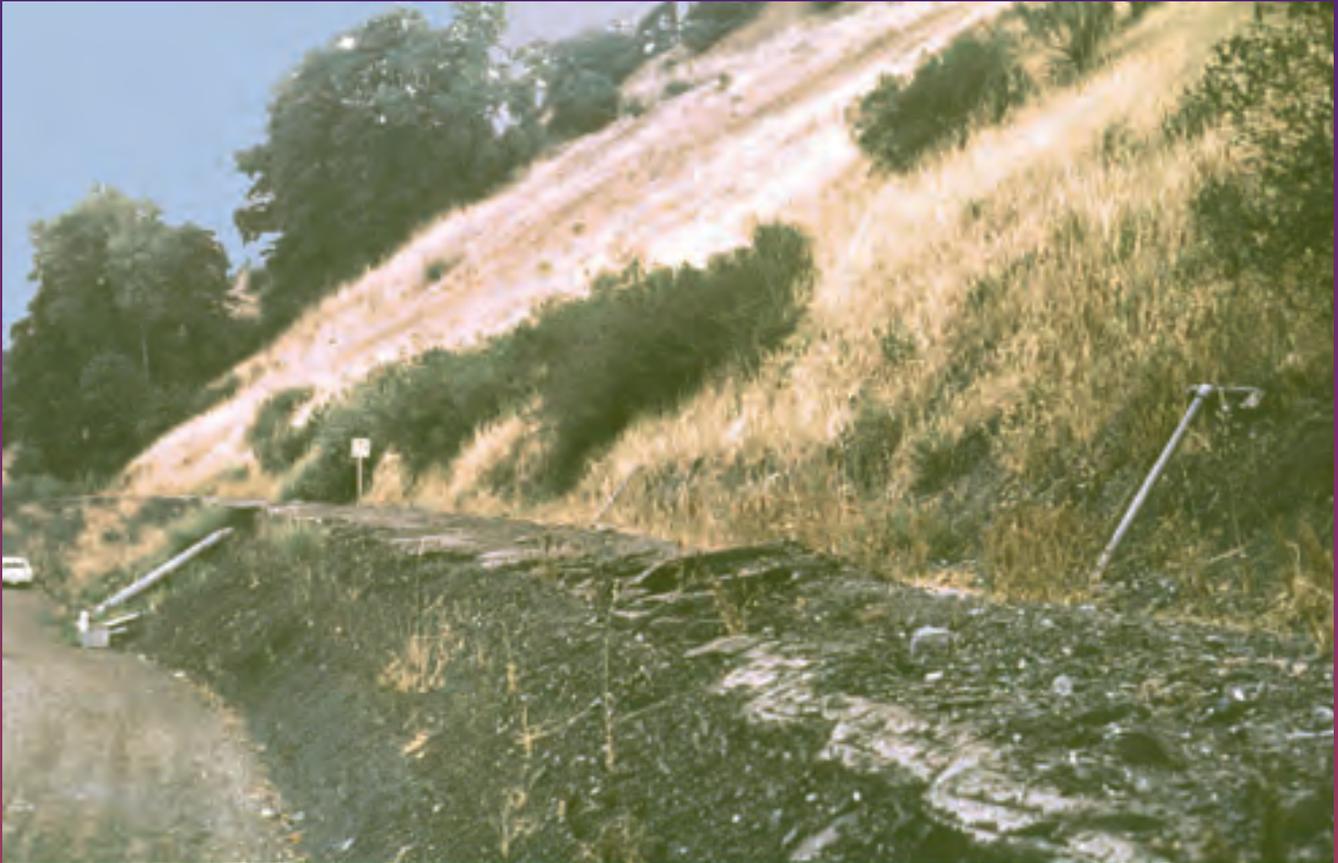
Cloverdale landslides, Sonoma County, California. These landslides occurred during the period 1938 to 1970. *Photograph by Fred Taylor, U.S. Geological Survey (taken July 1971).*

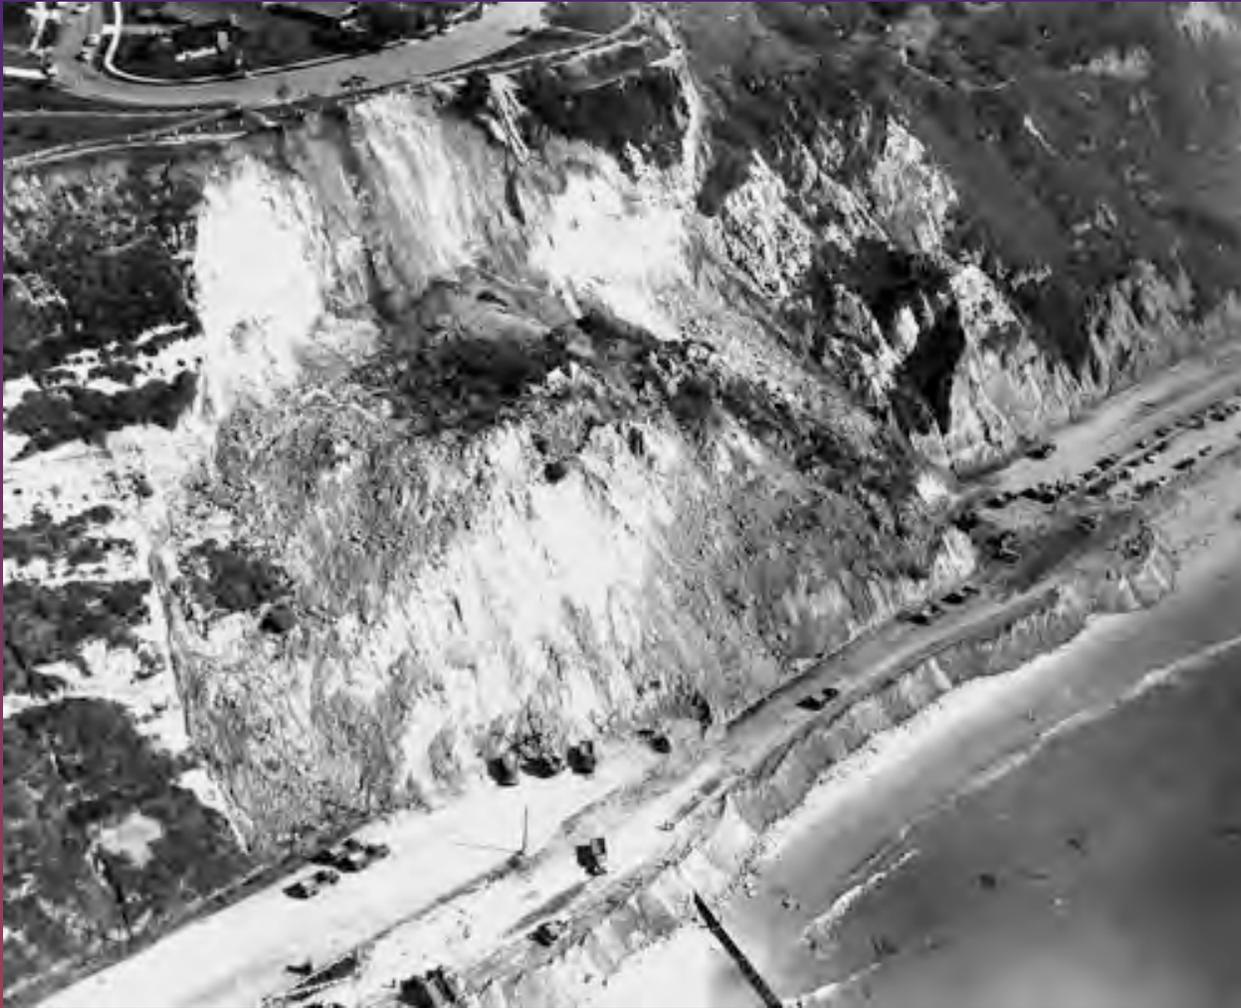
Landslide of February 3, 1956 off of Via de las Olas Palisades, Pacific Palisades area, Los Angeles, California.

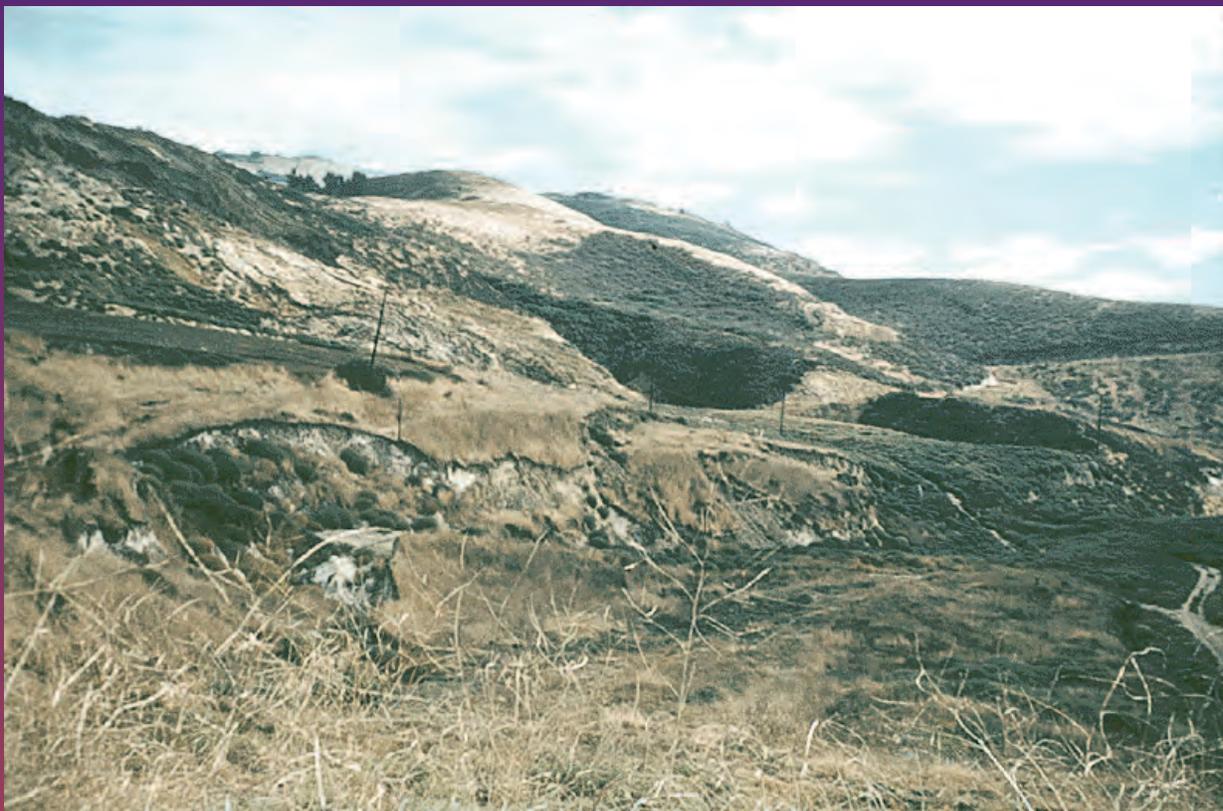
Head-scarp of the Portuguese Bend landslide that caused about 45 million dollars in damage in 1956.

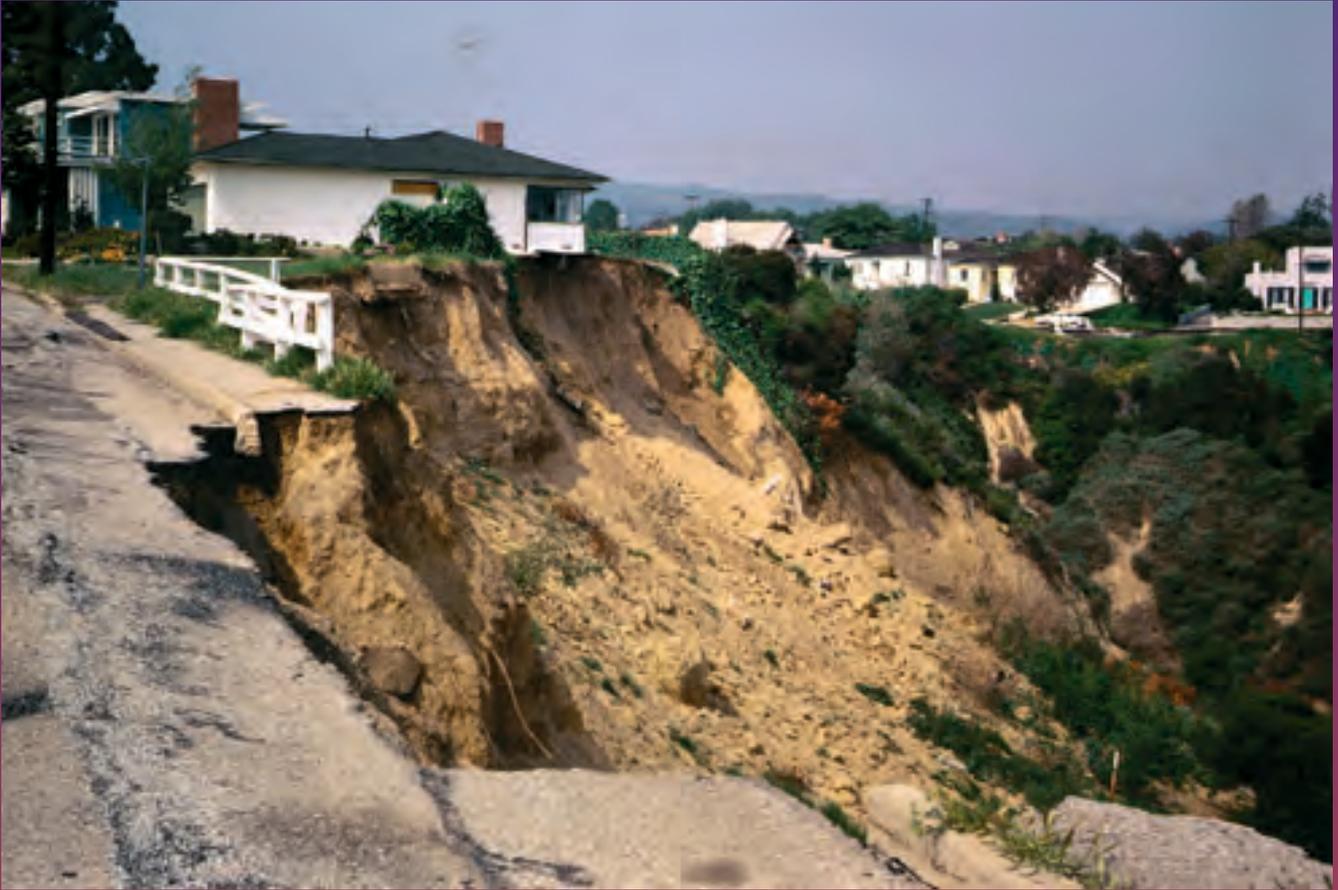
Landslides occurred in Pacific Palisades, California during the 1958-1971 period. The photograph of the Friends Street landslide shows detail of damage and overhanging corner of Friends Street. The view of the photograph is north-northeast. *Photograph by Jack McGill, U.S. Geological Survey.*

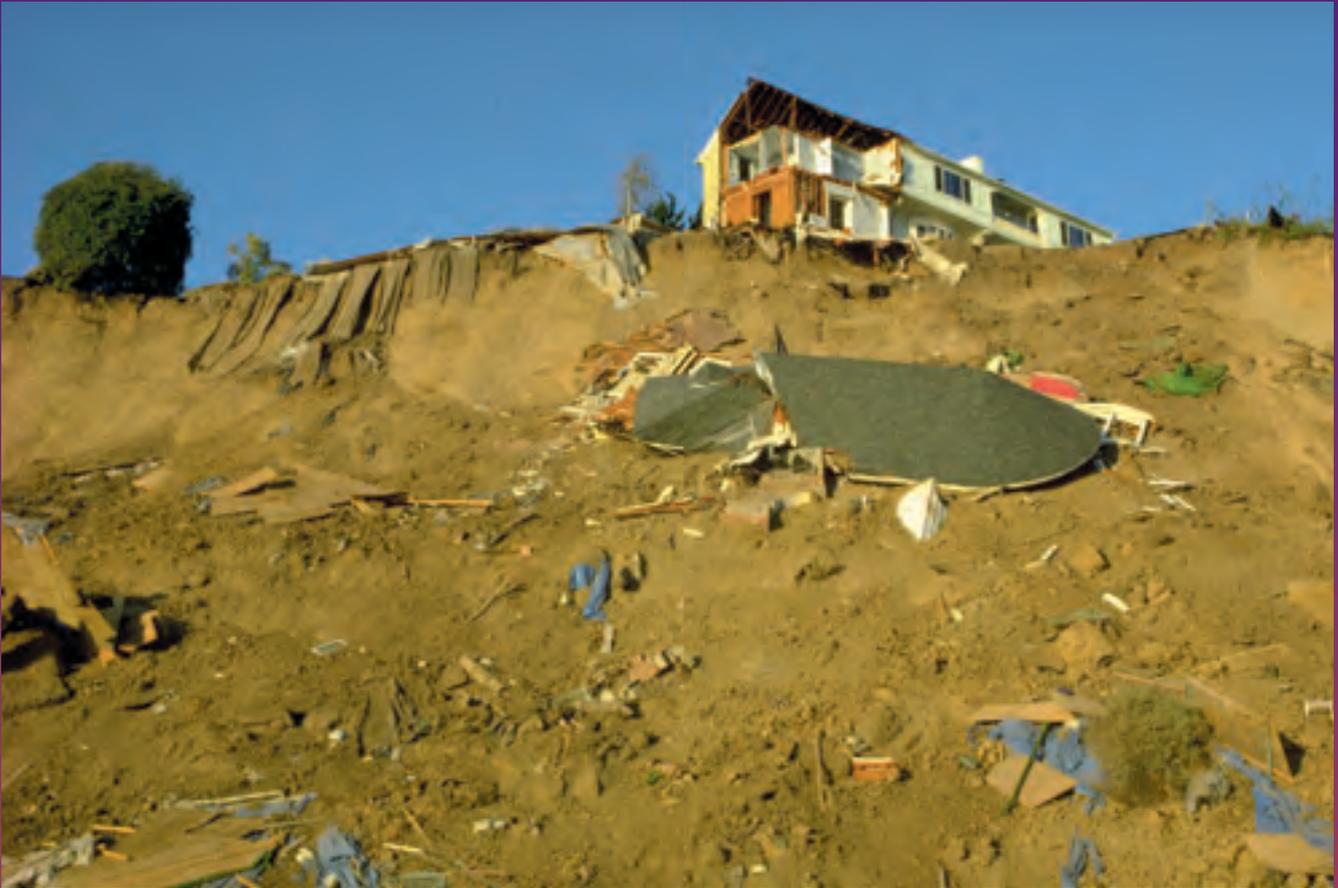
This home in Pacific Palisades near Santa Monica was damaged when the coastal bluff on which it was built failed during the earthquake. The landslide caused half the house to be torn loose and cascade down the steep slope.

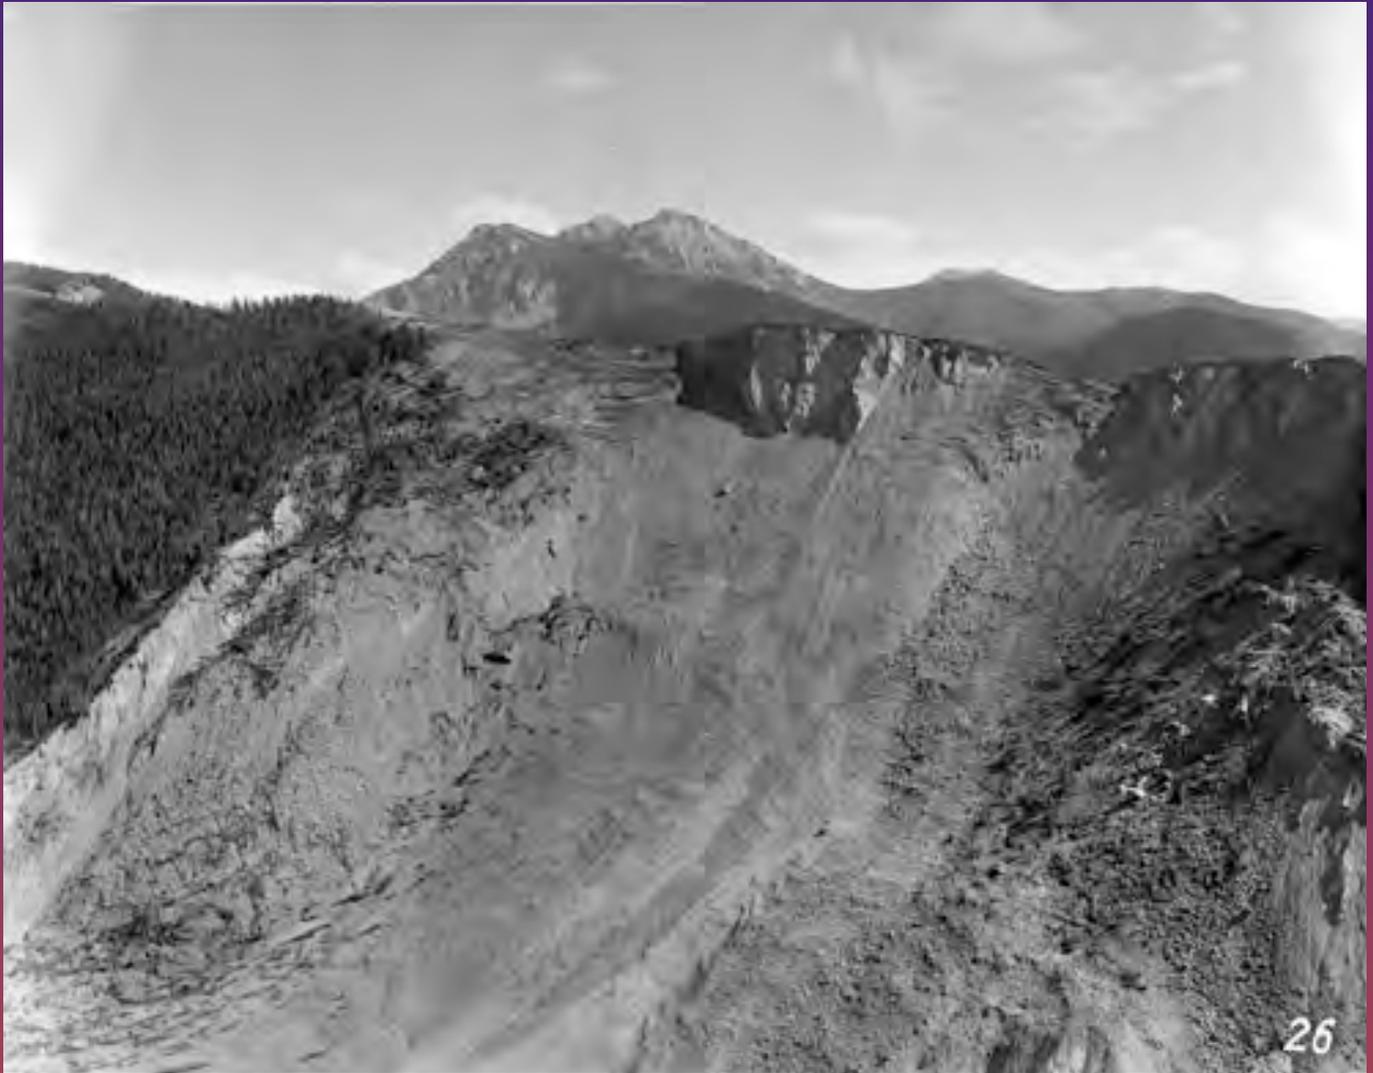
Headscarp of the 1959 Madison Canyon landslide. The magnitude 7.5 Hebgen Lake earthquake caused the massive slide that killed 28 people. *Photograph courtesy of the U.S. Forest Service.*

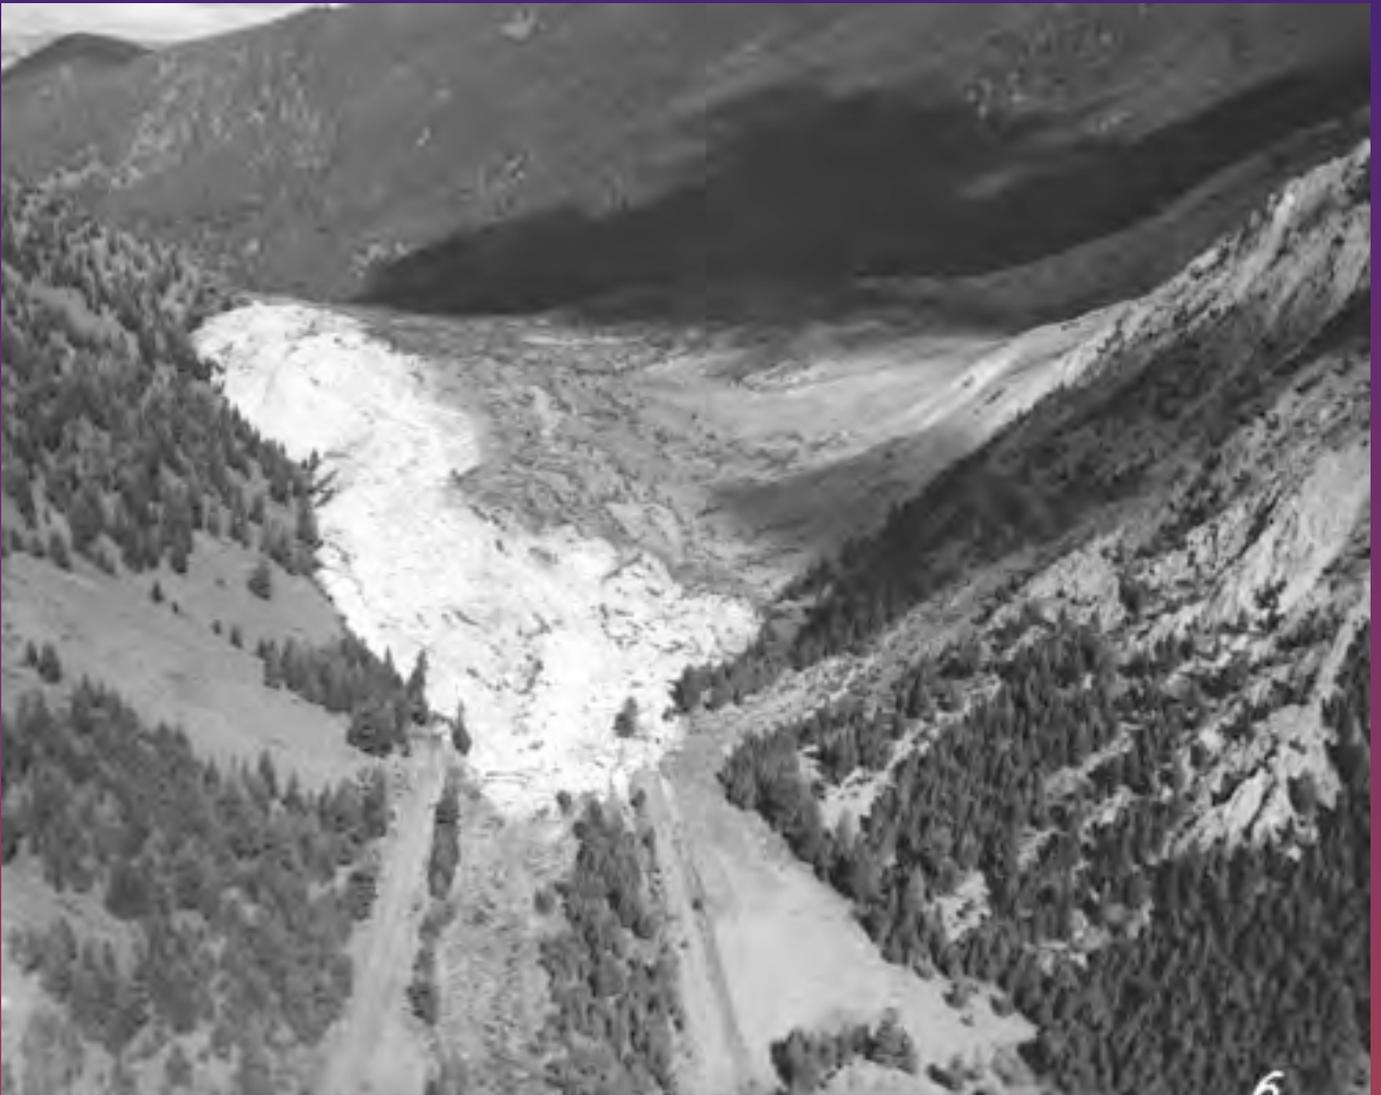
The 1959 Madison Canyon landslide, Montana caused by the Mg 7.5 Hebgen Lake earthquake. This view is from a point down river from where this massive slide dammed the Madison River. The resulting blockage of the river formed Earthquake Lake. *Photograph courtesy of the U.S. Forest Service.*

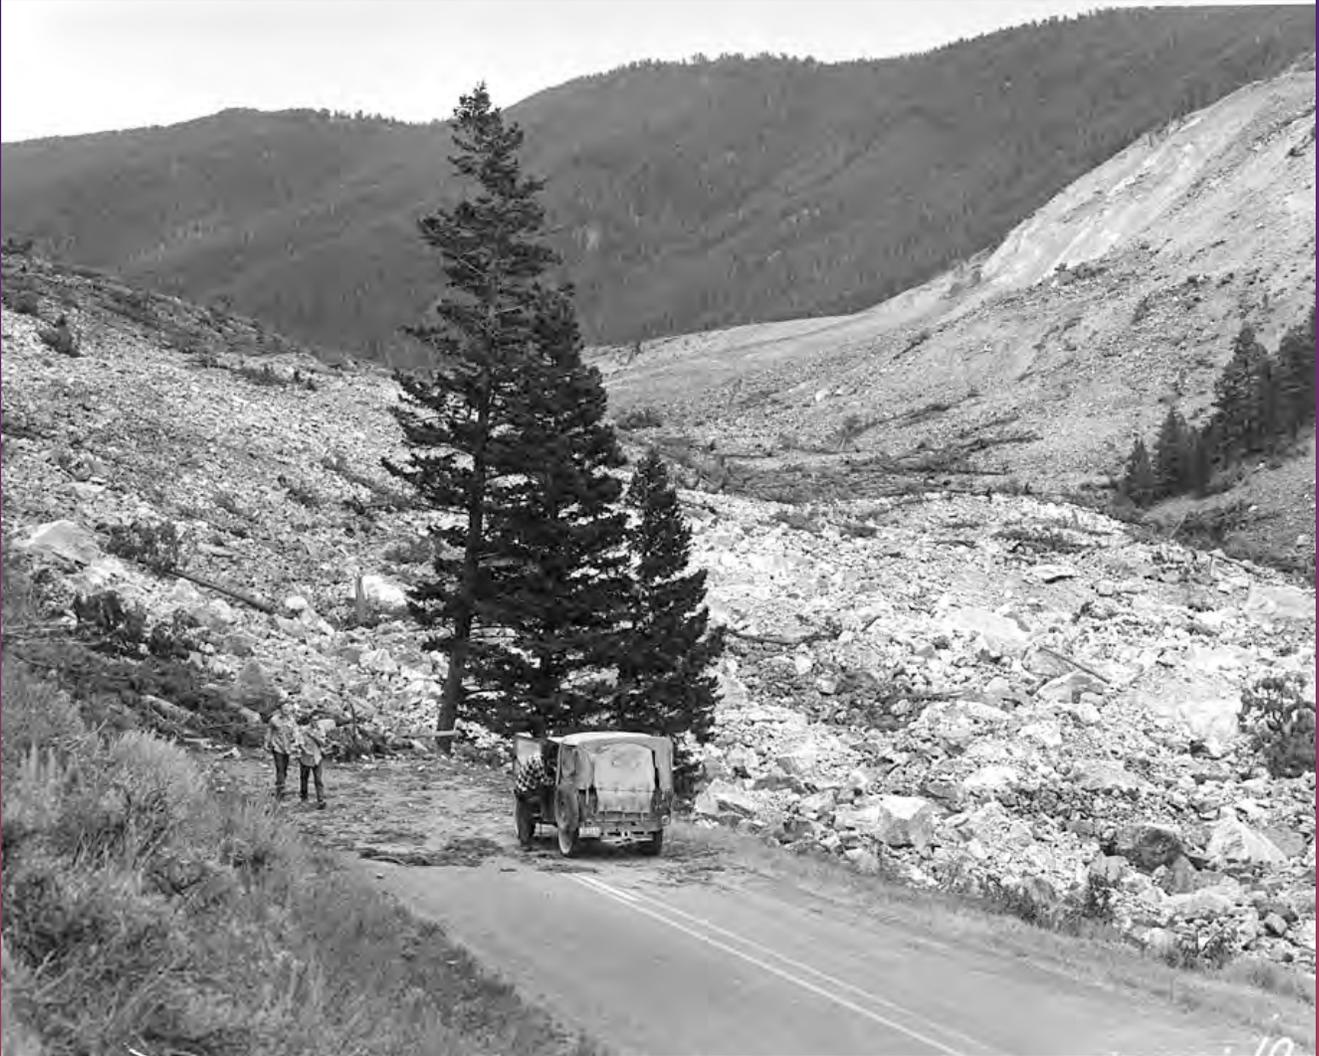
Landslide resulting from the Hebgen Lake, Montana earthquake of August 17, 1959. The massive rockslide dammed the Madison River, impounding Earthquake Lake.

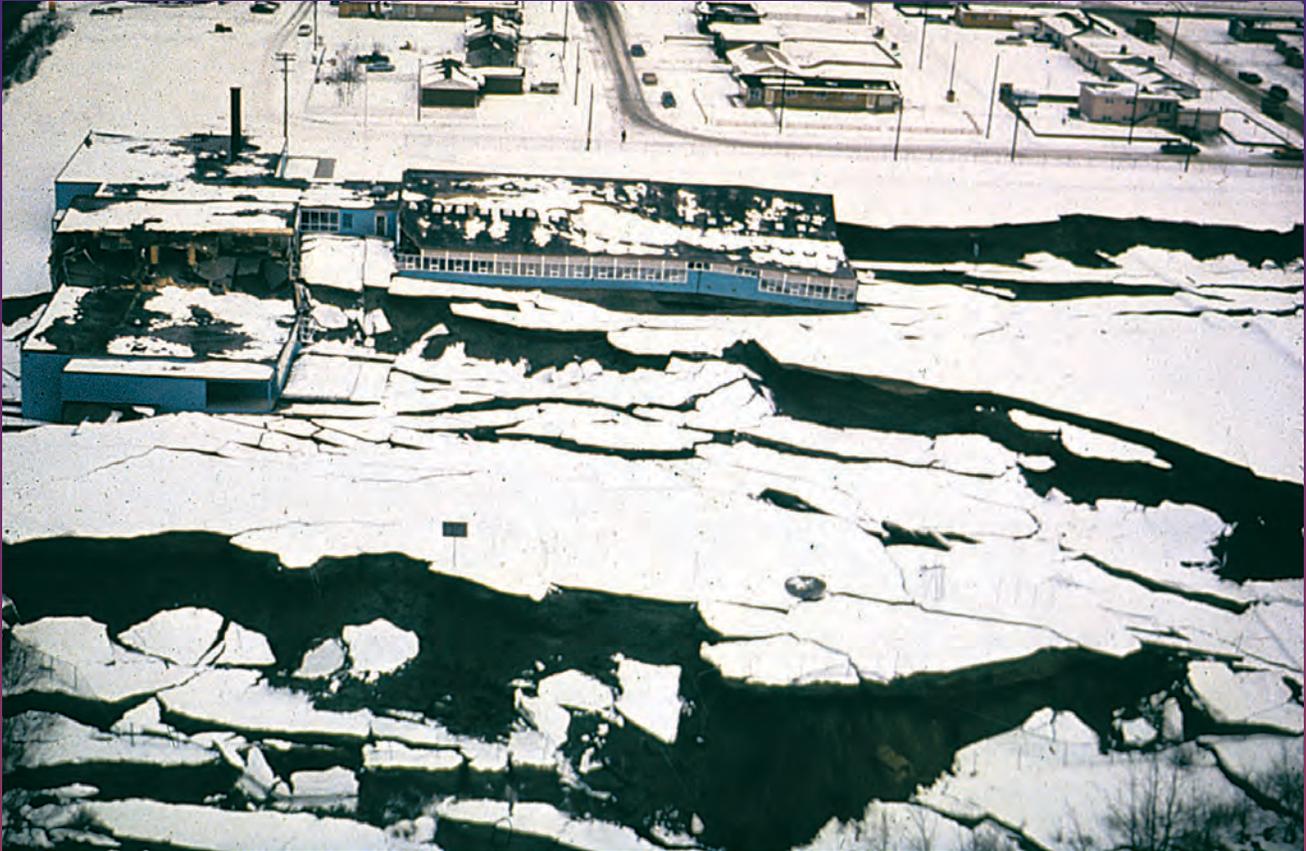
Subsidence of the graben at the head of the Government Hill landslide in Anchorage tore apart an elementary school and converted the schoolyard into a jumble of fissures, scarps, and tilted and subsided blocks of broken ground. The flat and relatively unbroken large slide block in the foreground moved away from the school horizontally and as a single mass, creating a void into which the graben block spread and subsided.

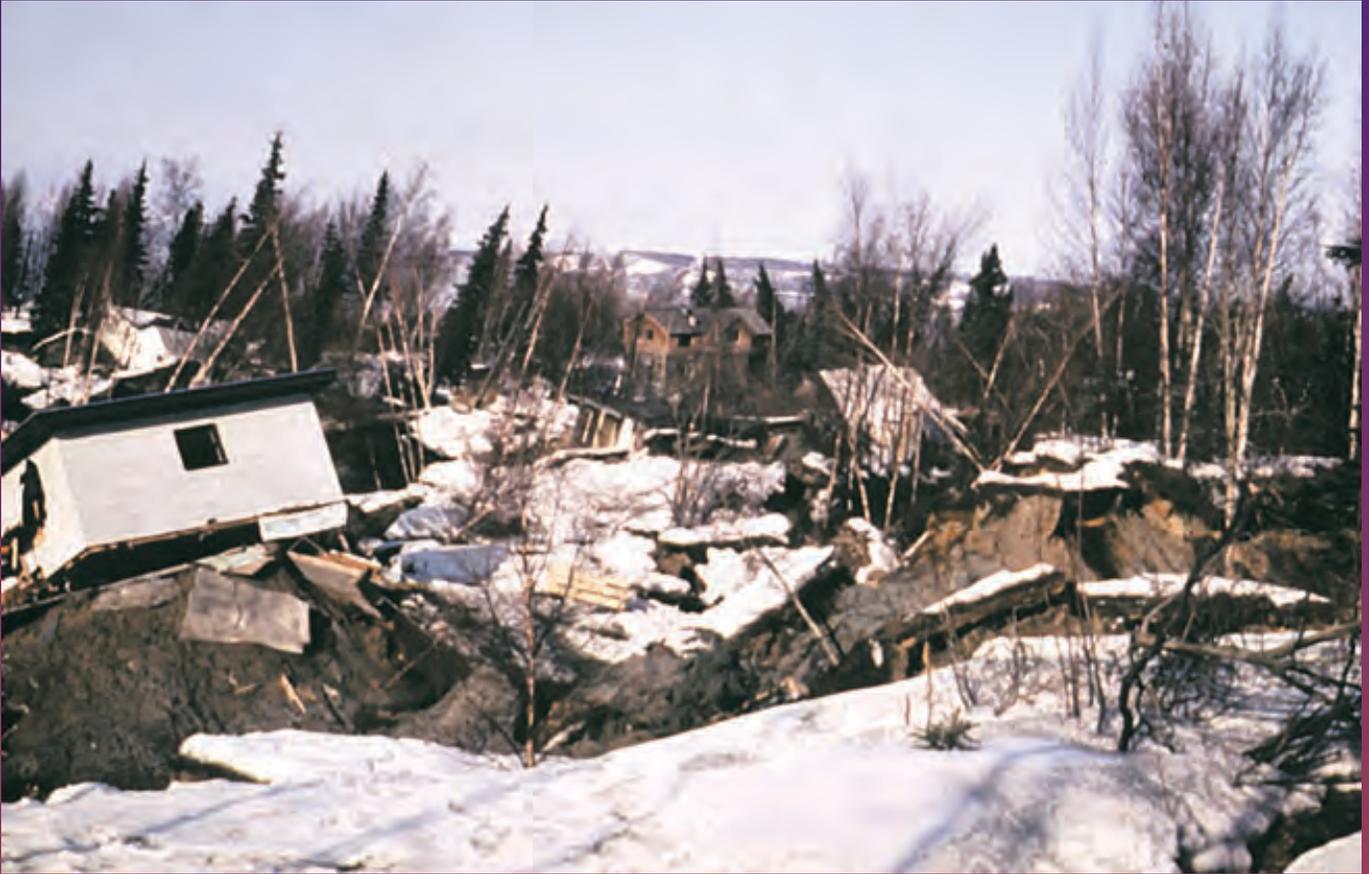
Damage resulting from landslides caused by the 1964 earthquake near Anchorage, Alaska. *Photograph , U.S. Geological Survey, Circular #491, 1964.*

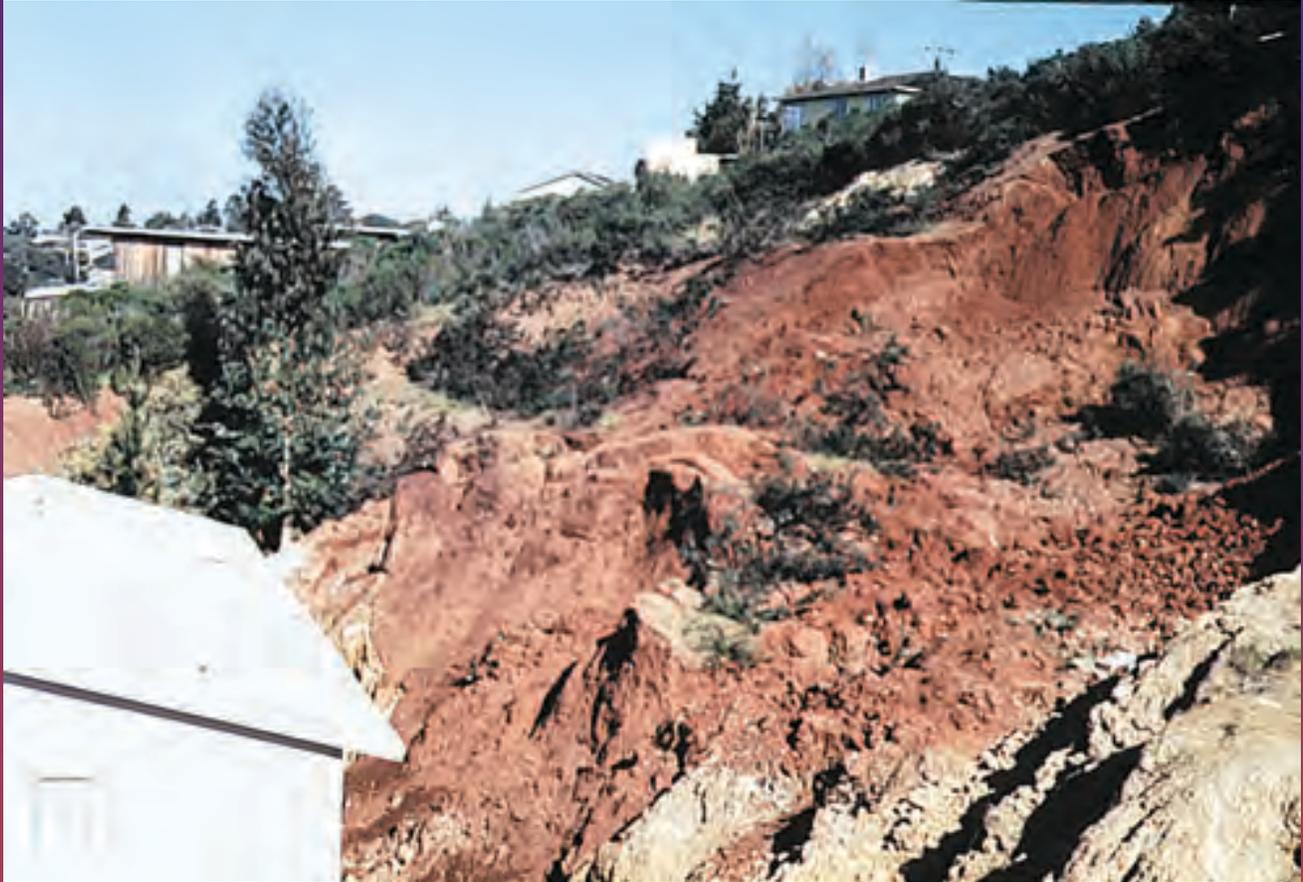
Landslide in Belmont, California, resulting from 1968-69 storms.
Photograph by Fred Taylor, U.S. Geological Survey.

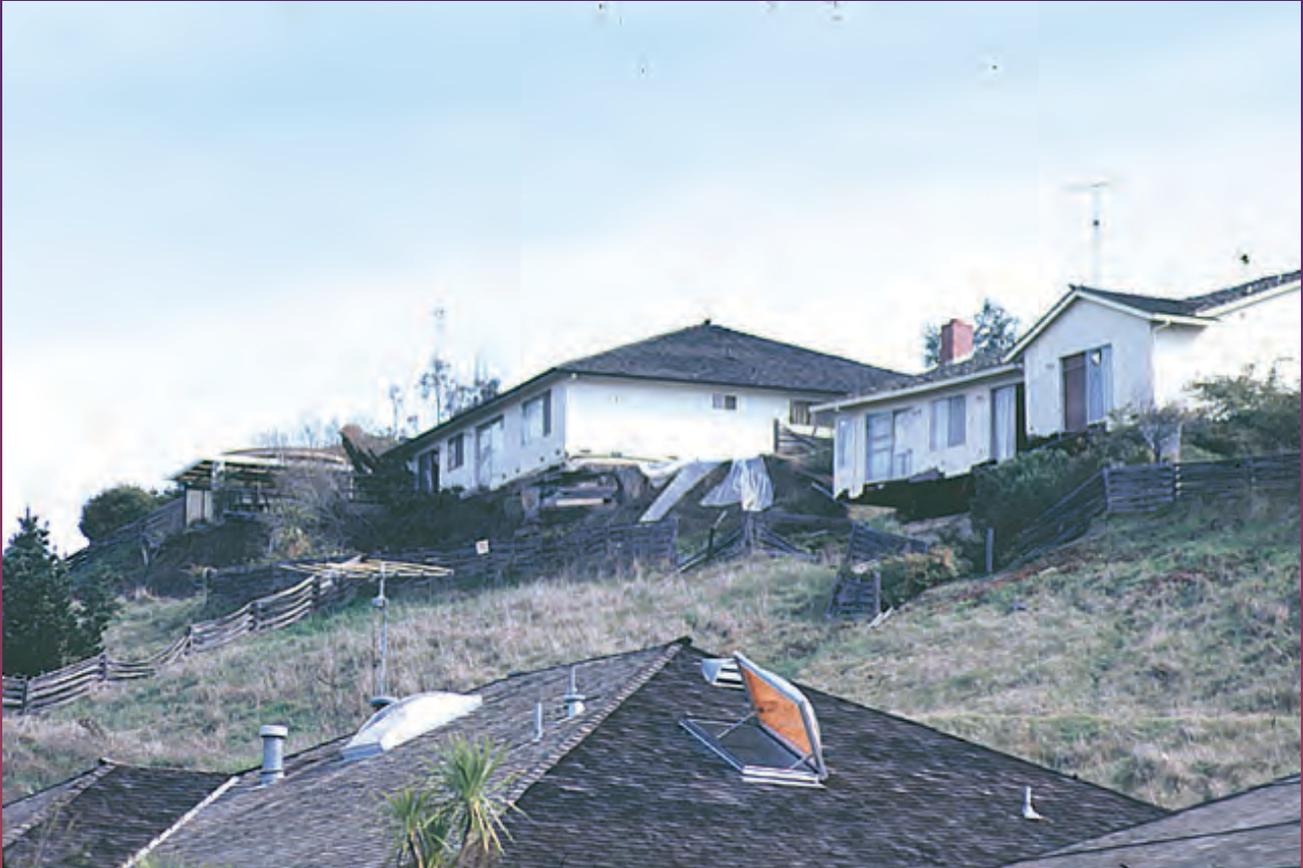
San Mateo County, California. Damage from the 1968-69
San Francisco Bay Area landslides.

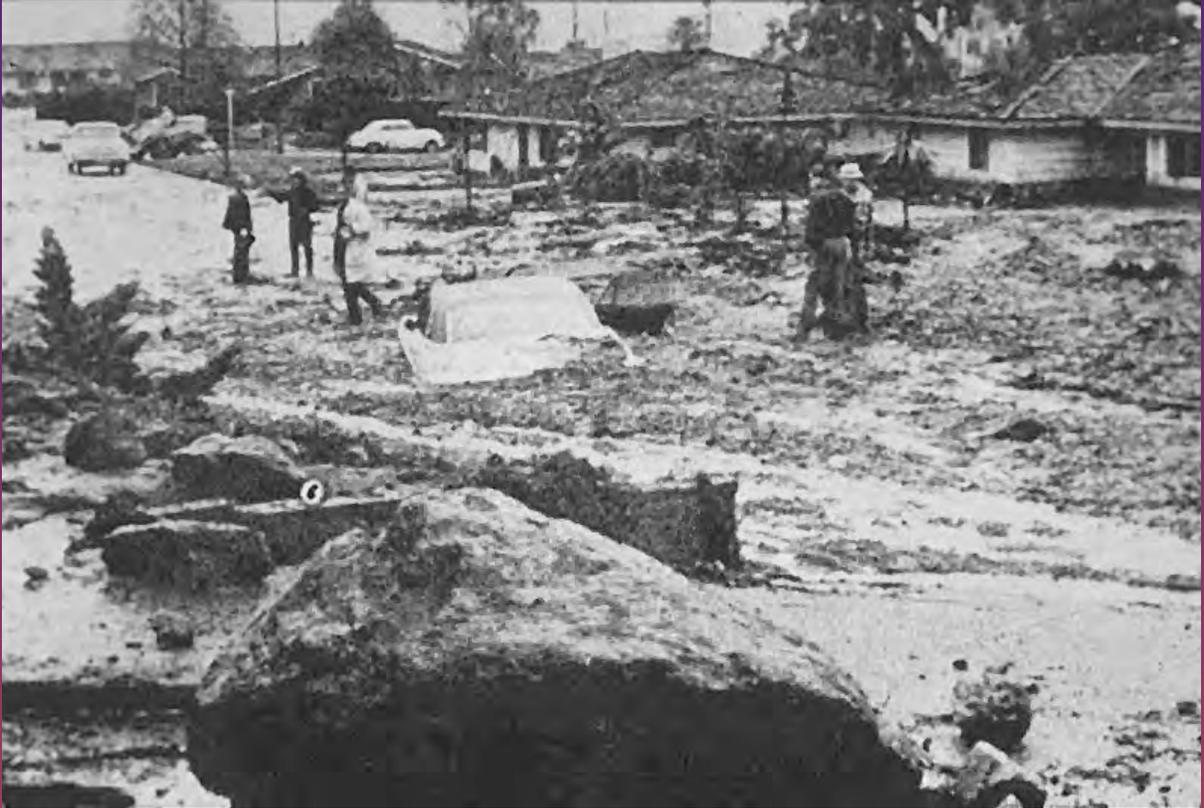
Debris-flow damage, Glendora, California. In 1969, 175 homes were damaged or destroyed during this event.

Cost, \$26.9 million (2000 dollars)—Los Angeles County, 175 houses damaged, mainly by debris flows.

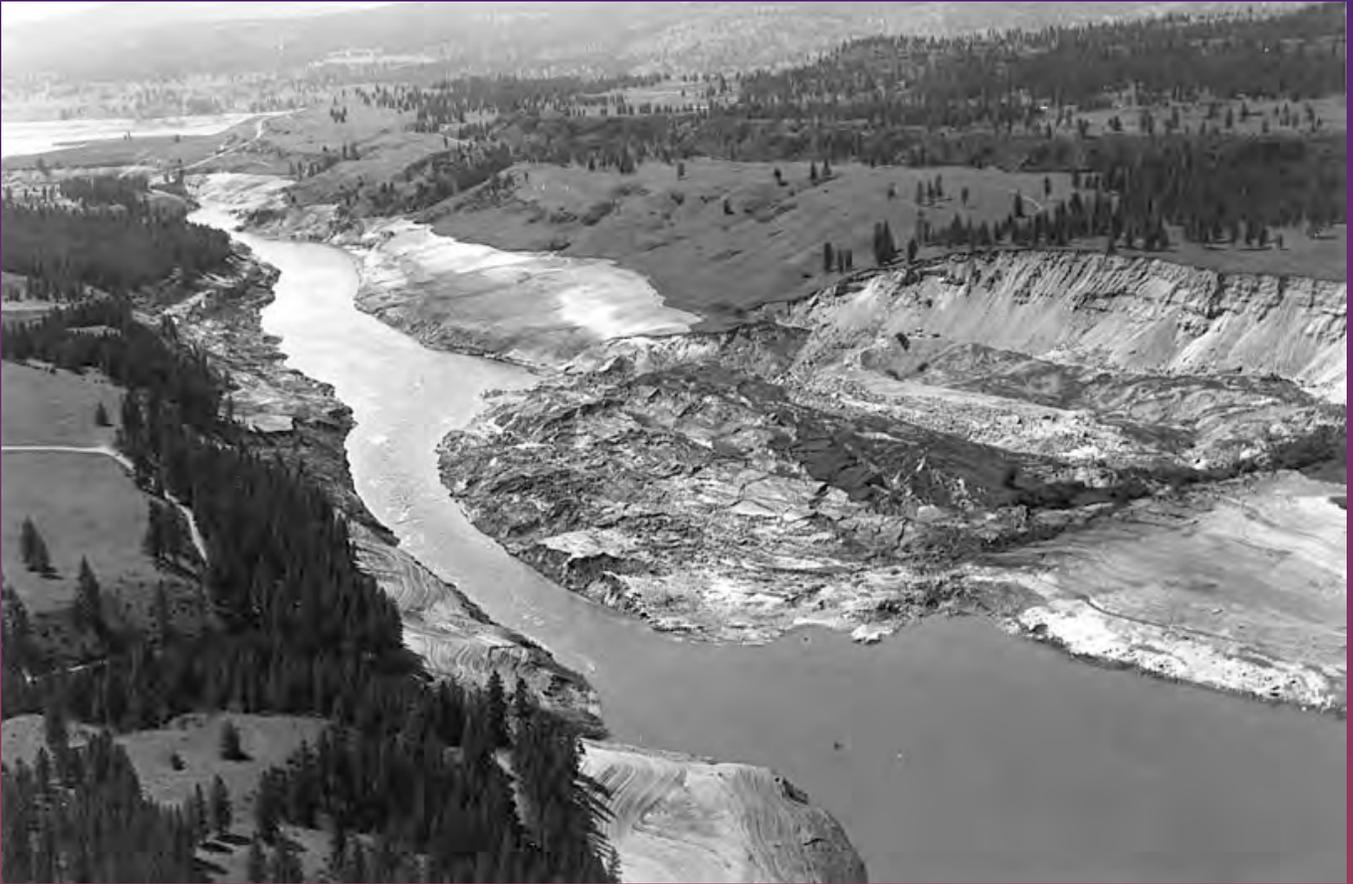
Jackson Springs landslide on the Spokane arm of Franklin D. Roosevelt Lake, Washington. This earth slump, with a volume estimated at more than 11 million cubic meters (14 million cubic yards), occurred in 1969 during a period of extreme draw down necessitated by excavation for a forebay dam preliminary to construction of the Third Powerplant at Grand Coulee Dam. *Photograph courtesy of the U.S. Bureau of Reclamation.*
