Significant Landslide Events in the United States

*by Lynn M. Highland and Robert L. Schuster
Graphic presentation by Margo L. Johnson*

Abstract

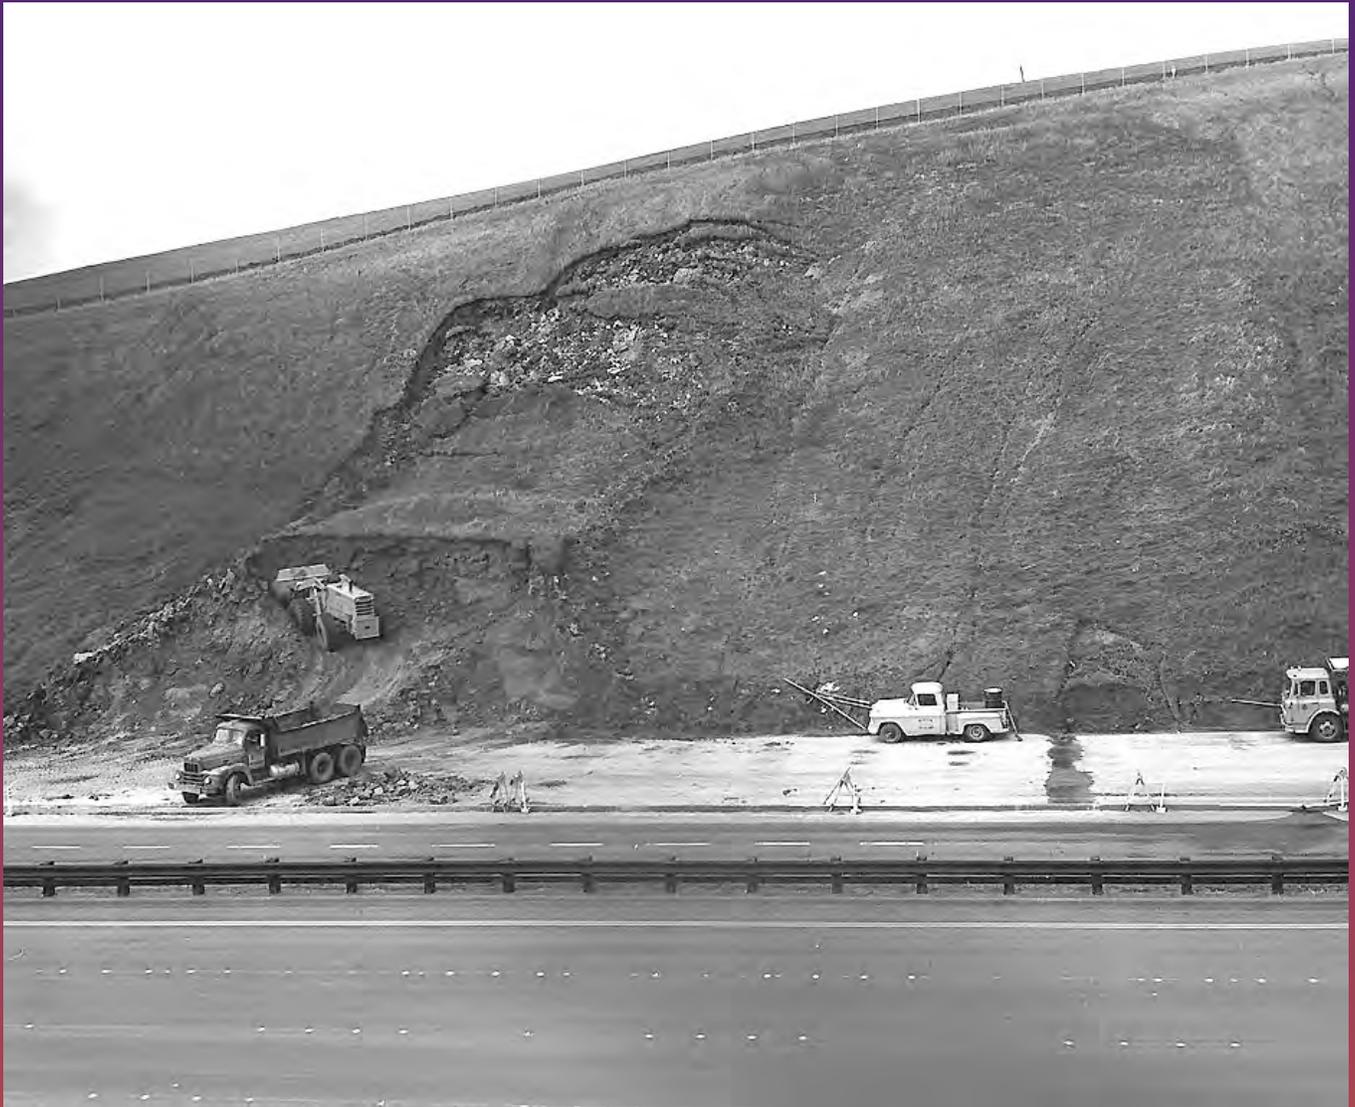
Landslide on Interstate 5 in northern California which occurred in 1969. There was a single fatality and the cost of repair to the highway was over 10 million dollars. *Photograph by E. Pampeyan.*

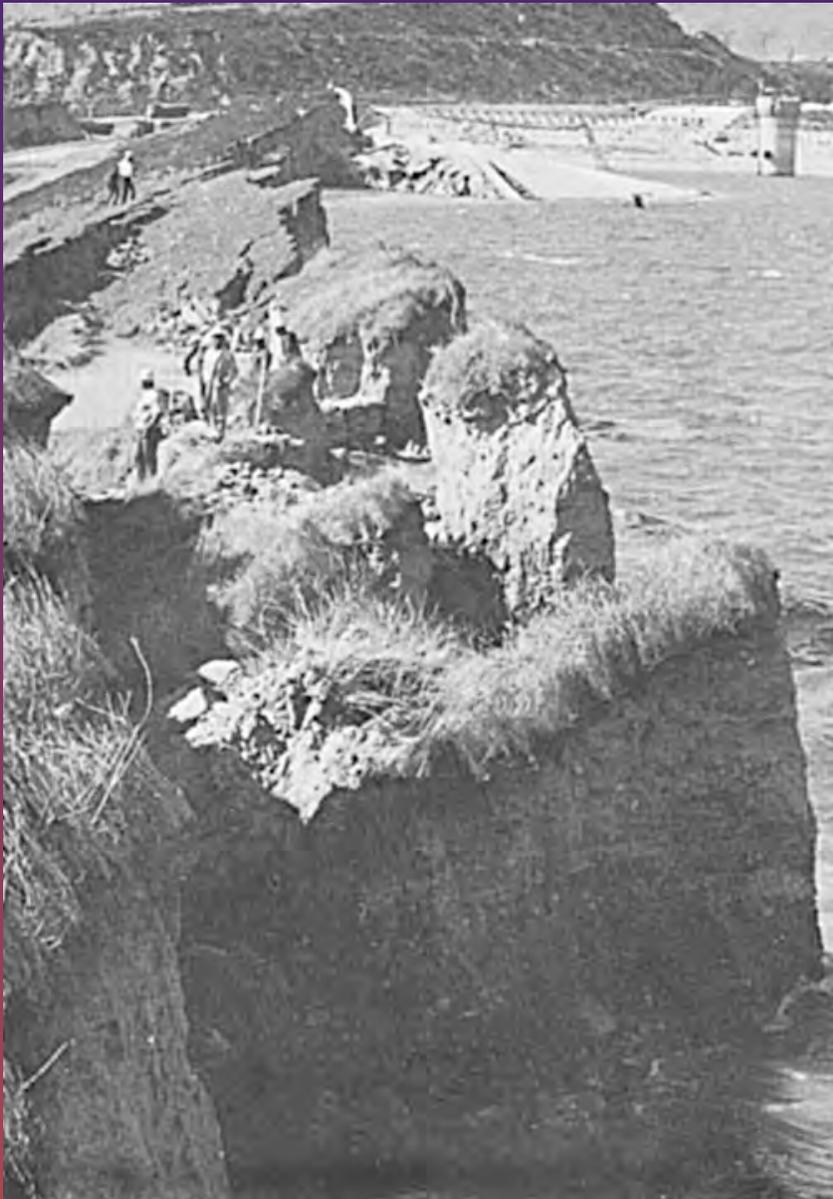
Scarp of upstream slope failure in the Lower Van Norman Lake Dam.

Earthquake-induced landslides—Cost, \$302.4 million (2000 dollars). Damage due to the February 9, 1971, magnitude 7.5 San Fernando, California, earthquake. The earthquake of February 9 severely damaged the Upper and Lower Van Norman Dams. The principal damage to the Lower Van Norman Dam (built in 1918) was a massive upstream slope failure which dislodged a major segment of the earthfill embankment and deposited it on the reservoir floor. The slide carried with it the upstream concrete lining and crest of the dam and moved along a rupture surface which intersected the downstream face of the dam at an elevation only 1.5 meters above water level. This dam appeared to have been on the brink of failure, which would have created catastrophic inundation of the heavily populated area below. Eighty thousand people were forced to abandon their homes for 4 days while the water level in the reservoir was lowered to a level that would preclude flooding in case of further damage to the dam during strong aftershocks. The massive slope failure in the Lower Van Norman Dam may have been caused by seismically induced inertia forces alone or in concert with liquefaction of the embankment materials, tectonic deformation, or foundation soil failures.

The Upper Van Norman Dam (built in 1921) subsided about 0.9 meters (2.8 feet) and shifted downstream about 1.5 meters (6 feet) during the earthquake shock. Extensive cracking and slumping disrupted the upstream concrete lining of this dam, and the downstream slope of the embankment also was cracked. Possible causes for the subsidence and downstream movement of the Upper Van Norman Dam include seismic compaction, lateral spreading of the embankment, and foundation movements associated with landslides. Damage to the canals in the vicinity was generally in the form of cracked and broken concrete linings and displaced canal banks. In nearly all places this damage was related to slumping of the canal structure by an underlying landslide.

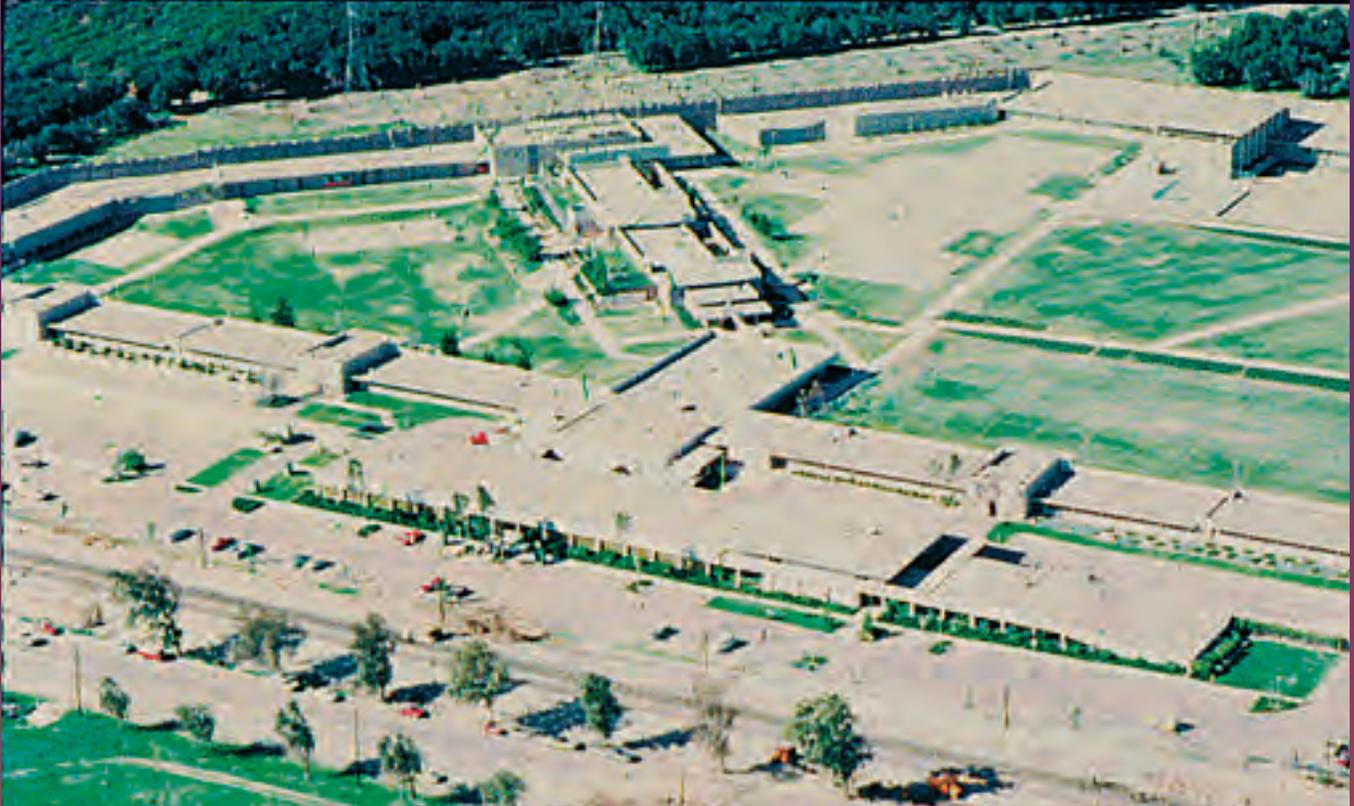
The landslide caused over 238 million dollars in damage to the Juvenile Hall facility; building and facility shown in the photograph.
Photograph courtesy of Lloyd Cluff.

Landslides caused by the February 9, 1971, San Fernando, California, earthquake—Cost, \$266.6 million (2000 dollars). One of the most damaging slides caused by the San Fernando earthquake (magnitude 7.5) was in the vicinity of the Van Norman Lakes. In addition to damaging the San Fernando Juvenile Hall, this 1.2 km-long slide damaged trunk lines of the Southern Pacific Railroad, San Fernando Boulevard, Interstate Highway 5, the Sylmar, California, electrical converter station, and several pipelines and canals. Because this slide occurred in an area of relatively low gradient, the most reasonable explanation for the slippage of the Juvenile Hall slide was that the underlying soils were partially or completely liquefied during the earthquake. The many sand boils observed on or near the slide are evidence that this occurred.

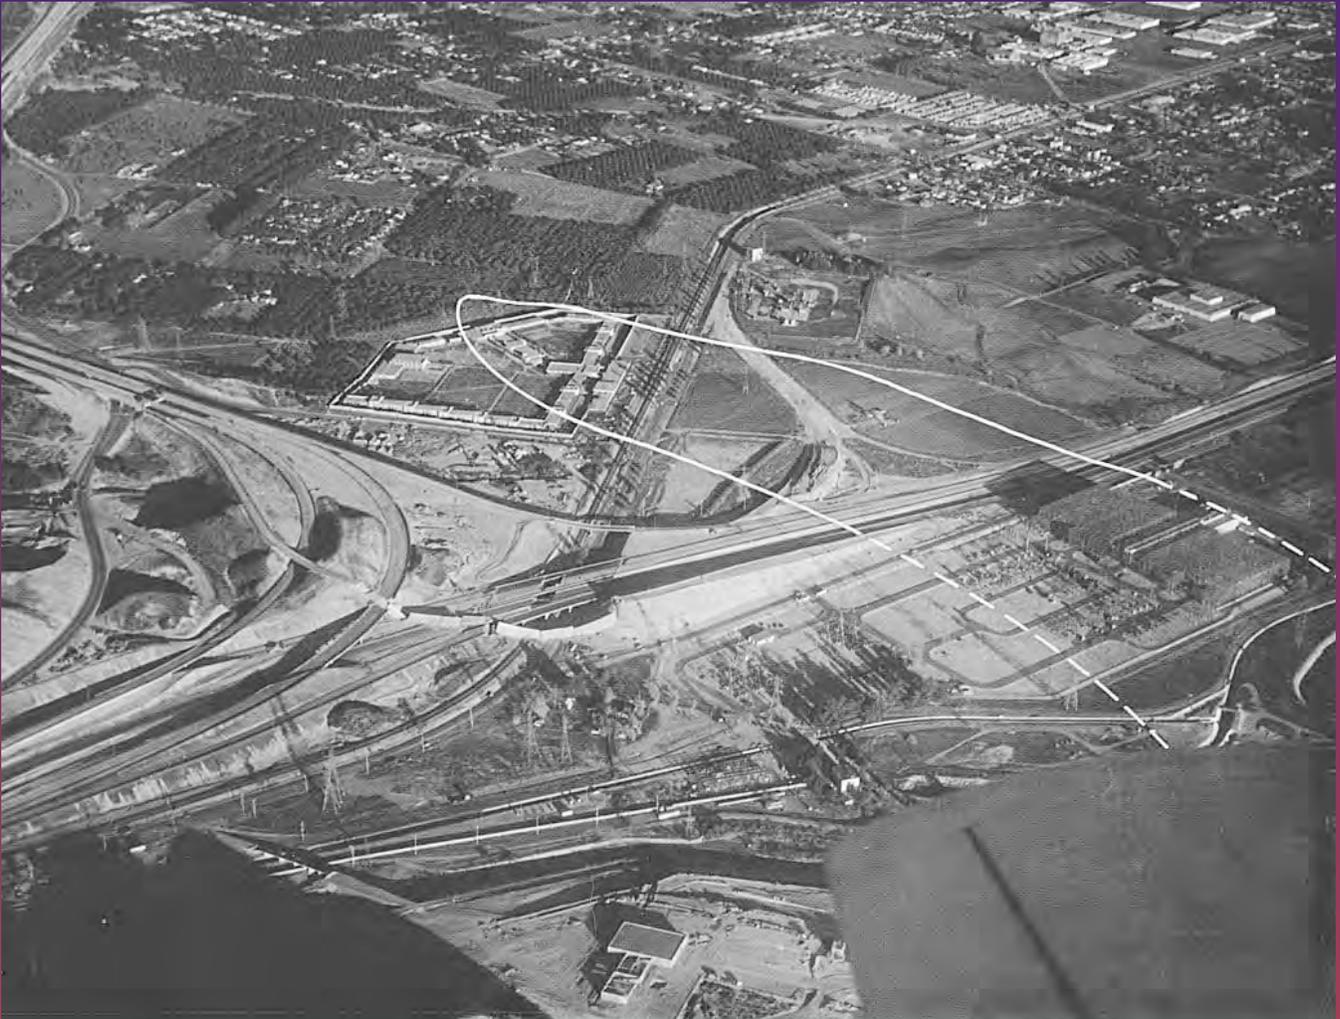
Oblique photograph of San Fernando Valley Juvenile Hall area and approximate boundaries of the Juvenile Hall slide.

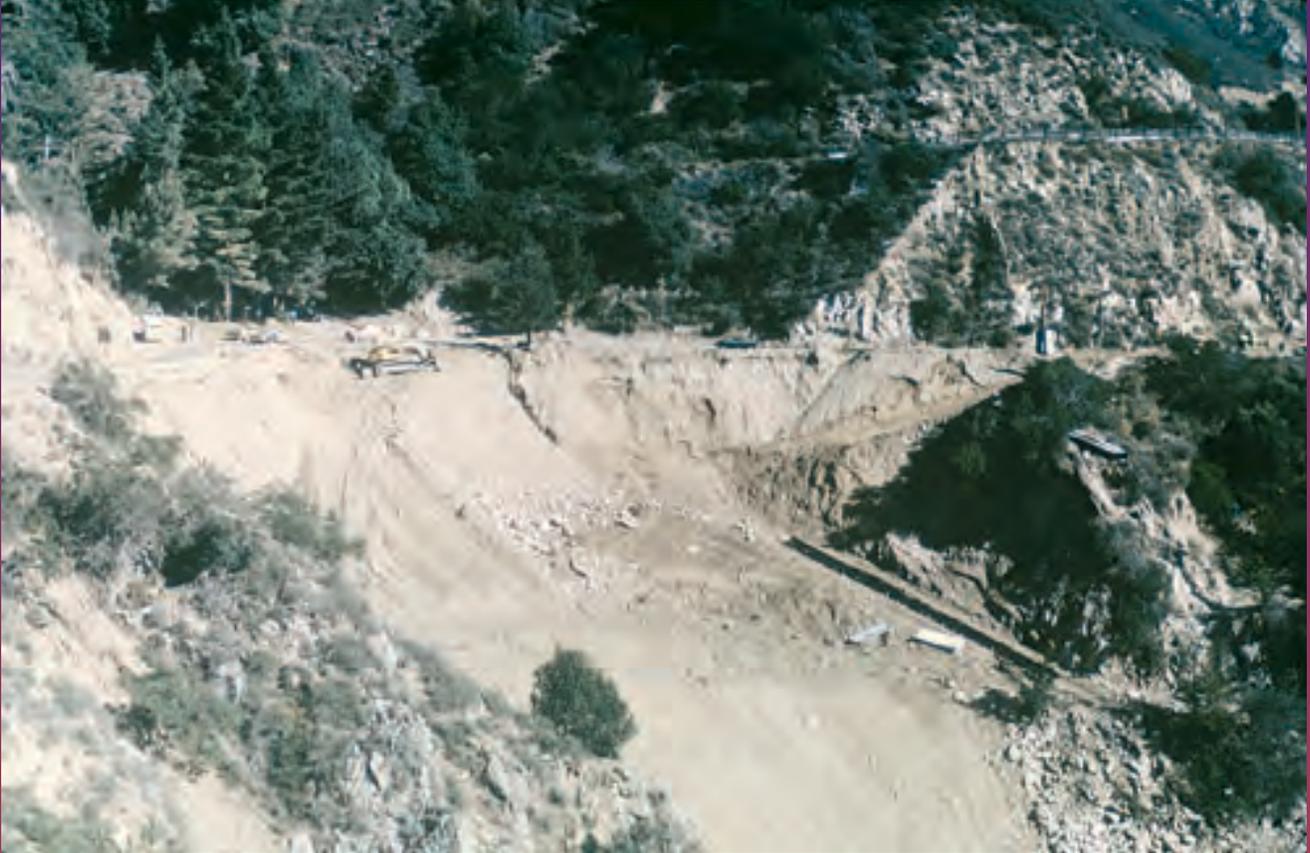
Photograph showing the damage to U.S. Highway 1 near Big Sur, California in 1973. Damage costs were estimated at over 23 million dollars.

Cost, \$26.9 million (2000 dollars)—California Highway 1 and surrounding areas. A wildfire, on August 1, 1972, developed west of California Highway 1, north of Big Sur Village, burning 4,300 acres of chaparral, grass, and timber. A series of rainstorms occurred in mid-October and lasted for several days, with a repeat performance again in mid-November. Both storm periods brought flooding and mudflow activity, the second period being more destructive. Damage included highways blocked by mud and debris, dozens of cars smashed into trees by the flows, and inundation of houses and other buildings by water, mud, and debris.

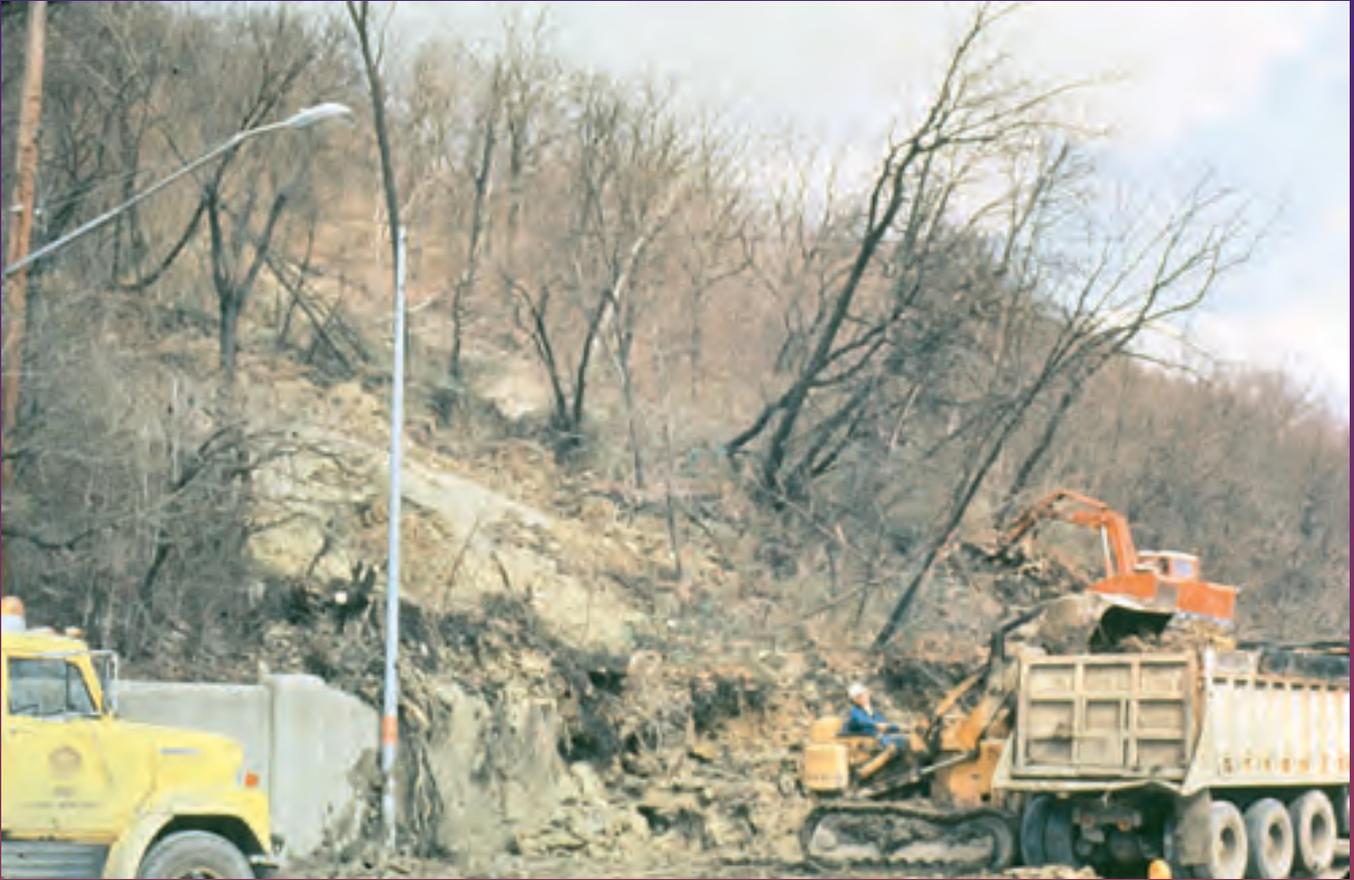
Earthflow in Cincinnati, Ohio. Material being removed by highway crew along the Columbia Parkway, Cincinnati, Ohio. Hamilton County, in the metropolitan Cincinnati area, experienced an average annual economic loss of \$5.80 per person (1975 dollars) between 1973 and 1978, the highest calculated per capita loss of any municipality in the United States. *Photograph by Earl Brabb, U.S. Geological Survey.*

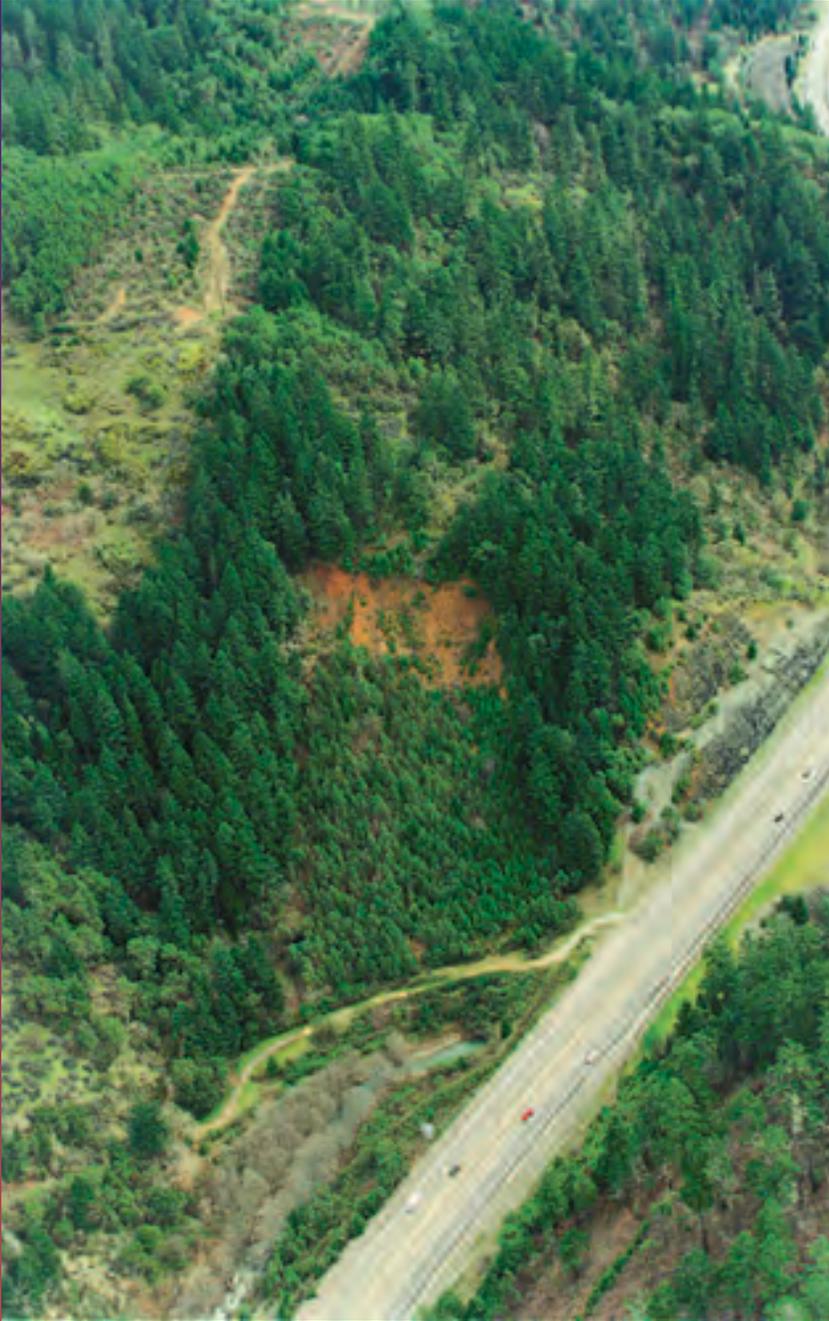
Small catastrophic landslide near Canyonville, Oregon, which occurred on January 16, 1974, killing nine construction workers. This landslide is one of the single most costly in the United States in terms of lives lost in the 20th century. *Photo by Ed Busby, GeoWest, Inc.*

January 16, Douglas County, nine were killed when a catastrophic landslide, although small, caused great loss of life to a construction crew working on a coaxial cable. This was one of the most deadly single slides of the 20th century in the U.S.

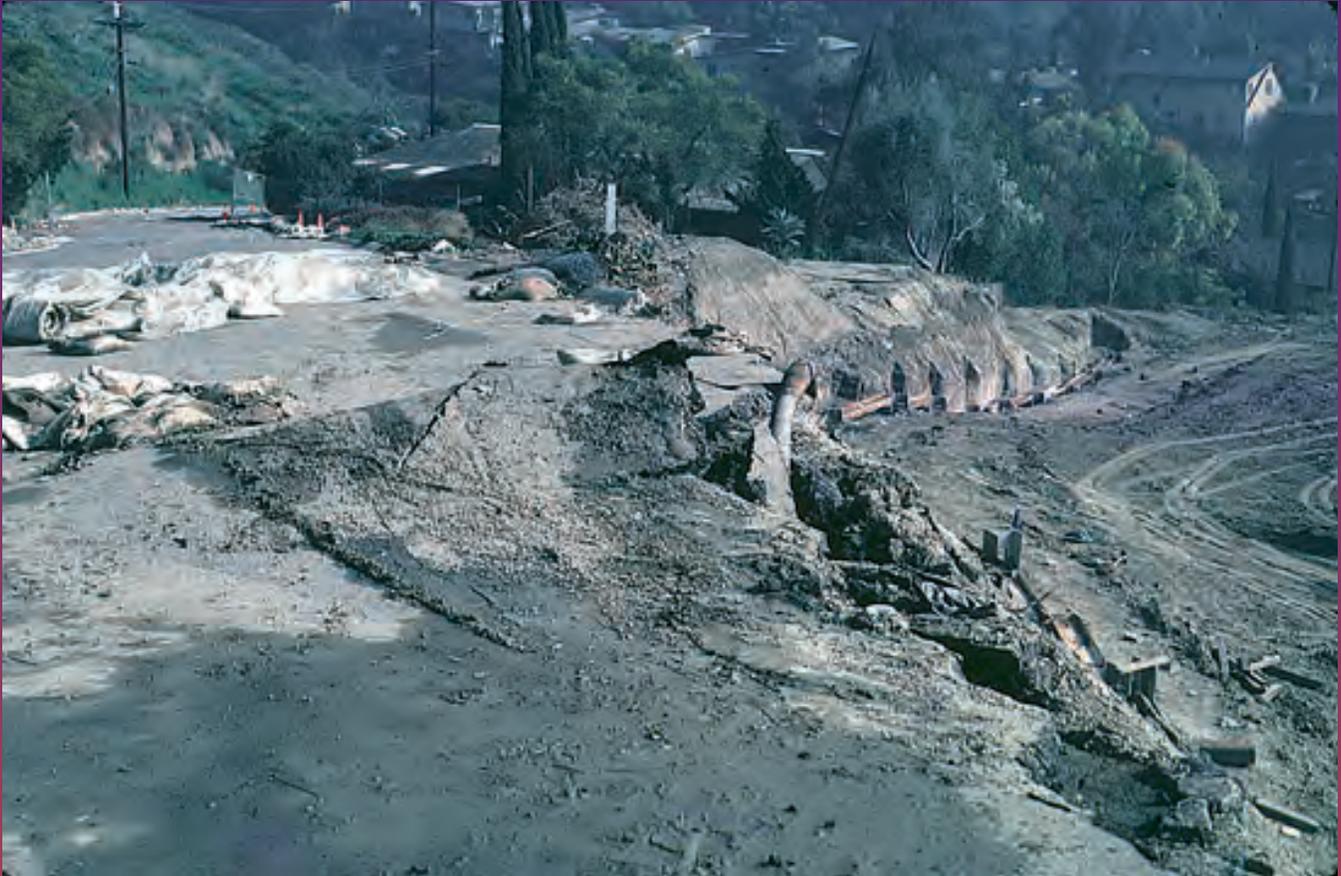
Bluebird Canyon landslide, Laguna Beach California. The landslide occurred on April 21, 1978. *Photograph courtesy of Bruce Clark, Leighton & Associates, California.*

October 2, cost, \$52.7 million (2000 dollars)—60 houses destroyed or damaged. Unusually heavy rains in March of 1978 may have contributed to initiation of the landslide. Although the 1978 slide area was approximately 3.5 acres, it is suspected to be a portion of a larger, ancient landslide. The Bluebird Canyon landslide was determined to be a “block glide” or “rock block” slide—a slide with little or no rotational movement.

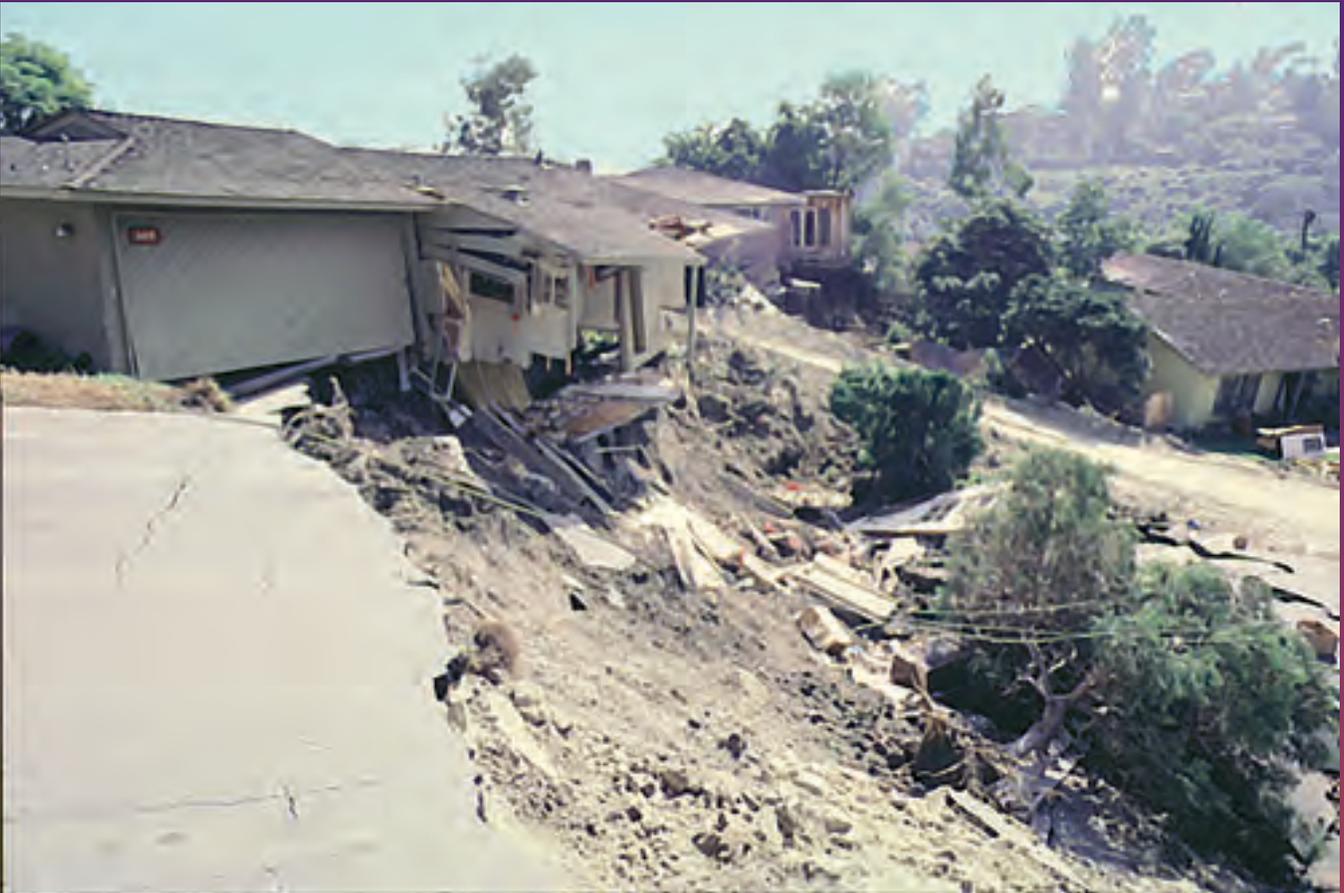
Bluebird Canyon landslide, Laguna Beach, California. This slide occurred on April 21, 1979. Houses affected were a total loss and could not be rebuilt on the site. *Photograph by Bruce Clark, Leighton & Associates, California.*

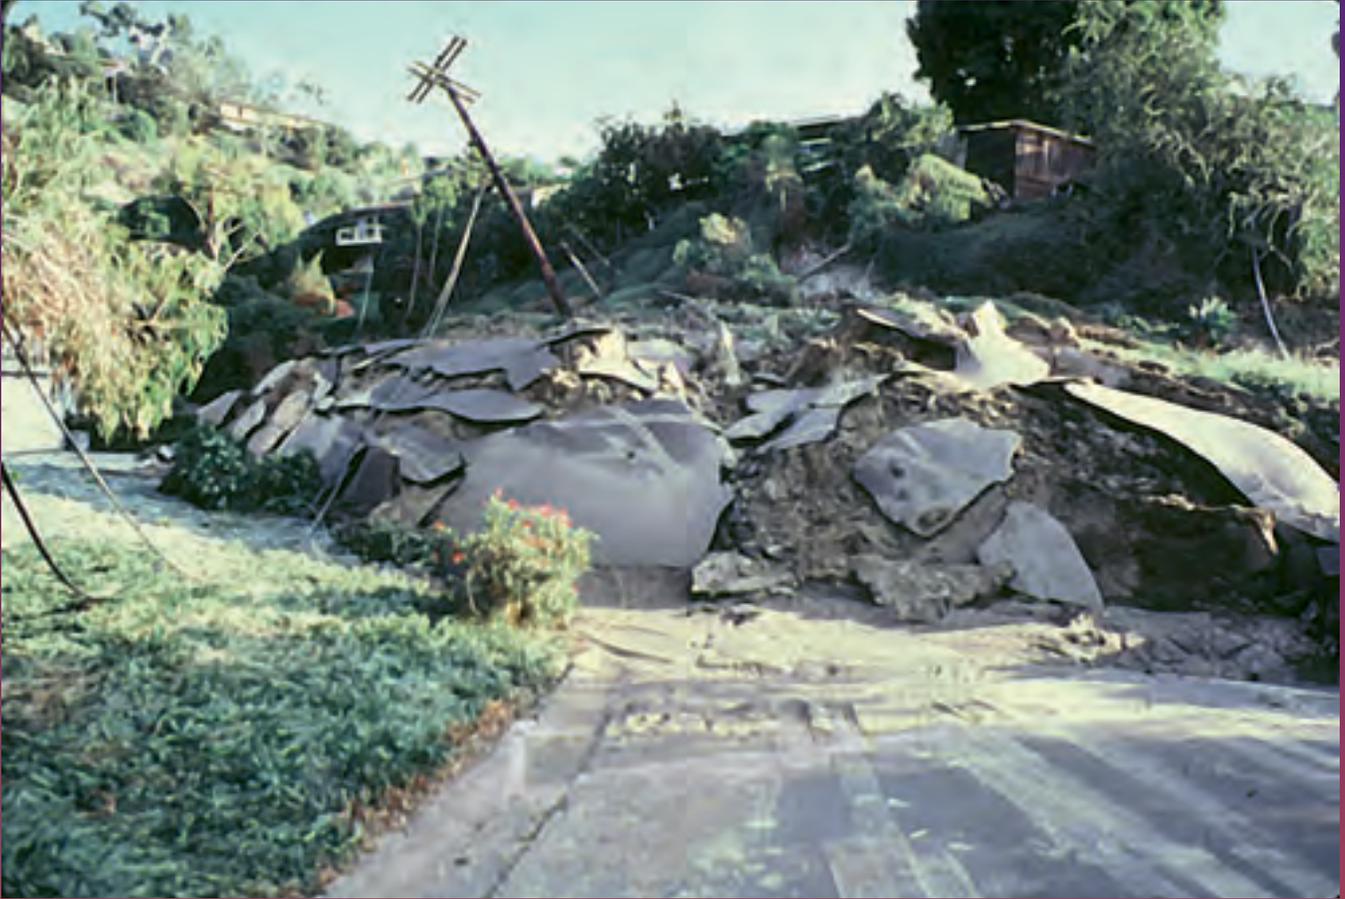
Bluebird Canyon landslide of April 21, 1979. This slide took out telephone lines, blocked roads, and seriously damaged other lifelines in the area. *Photograph courtesy of Bruce Clark, Leighton & Associates, California.*

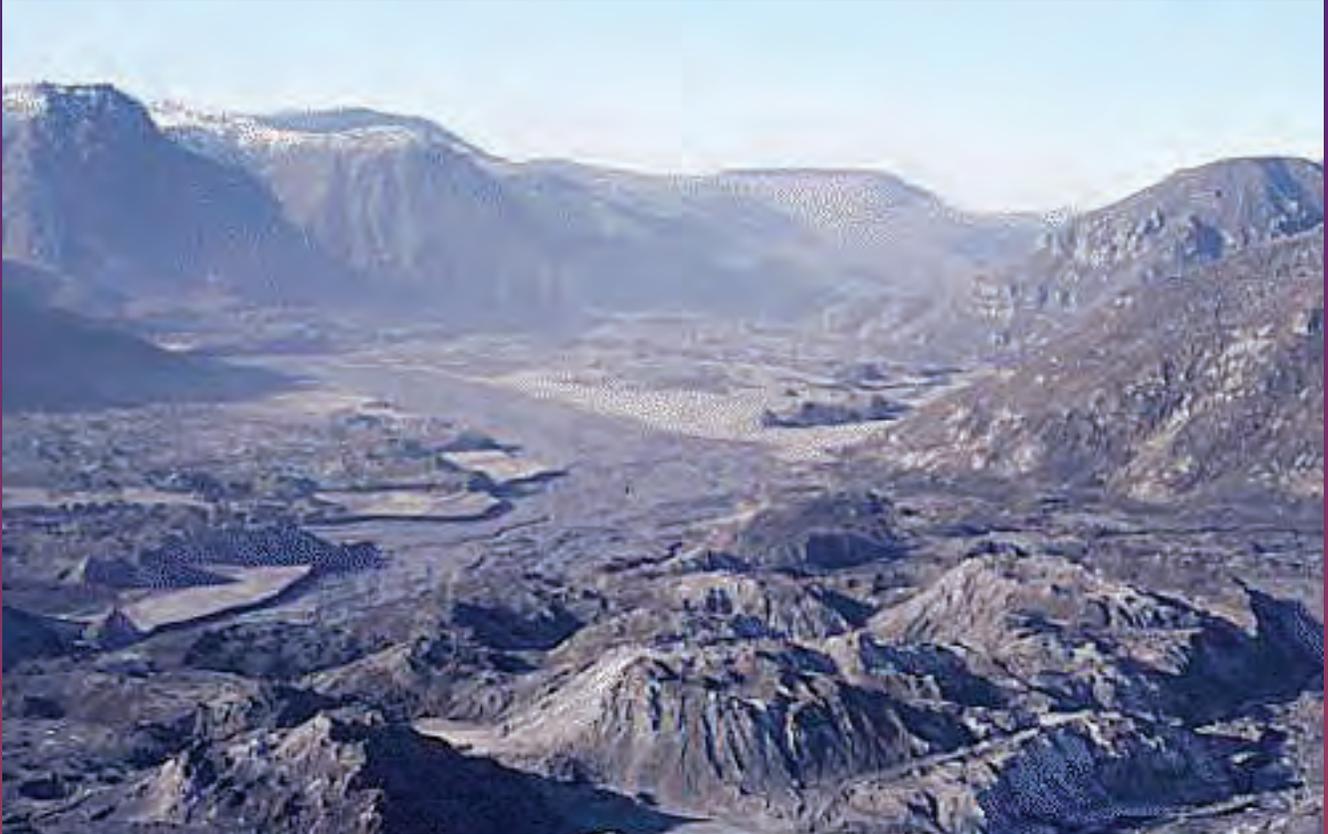
This downstream view of the North Fork Toutle River valley, north and west of St. Helens, shows part of the nearly 2/3 cubic miles (2.3 cubic kilometers) of debris avalanche that slid from the volcano on May 18. This is enough material to cover Washington, D.C. to a depth of 14 feet (4 meters). The avalanche traveled approximately 15 miles (24 kilometers) downstream at a velocity exceeding 150 miles per hour (240 km/hr). It left behind a hummocky deposit with an average thickness of 150 feet (45 m) and a maximum thickness of 600 feet (180 meters). *Photo by Lyn Topinka, USGS, November 30, 1983.*

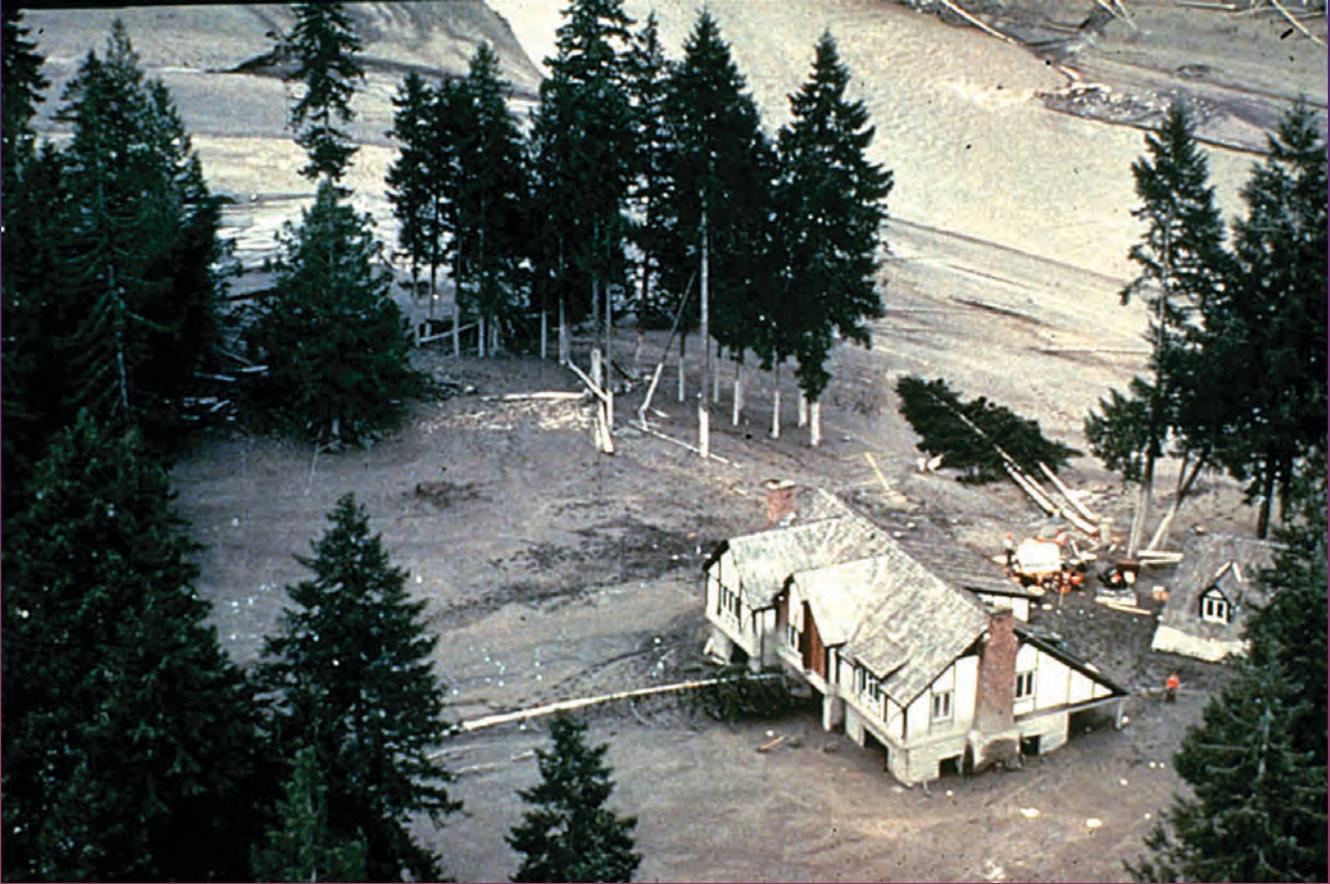
Home damaged by a mudflow (lahar) along the Toutle River, about 25 miles west northwest of Mount St. Helens, Washington. This lahar resulted from the May 18, 1980, eruption of Mount St. Helens. The depth of the flow was recorded by mud coatings on tree trunks. *Photograph by D.R. Crandell, U.S. Geological Survey.*

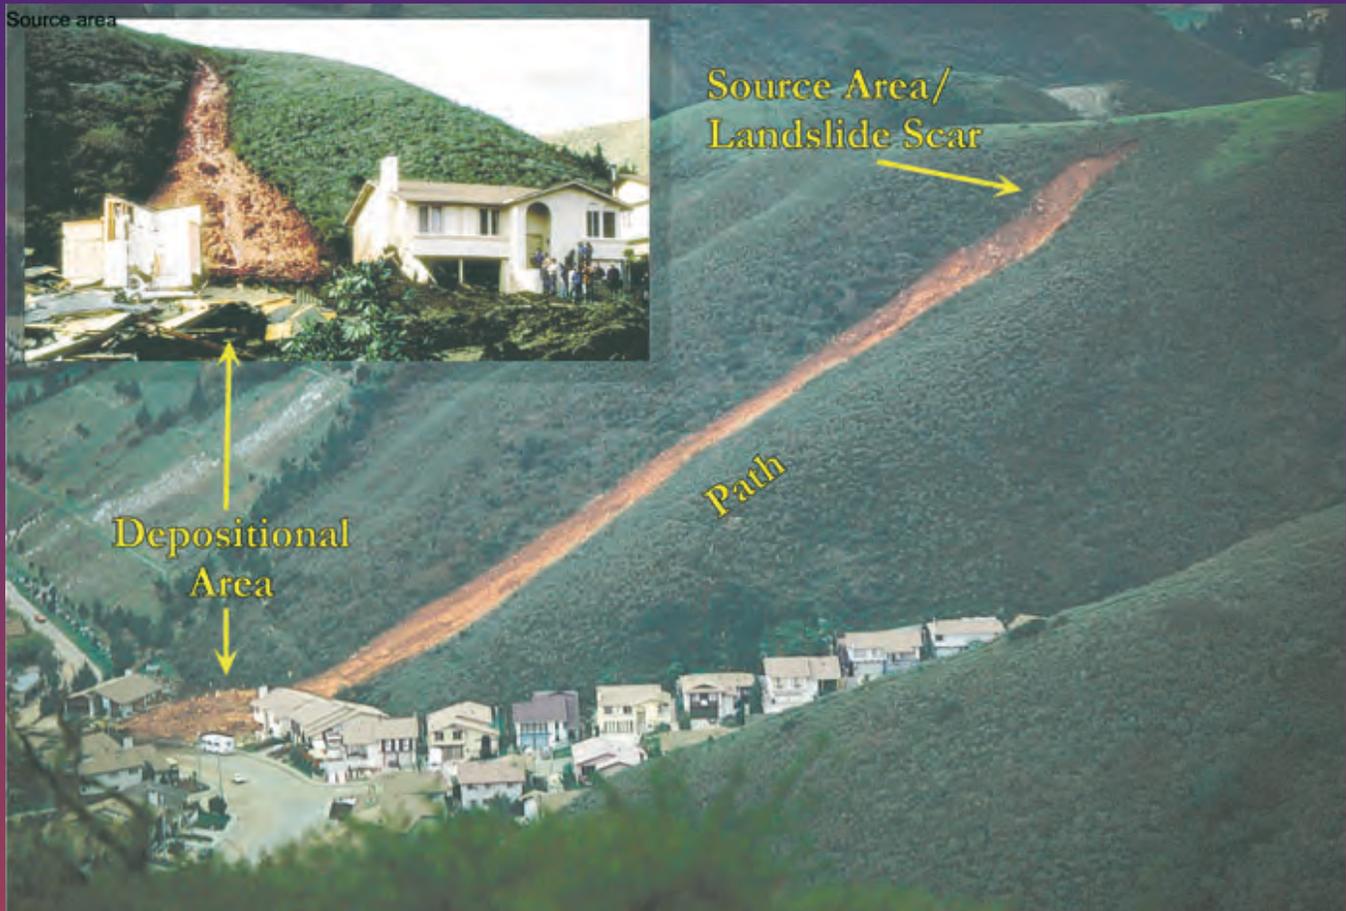
Oddstad Boulevard debris flow occurred in 1982 in Pacifica, San Mateo County, California. Three children were killed and two homes destroyed. *Photograph by Gerald Wieczorek, U.S. Geological Survey.*

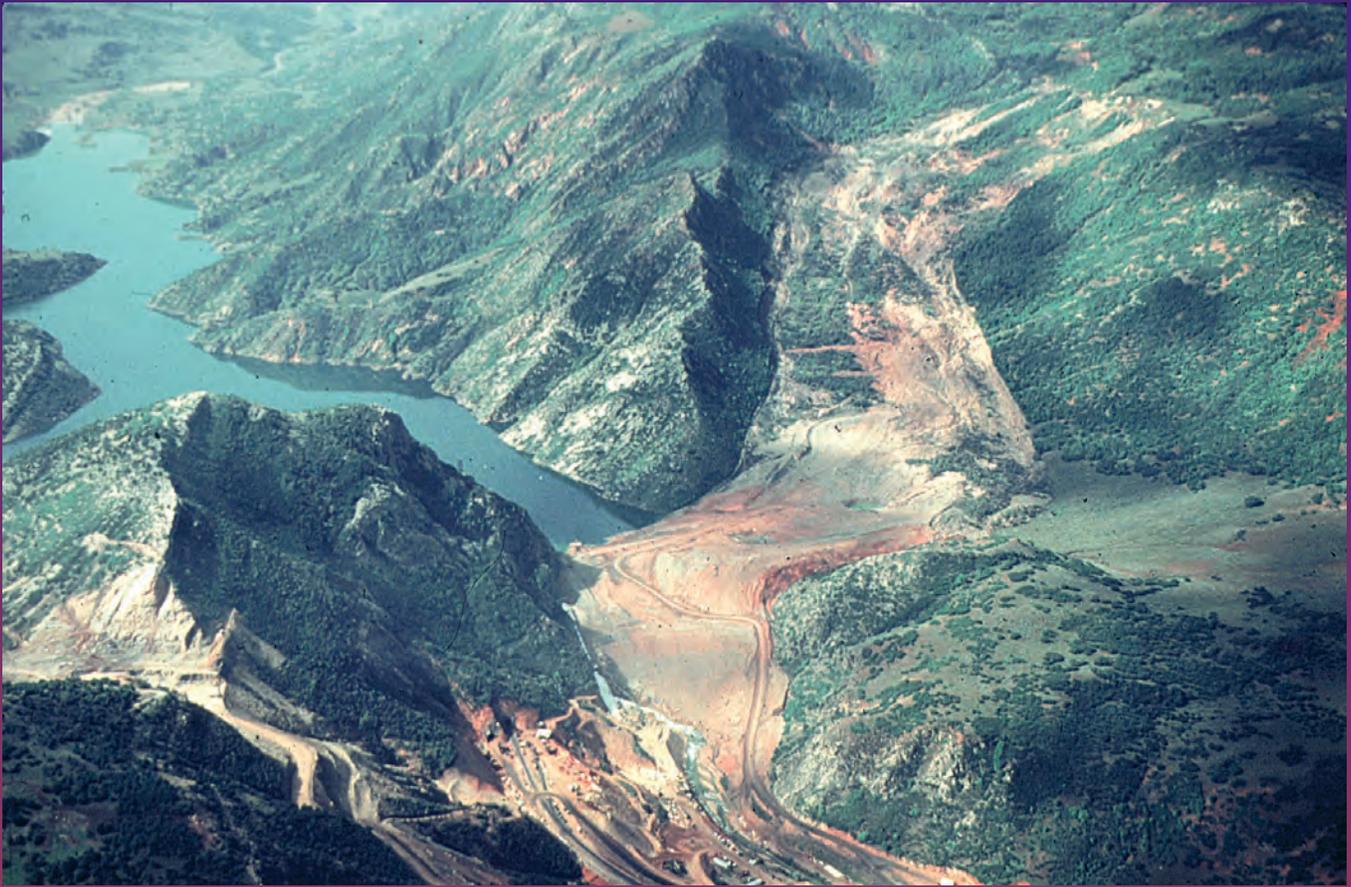
The 1983 Thistle landslide at Thistle, Utah. The landslide began moving in the spring of 1983 in response to groundwater buildup from heavy rains the previous September and the melting of a deep snow pack that fell during the winter of 1982-83. Within a few weeks of the start of movement, the landslide dammed the Spanish Fork River, obliterating U.S. Highway 6 and the main line of the Denver and Rio Grande Western Railroad. The town of Thistle was inundated under the floodwaters rising behind the landslide dam. The slide required extensive engineering to mitigate the impact on transportation infrastructure, including railroad tunnels that were excavated under the slide. Total costs (direct and indirect) incurred by this landslide exceeded \$400 million, the most costly single landslide event in U.S. history. The slide remains today, and accommodates a small visitor center, which describes the history and engineering procedures. *Photograph by R.L. Schuster, U.S. Geological Survey.*

Cost, \$688 million (2000 dollars), direct and indirect costs. Debris slide caused by rainfall and snowmelt—most expensive U.S. landslide in history. This landslide which occurred in the spring of 1983, dammed the Spanish Fork River (forming a lake), and severed three major transportation arteries: U.S. Highways 6/50 and 89, and the main transcontinental line of the Denver and Rio Grande Western Railroad. A twin-bore tunnel had to be constructed around the slide to restore the railroad route. This landslide continues to experience occasional movement. An economic analysis by the University of Utah (1984) evaluated both direct and indirect costs of the Thistle landslide. Direct costs totaled \$200 million (\$344 million). In addition, numerous indirect costs were reported; most of these involved temporary or permanent closure of highways and railroads to the detriment of local coal, uranium, and petroleum industries, several types of businesses, and tourism. Perhaps the largest single loss due to the Thistle slide was \$81 million (\$139 million) in revenue lost by the D&RGW during 1983. These indirect losses from the Thistle landslide disaster may exceed the direct costs. Although there were no casualties as a result of the Thistle slide, it ranks as the most economically costly individual landslide in North America, and probably the world.

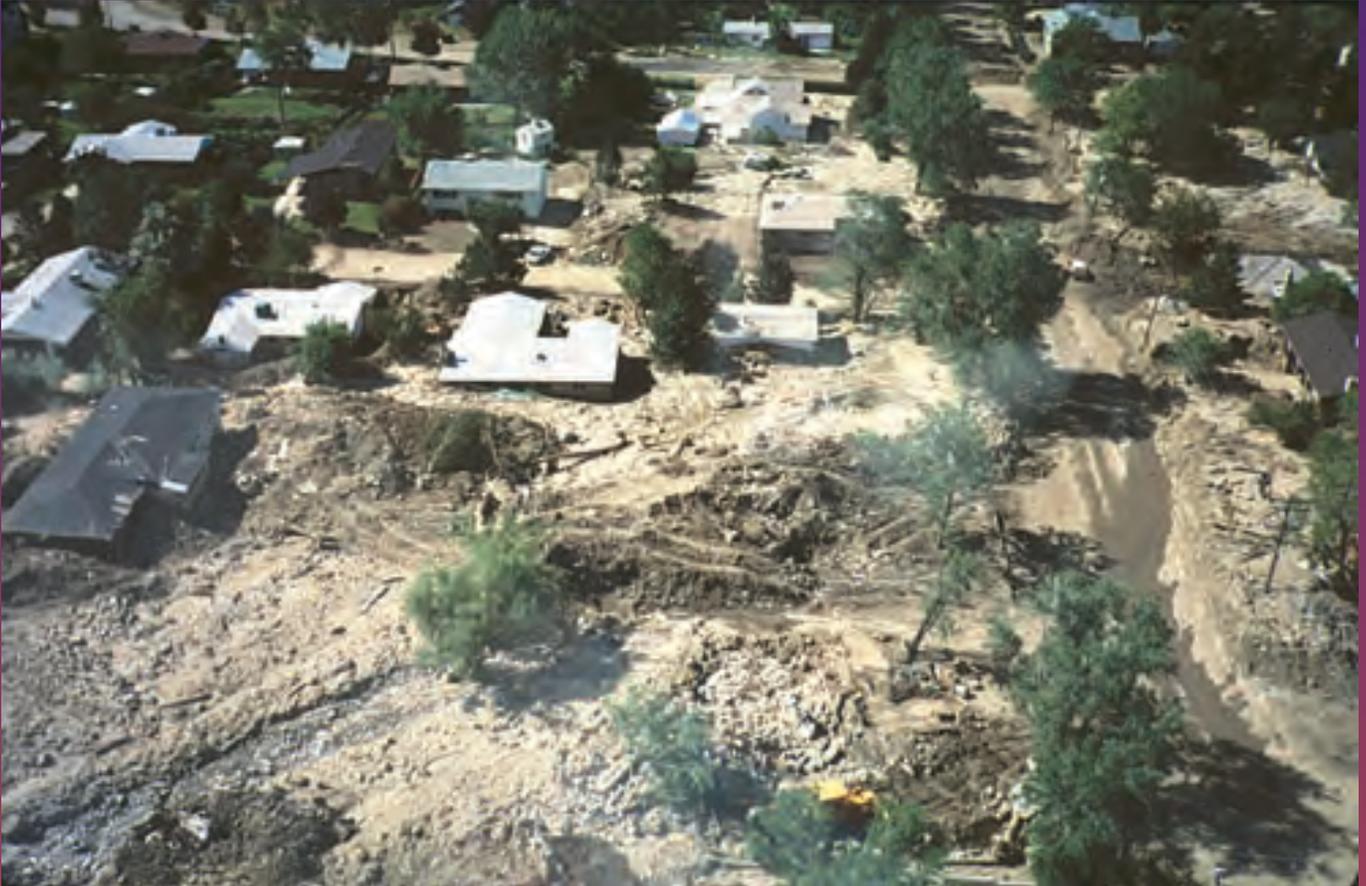
Homes partially buried by debris flows resulting from snowmelt and rainfall. Damage was due to extensive number of landslides during the Spring of 1983, in Utah. Direct damage costs exceeded 330 million dollars. *Photograph by Earl Brabb, U.S. Geological Survey.*

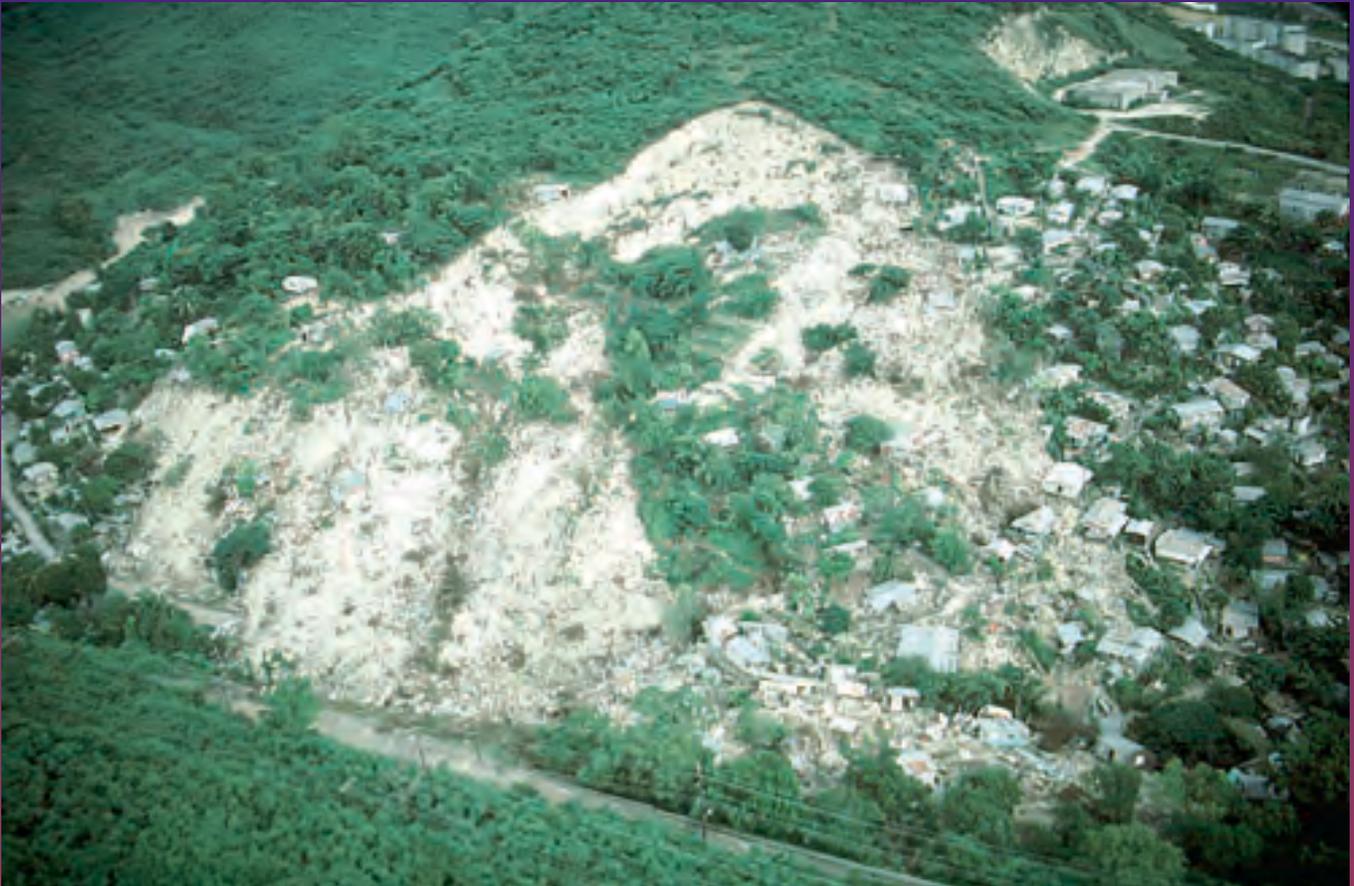
The 1985 Mameyes, Puerto Rico, landslide (areal view). This landslide destroyed 120 homes and killed at least 129 people, the greatest number of casualties from any single landslide in North America (as of early 2000). The catastrophic block slide was triggered by a tropical storm that produced extremely heavy rainfall. Contributing factors may have included sewage directly discharged into the ground in the densely populated area and a leaking water pipe at the top of the landslide. *Photograph by R.W. Jibson, U.S. Geological Survey.*

October 5—129 people killed, 120 houses destroyed. Heavy rainfall from tropical storm Isabel, plus possible sewage leak, and additionally, a leaky water pipe caused this major rock slide. This event obliterated much of the Mameyes district of the city of Ponce on the south coast of the island. This slide caused the greatest death toll in North American history from a single landslide.
