Significant Landslide Events in the United States

*by Lynn M. Highland and Robert L. Schuster
Graphic presentation by Margo L. Johnson*

Abstract

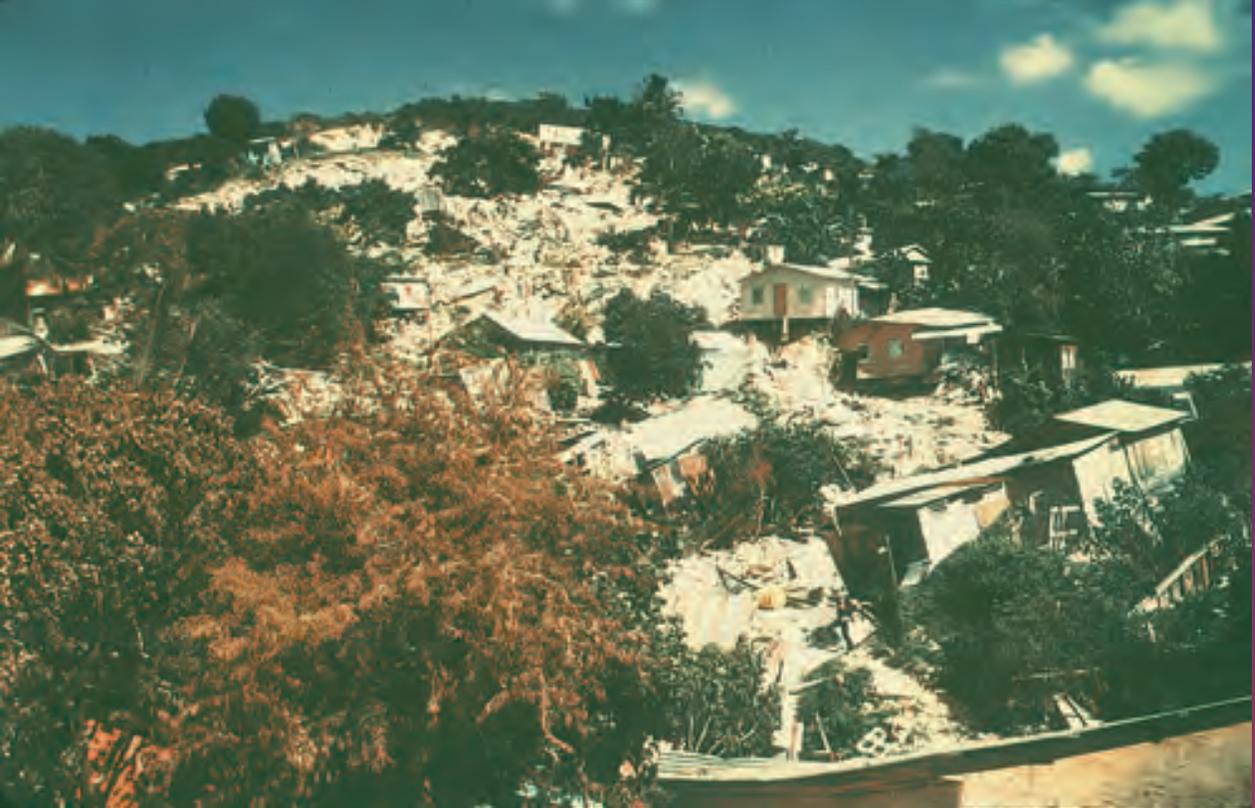
The 1985 Mameyes, Puerto Rico, landslide (closeup). This landslide destroyed 120 houses and killed at least 129 people, the greatest number of casualties from any single landslide in North America. The catastrophic block slide was triggered by a tropical storm that produced extremely heavy rainfall. Contributing factors could also have included sewage directly discharged into the ground in the densely populated area and a leaking water pipe at the top of the landslide. *Photograph by Earl Brabb, U.S. Geological Survey.*

October 5—129 people killed, 120 houses destroyed. Heavy rainfall from tropical storm Isabel, plus possible sewage leak, and additionally, a leaky water pipe caused this major rock slide. This event obliterated much of the Mameyes district of the city of Ponce on the south coast of the island. This slide caused the greatest death toll in North American history from a single landslide.

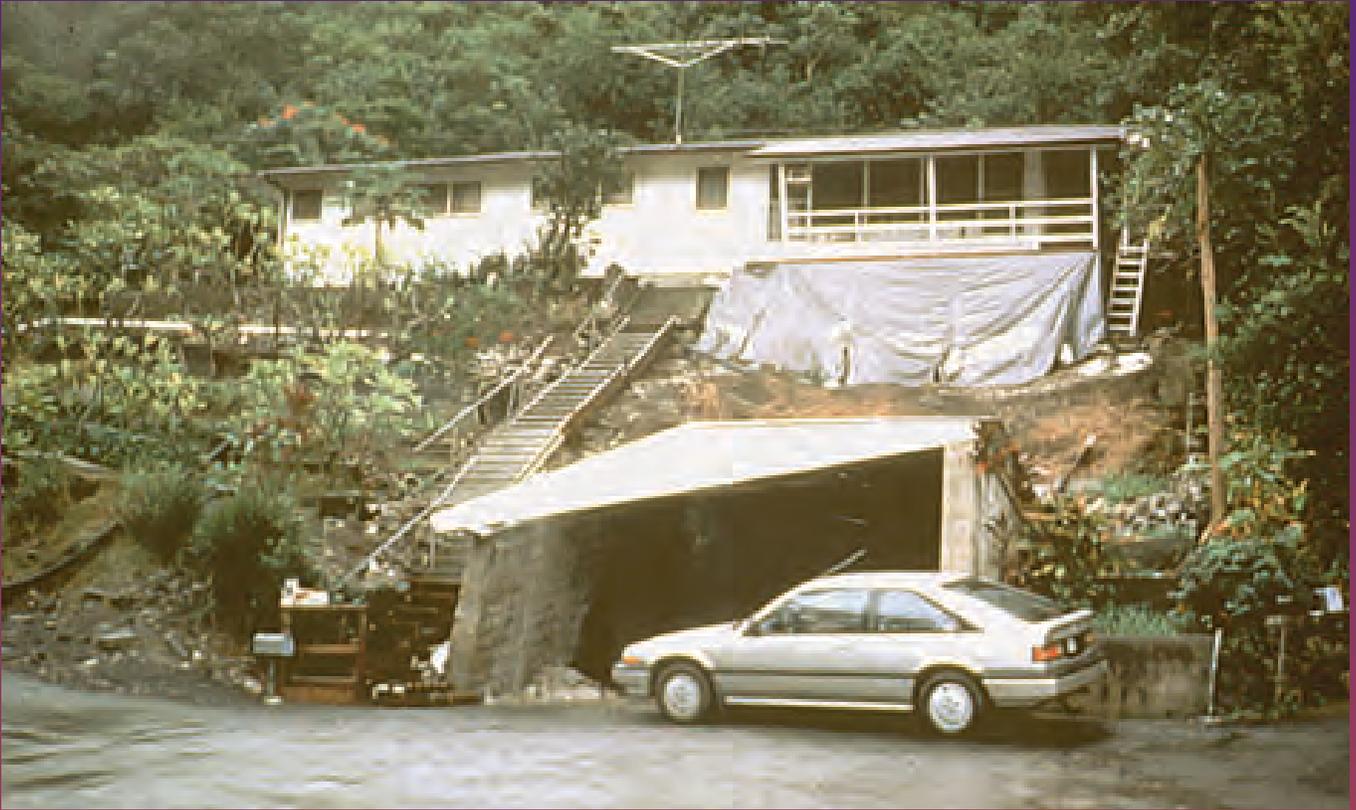
Home damaged by the 1989 Alani-Paty landslide near Honolulu, Hawaii. *Photograph by Rex Baum, U.S. Geological Survey.*

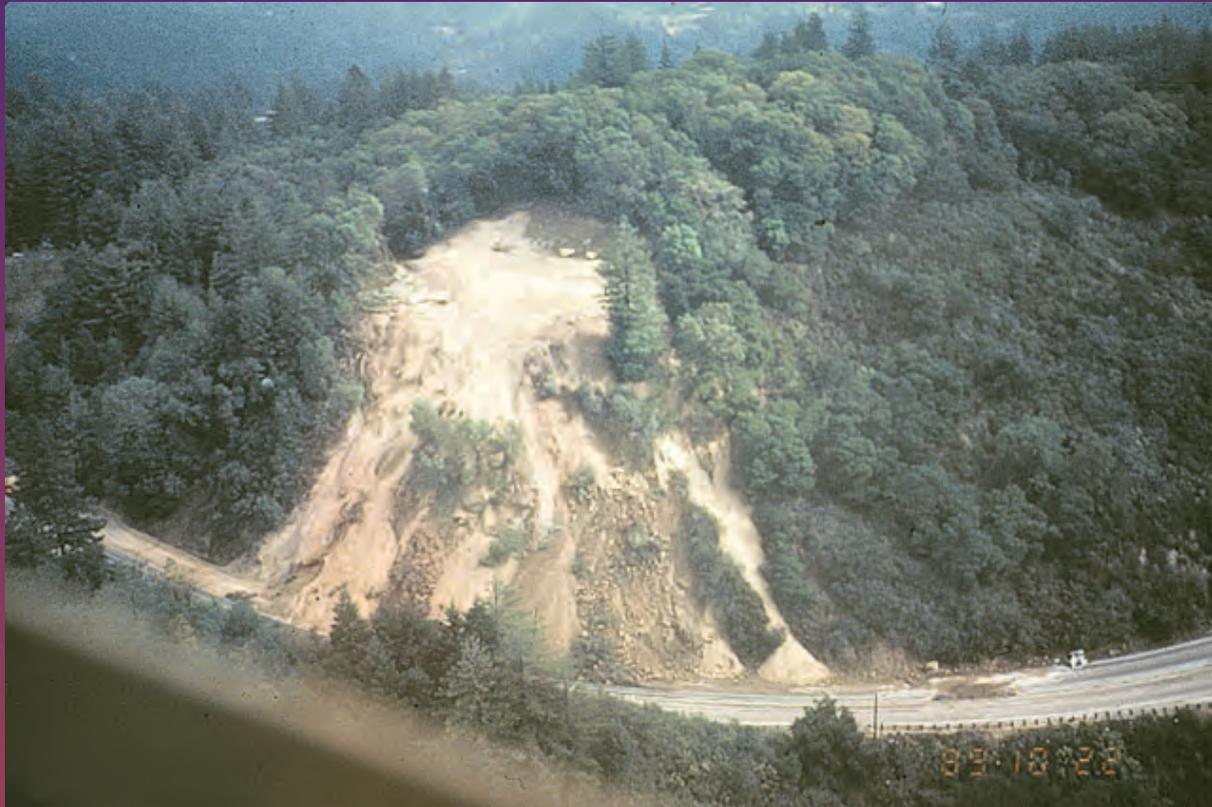
Landslide triggered by the 1989 Loma Prieta earthquake, north of Fort Funston, California. This slide mass has a volume of approximately 2,830 cubic meters (3,700 cubic yds) and is 30 meters (100 feet) high. *Photograph by D.M. Peterson.*

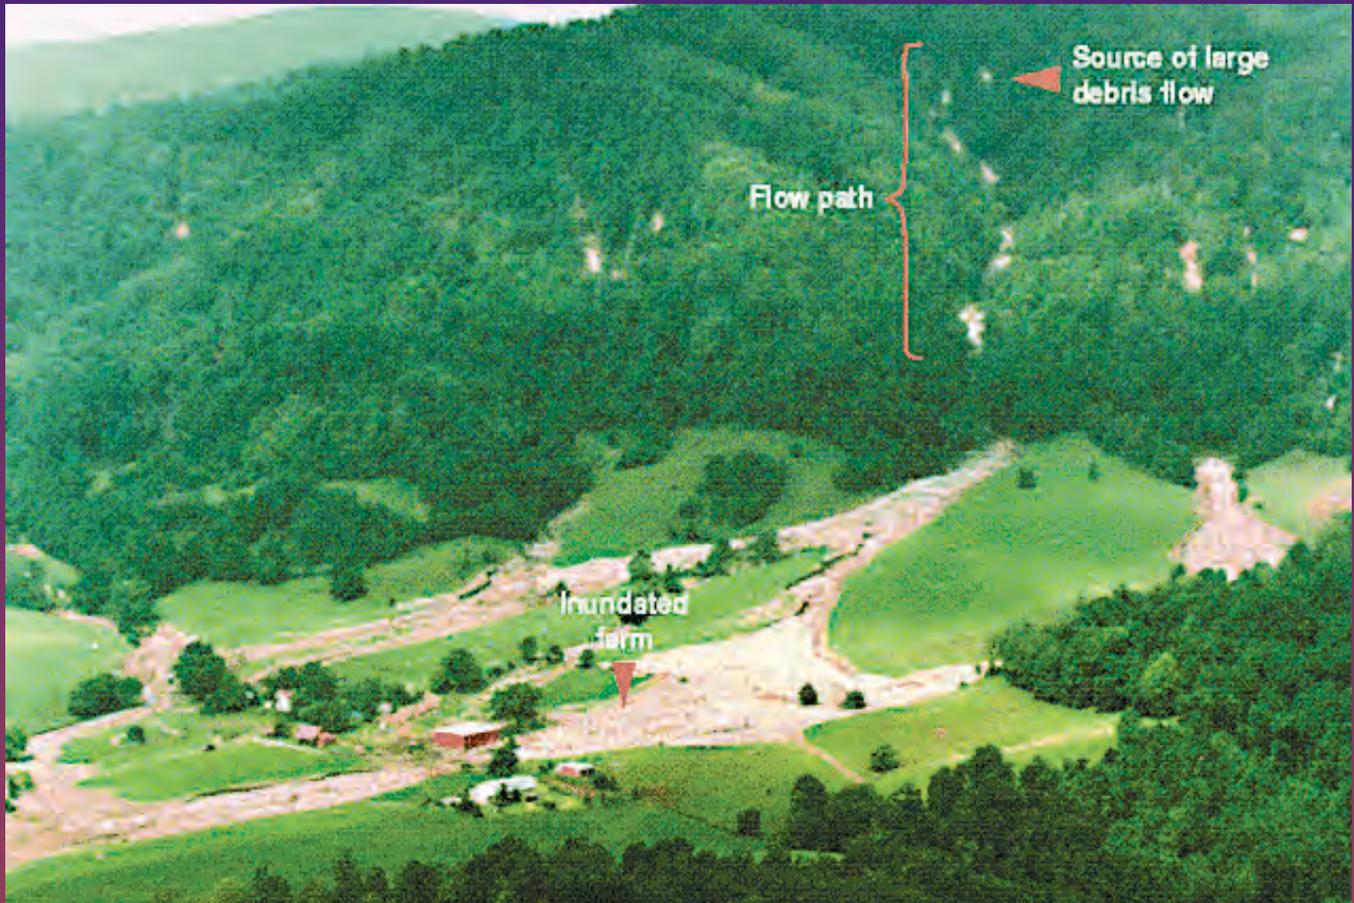
Numerous debris flows scarred the foothills of the Blue Ridge in Madison County, Virginia, after the devastating storm of June 27, 1995. The debris flows began on steep slopes and moved rapidly down stream channels. The smaller debris flows joined to form larger flows lower in the valleys and spread mud, boulders, and other debris, inundating residents' homes and farms. *Photograph copyright by Kevin Lamb, 1995, used with permission.*

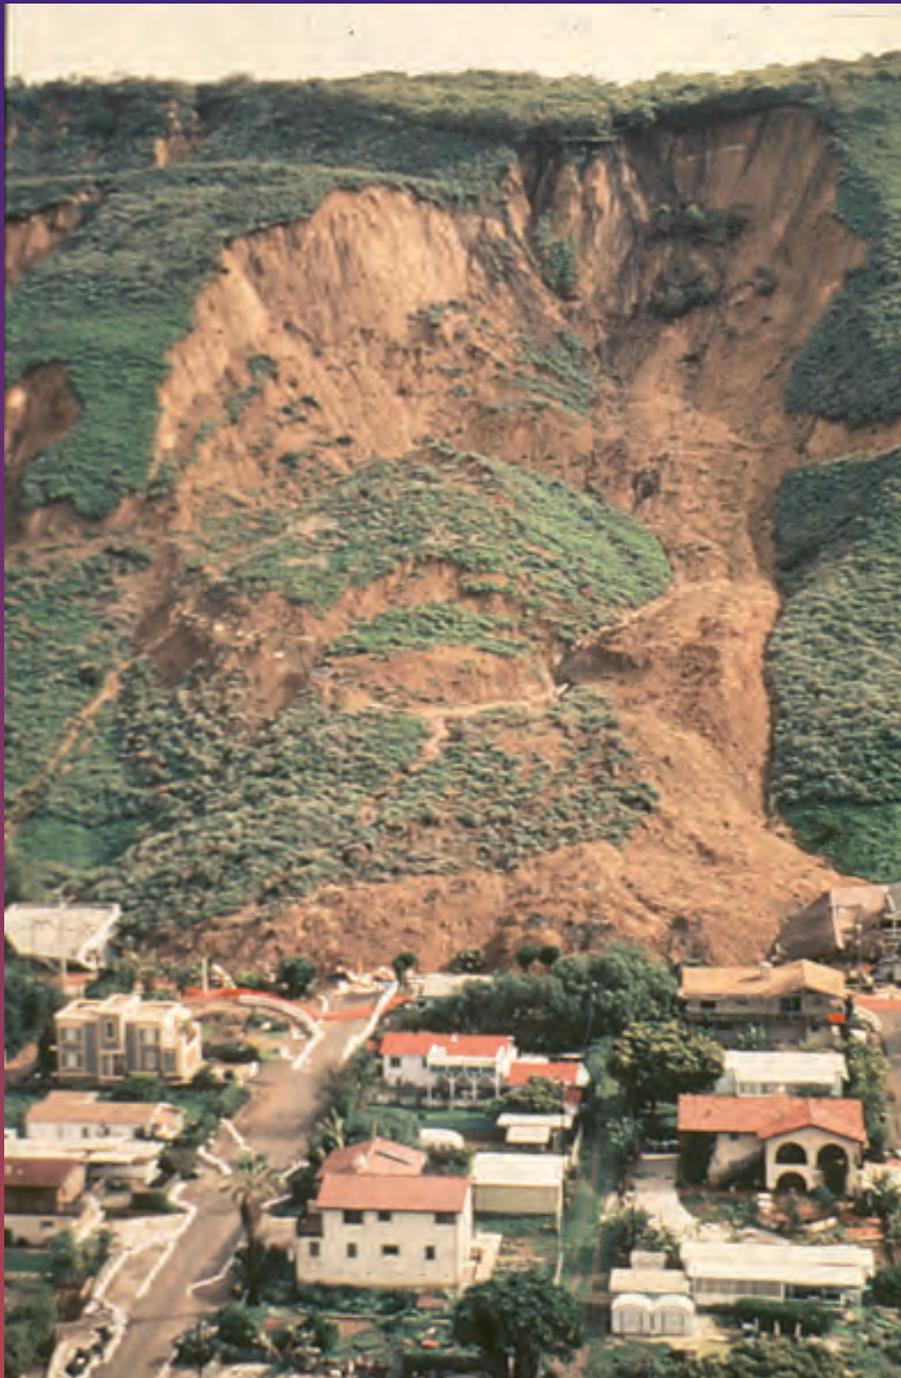
La Conchita is a small community along Highway 101 north of Santa Barbara. This landslide occurred in the spring of 1995. Many people were evacuated as about a dozen houses nearest the slide toe were destroyed. Fortunately, no one was killed or injured. *Photograph by R.L. Schuster, U.S. Geological Survey.*

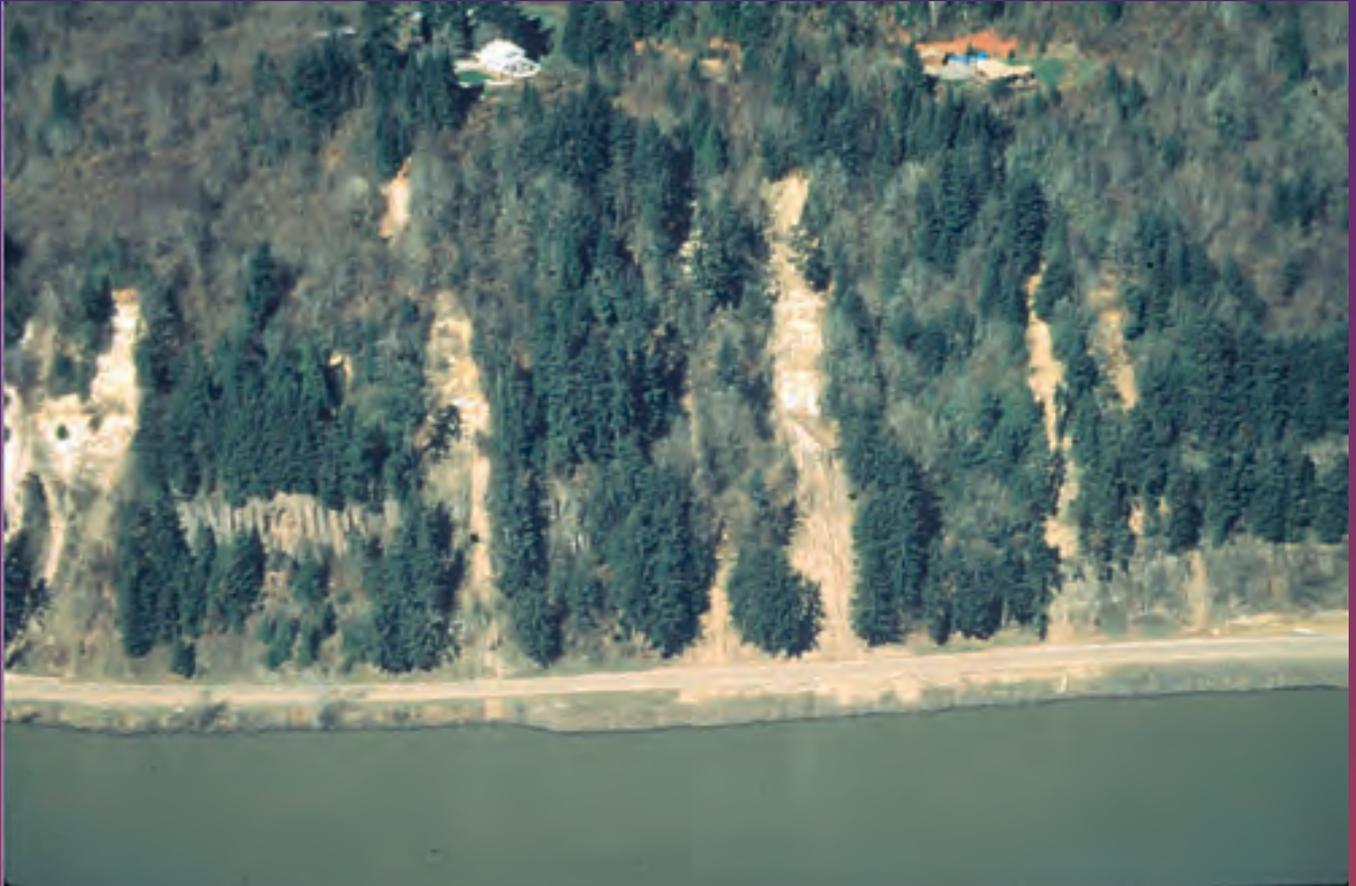
Large slump-debris flows near Stella, Washington, on State Highway 4. Over 800 million dollars in damage due to landslides, in western Washington State, was estimated following the severe winter storm of February 1996. The Columbia River is in the foreground. *Photograph by E.L. Harp, U.S. Geological Survey.*

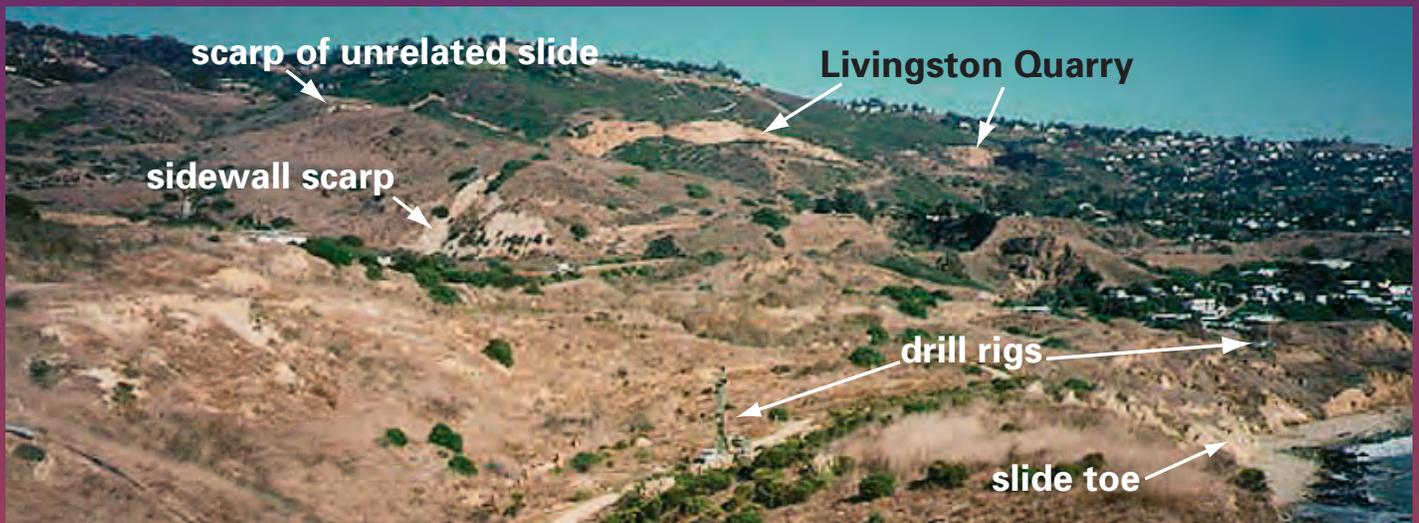
Labeled overview of the Portuguese Bend landslide, California looking toward the east. *Photograph by Josh Myers (1997), Department of Geological Sciences, California State University, Long Beach.*

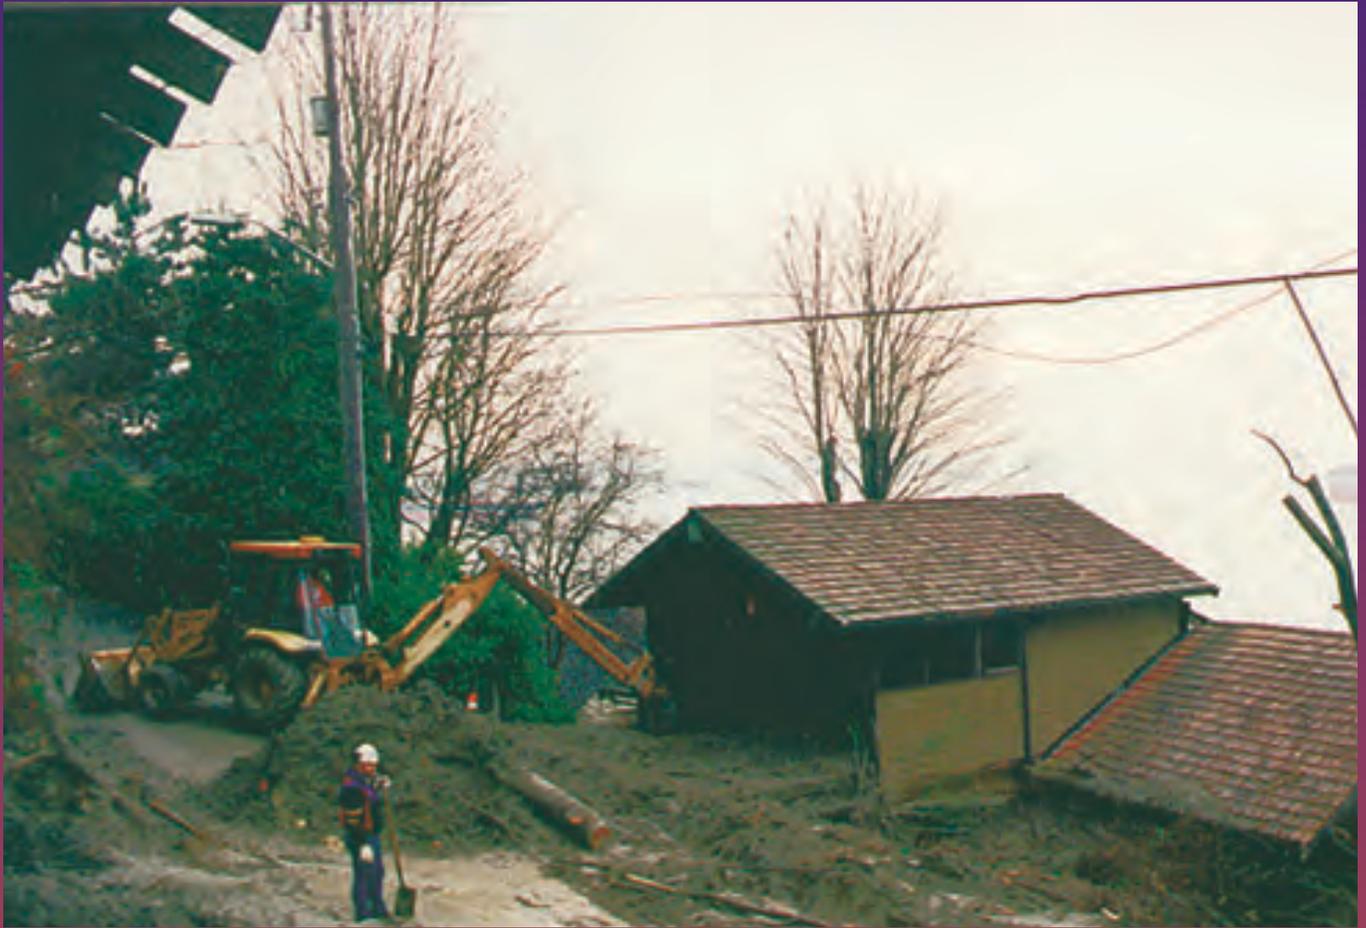
House in the Magnolia Bluffs area overlooking Puget Sound, Seattle, Washington, that was struck by a debris flow. The flow deposited material in the garage (upper level) and collapsed the front wall of the living quarters (lower level).

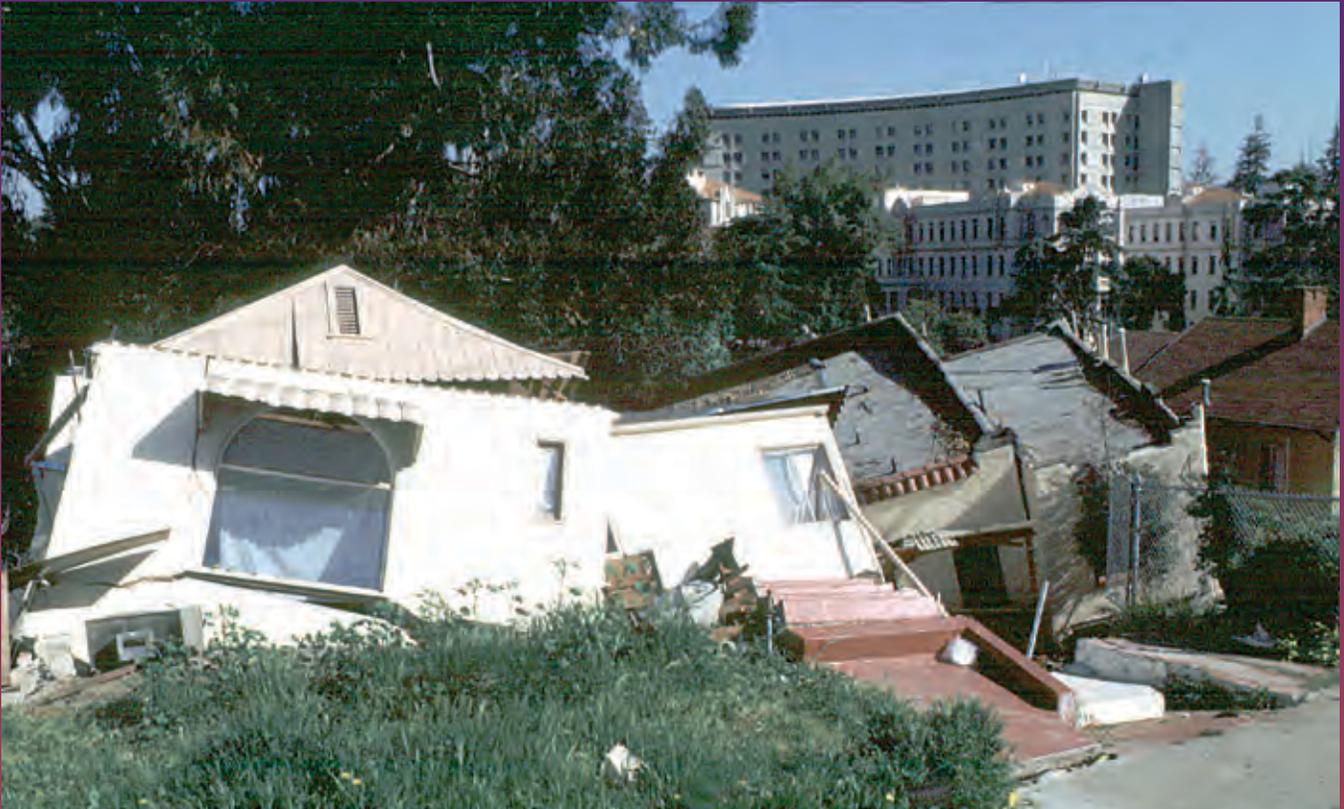
Damage due to El Nino storms and resultant heavy rainfall. Damaged house located on 19th Avenue in Oakland, Alameda County. *Photo by Jeff Coe, U.S. Geological Survey.*

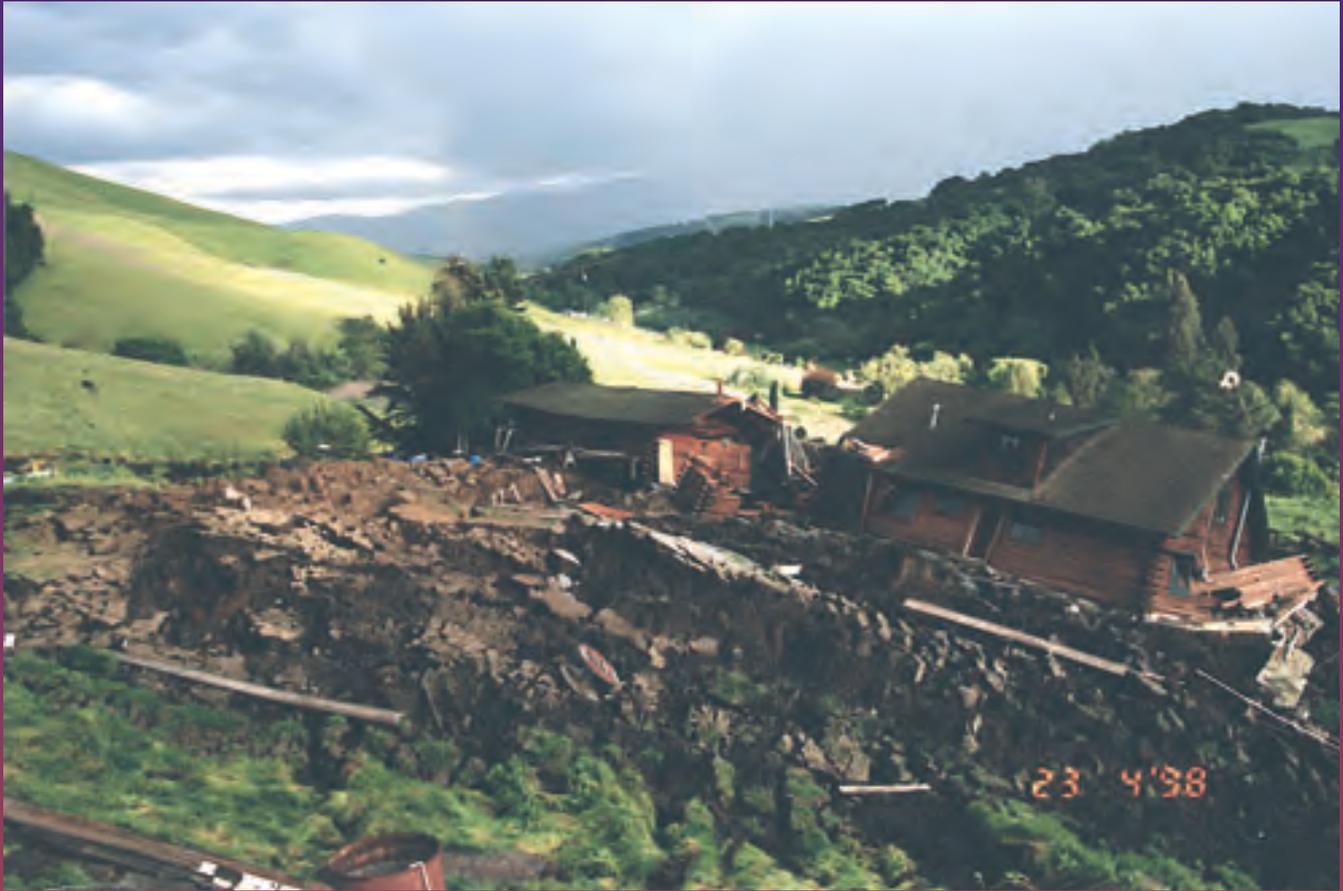
Anzar Road, San Benito County, California landslide of April 22, 1998.
Photograph by Lynn Highland, U.S. Geological Survey.

April 22—rainfall reactivated old landslide deposits near San Andreas Fault. One house was destroyed. Slide severed a natural gas pipeline serving thousands of customers in Santa Cruz, California, and surrounding areas. Area was without gas service for 3 days. \$11.2 million (2000 dollars) in pipeline repair. Anzar Road repair was approximately \$746 million (2000 dollars). Indirect costs were extremely high because of lost natural gas service to area businesses, restaurants, hospitals, etc. PG & E (Pacific Gas and Electric) had to manually relight all gas pipeline outlets.

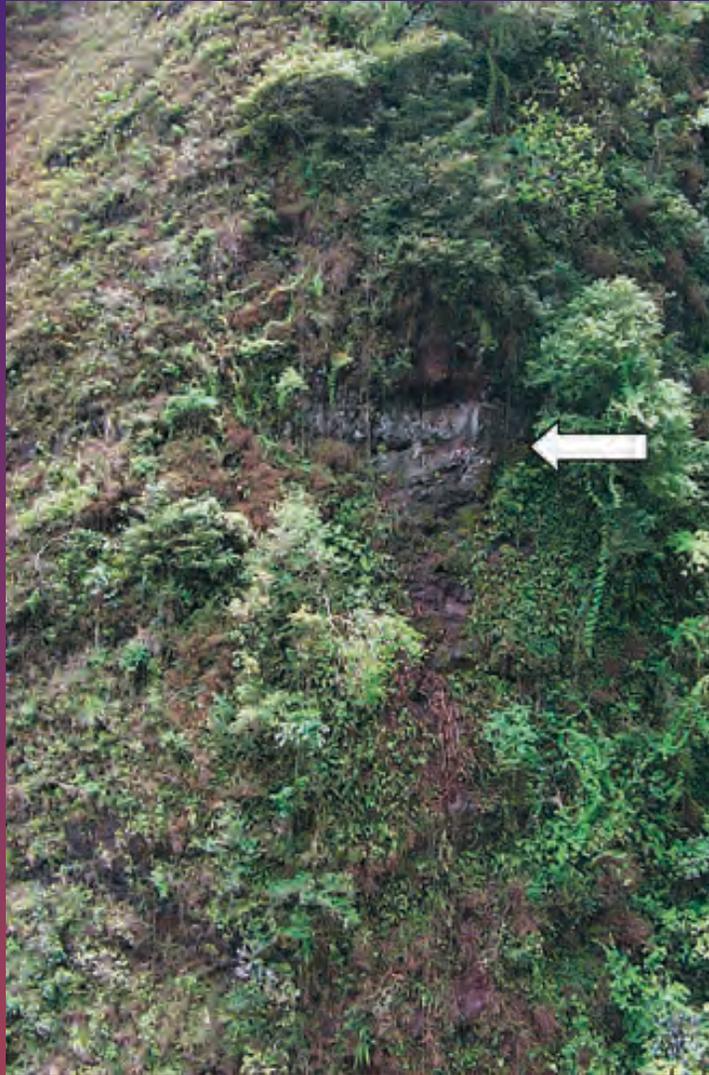
Source area (indicated by arrow) of Sacred Falls, Hawaii, rock fall of 1999. *Photograph by R. W. Jibson, U.S. Geological Survey.*

Rockslide—8 people killed, many injured. This event occurred about 2:30 p.m. on Sunday, May 9, 1999. Sacred Falls State Park is located near the town of Hauula on the north shore of Oahu, Hawaii. The source of the rockfall, which occurred in Kaluanui Gulch, is at an elevation of about 800 feet above sea level on the southeast canyon wall directly above the plunge pool of Sacred Falls. The source area consists of a scar of freshly exposed rock about 5-6 meters (15-20 feet) wide by 3.3 meters (10 feet) high on a nearly vertical slope. The thickness of the slab of rock that failed appears to have been about 1-2 meters (3-6 feet). The rockslide occurred as a result of long-term, gradual degradation of the slope rather than by being triggered by external factors, such as an earthquake, or heavier-

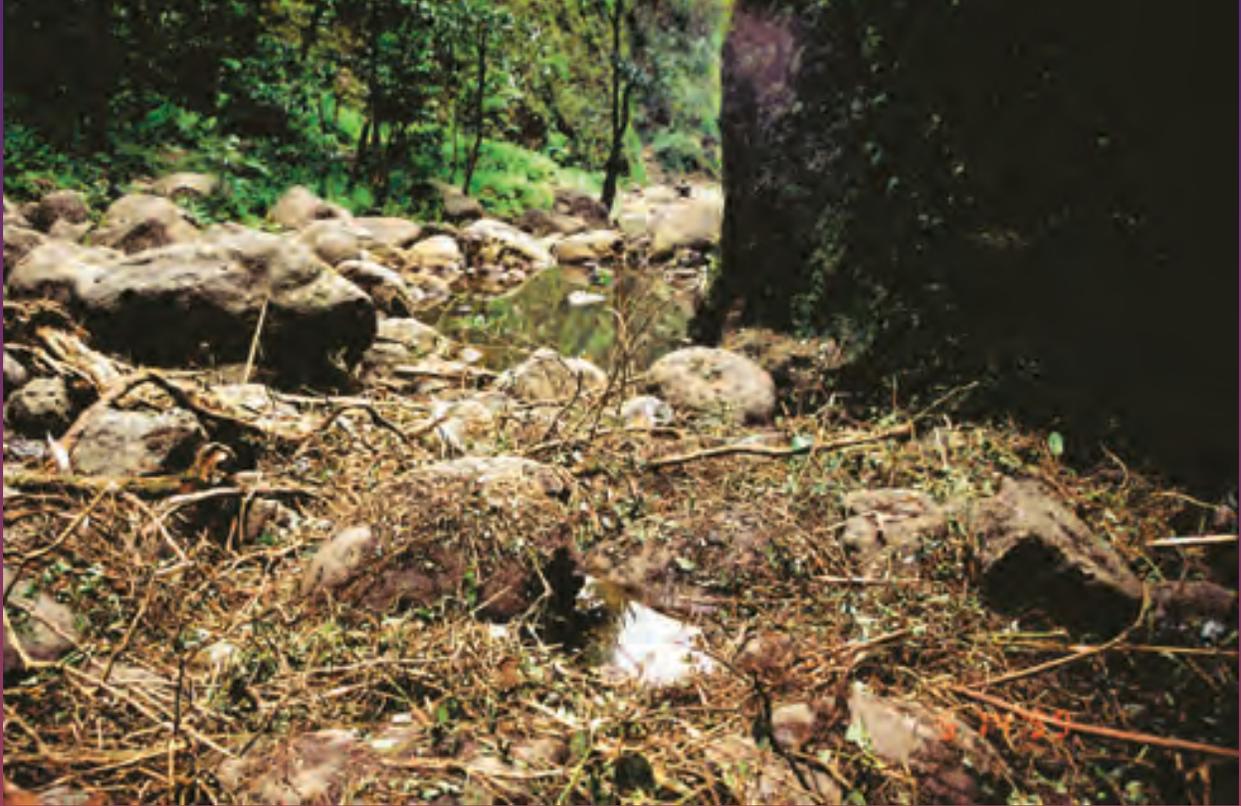
1991 Sacred Falls, Hawaii, rock-fall deposit. *Photograph by R. W. Jibson, U.S. Geological Survey.*
