Catastrophic rockfalls and rockslides in the Sierra Nevada, USA

Gerald F. Wiczorek

U.S. Geological Survey, 926A National Center, Reston, Virginia 20192, USA

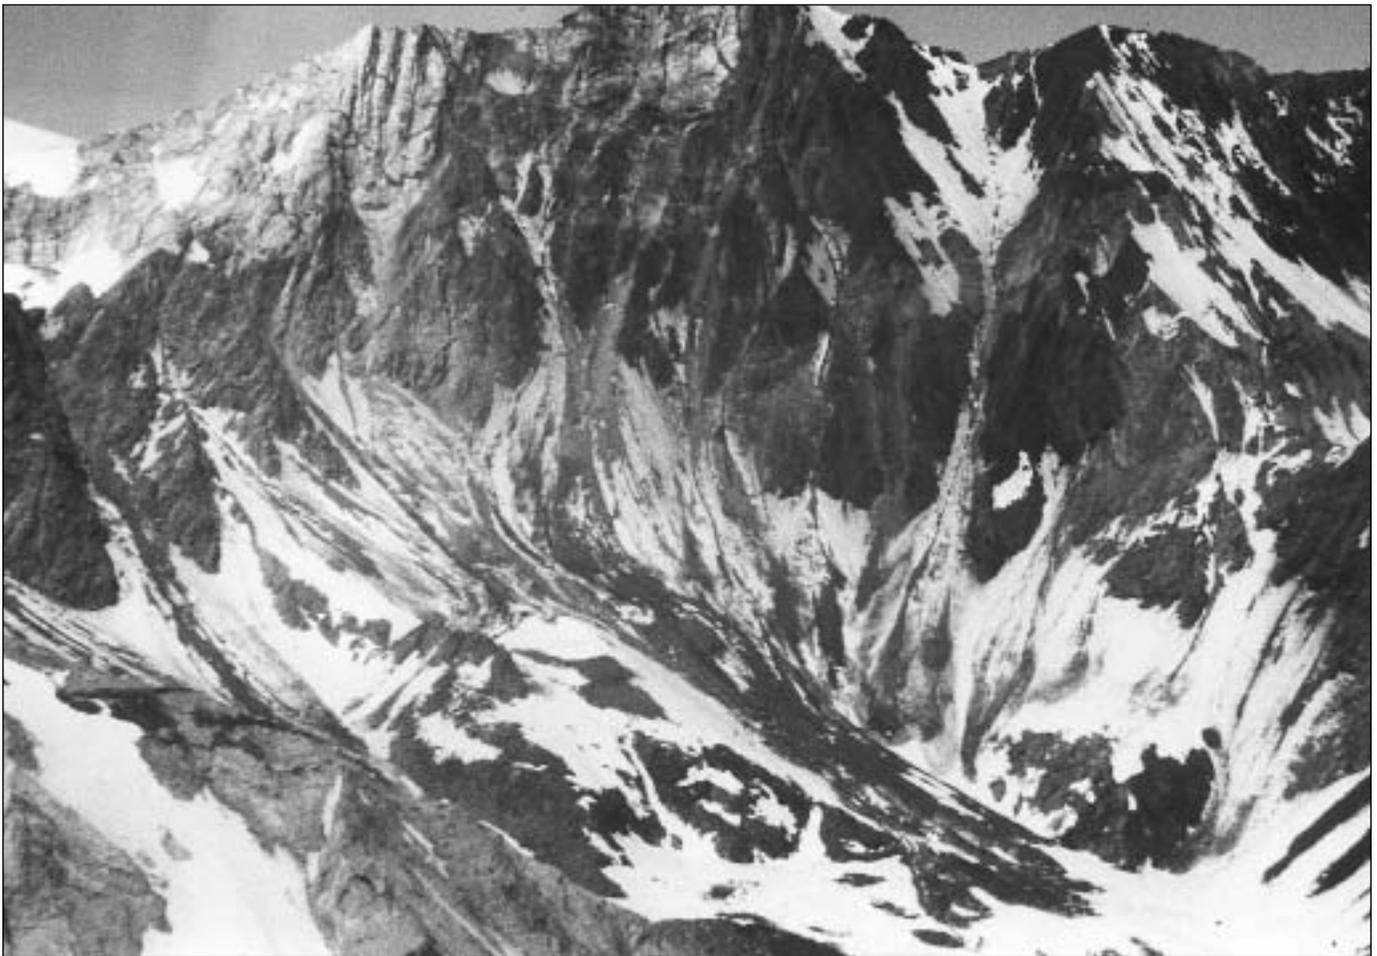
Figure 2. Photograph of rockfalls and rockslides triggered by 1980 Mammoth Lakes earthquake sequence, Mount Baldwin, eastern-central Sierra Nevada (Photograph by David Keefer, U.S. Geological Survey, 1980).

Nevada. The 1980 Mammoth Lakes earthquake sequence triggered several thousand rockfalls and slides (Fig. 2) in the eastern Sierra Nevada (Harp et al., 1984). During the unusually wet winters of 1982 and 1983, DeGraff et al. (1984) estimated \$1.3 million damage from landslides, including a reactivated rockslide along a 23 km section of Stump Springs Road, a major timber-haul route in the Sierra National Forest. Some large rockfalls occur without apparent triggering events, such as the July 10, 1996, rockfall at Happy Isles, Yosemite National Park, that killed one person and seriously injured several others (Snyder, 1996; Wieczorek et al., 2000). With fluvial and glacial downcutting of the Yosemite and other valleys of the Sierra Nevada, the lack of lateral confinement may initiate the release of horizontal residual stress in the oversteepened valley slopes. This release of stress may be responsible for the formation of exfoliation sheets, the dilation of joints, and the occurrence of some rockfalls without recognized triggering events (Wieczorek et al., 1995).

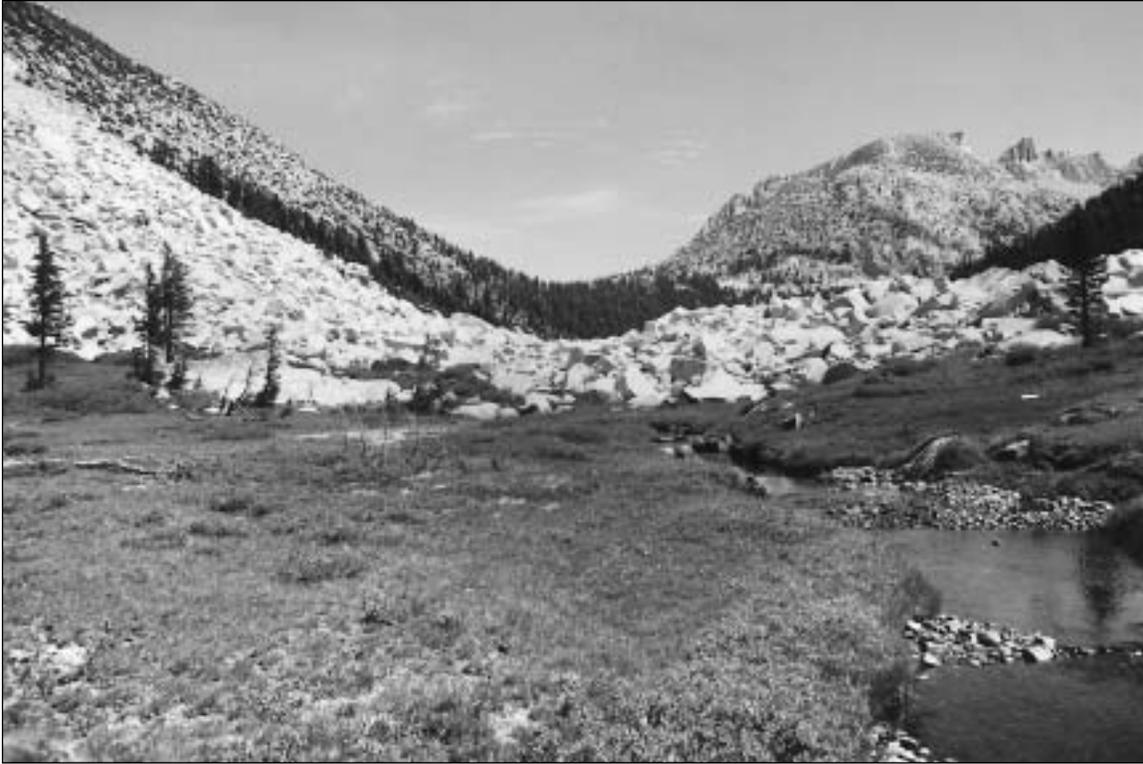
Figure 4. Photograph of Slide Mountain deposit blocking Piute Creek; slide movement was from left to right in photograph. Photograph was taken in 1988 by King Huber, U.S. Geological Survey.

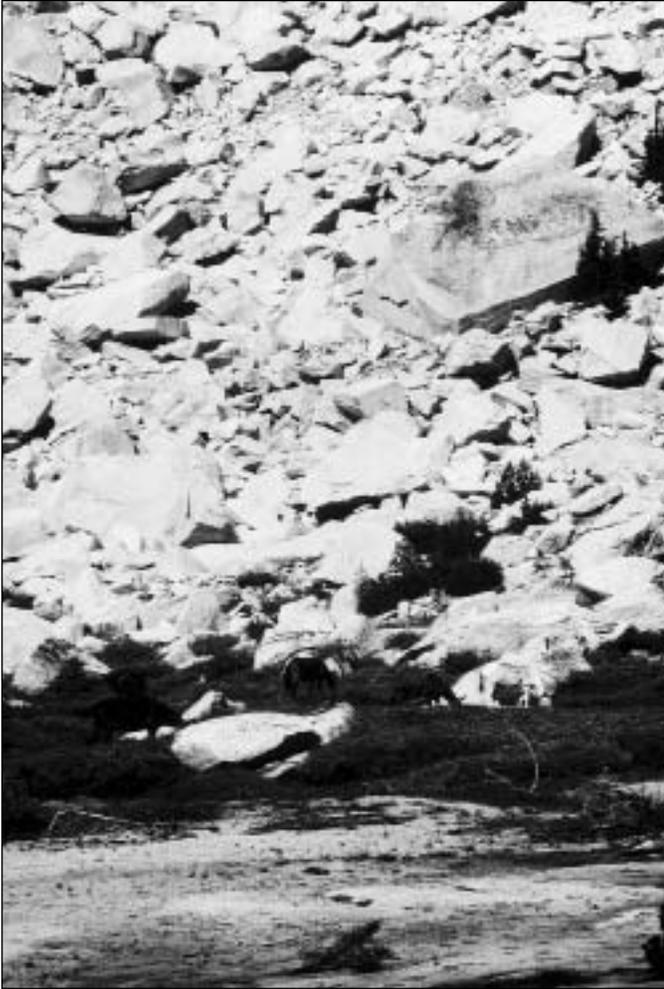
Figure 5. Photograph of Slide Mountain rockslide deposit with mules (circled) in foreground for scale, Yosemite National Park. Photograph was taken in 1988 by James Snyder, National Park Service.

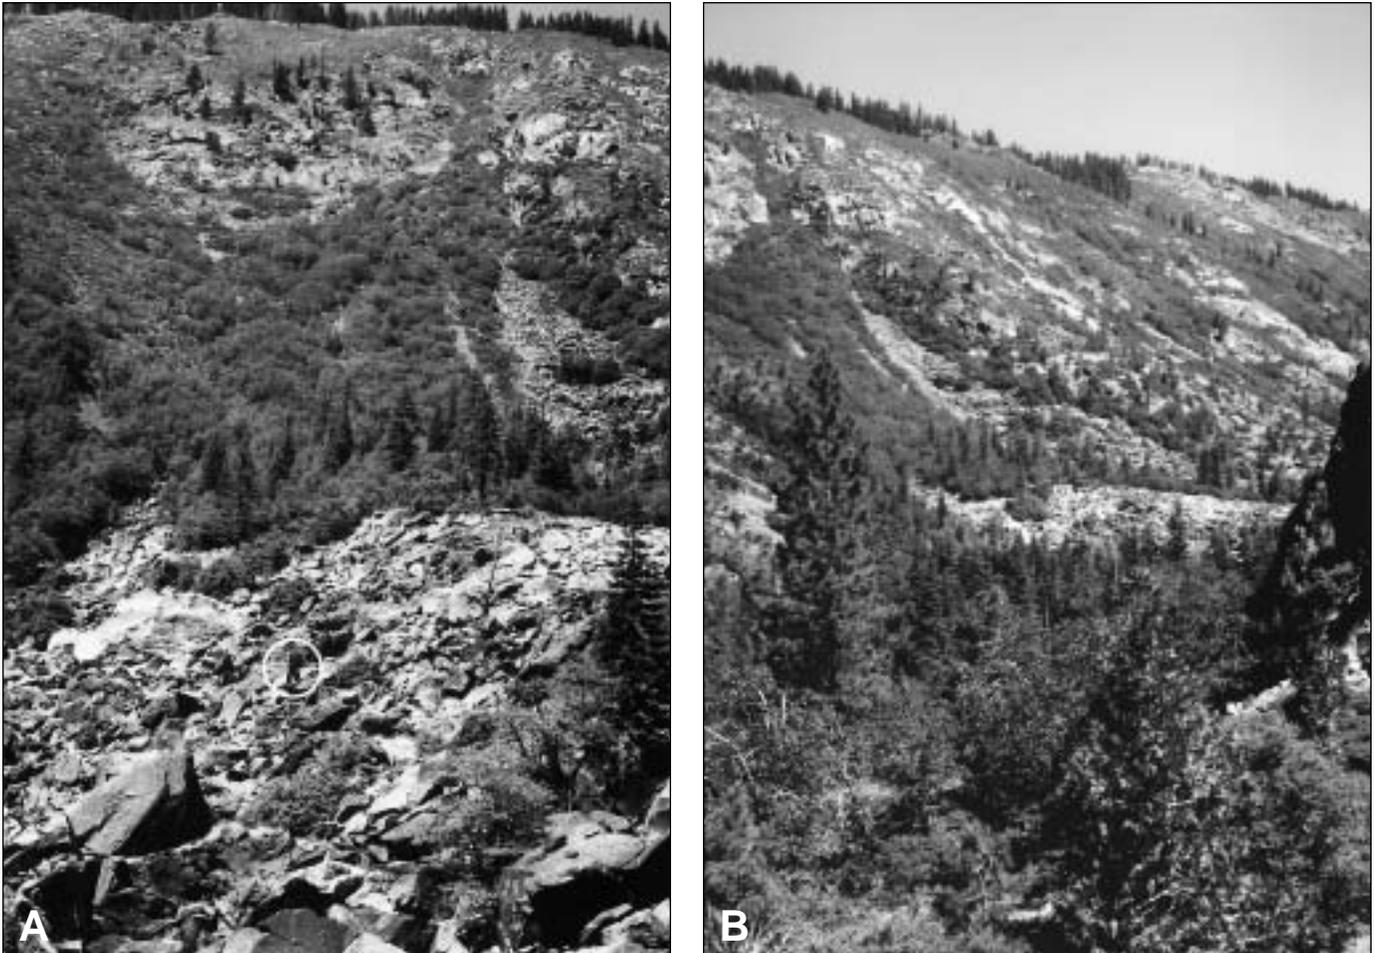
Figure 7. Photographs of rockslide deposits and release area of Tiltill rockslide. A: Revegetation has covered most of release point and is encroaching on rockslide deposits. More recent smaller rockfall deposits cover eastern edge of scarp (right). Person (circled) for scale. B: Looking across rockslide deposits at release point; size of individual rocks is indicated by person for scale. (Photographs are by James Snyder, National Park Service, 1993.)

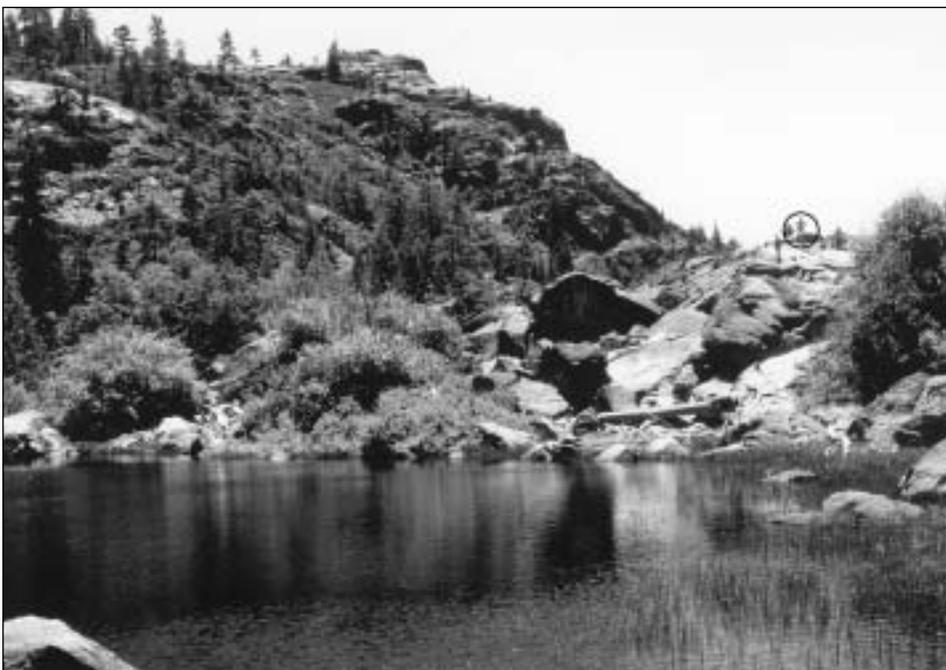
Figure 8. Photograph of lake behind deposit of Tiltill rockslide with two people (circled) on crest of landslide dam for scale. Deposit is ~10 m thick above level of lake. Tiltill Creek drains from lake to left in this photograph. (Photograph is by James Snyder, National Park Service, 1993.)

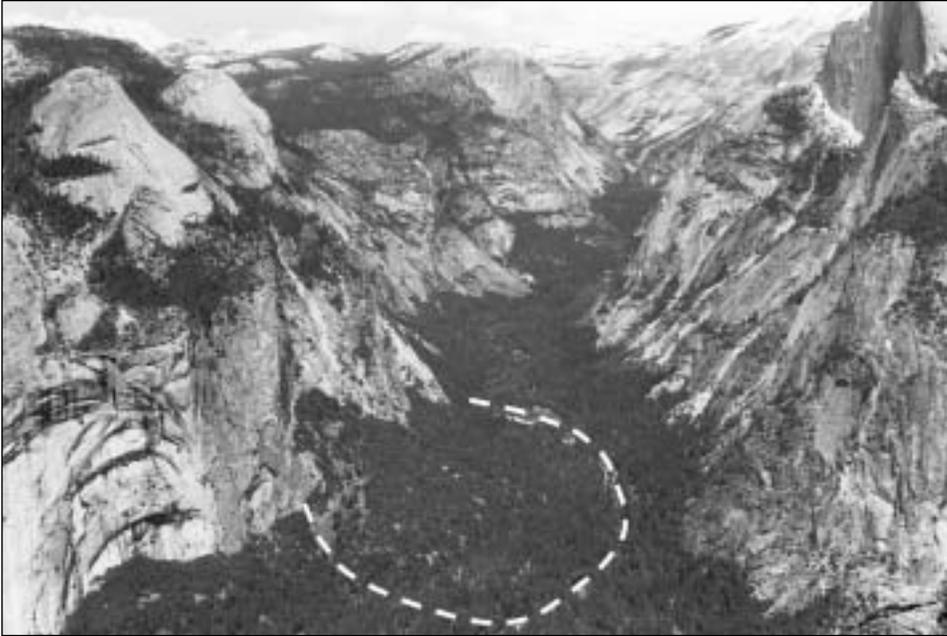
Figure 10. Photograph of prehistoric Mirror Lake rockfall deposit (dashed lines) from cliffs behind Washington Column and below North Dome. Deposit blocked Tenaya Creek and formed prehistoric lake that extended ~2 km upstream in Tenaya Canyon.

The prehistoric Mirror Lake, which extended 2 km upstream, has now been almost completely transformed by sedimentation into a marshy meadow (Fig. 10). Matthes (1930) believed that the blockage of Tenaya Creek by prehistoric rockslides must have occurred recently in prehistoric time because of the noticeable rate at which the lake has been filling with sediment during historical time. Revegetation among the rocky deposit with thick pines (1.2 m diameter), large (7 cm diameter) individual lichens on the boulders, and evidence of Native American occupation of caves among the large interlocked

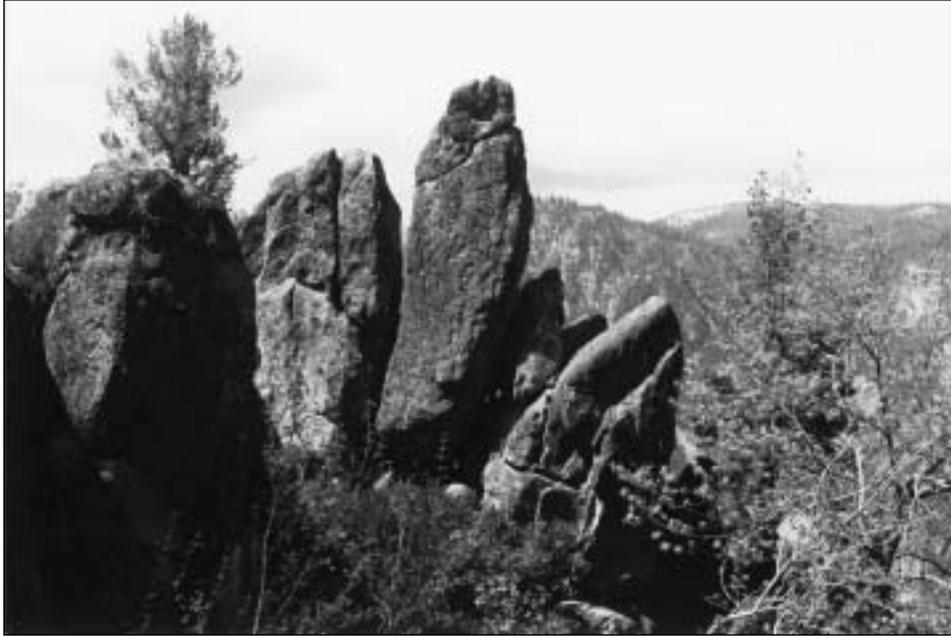
Figure 13. Photograph of open joints in closely jointed rock mass along Glacier Point trail between Union Point and Moran Point.

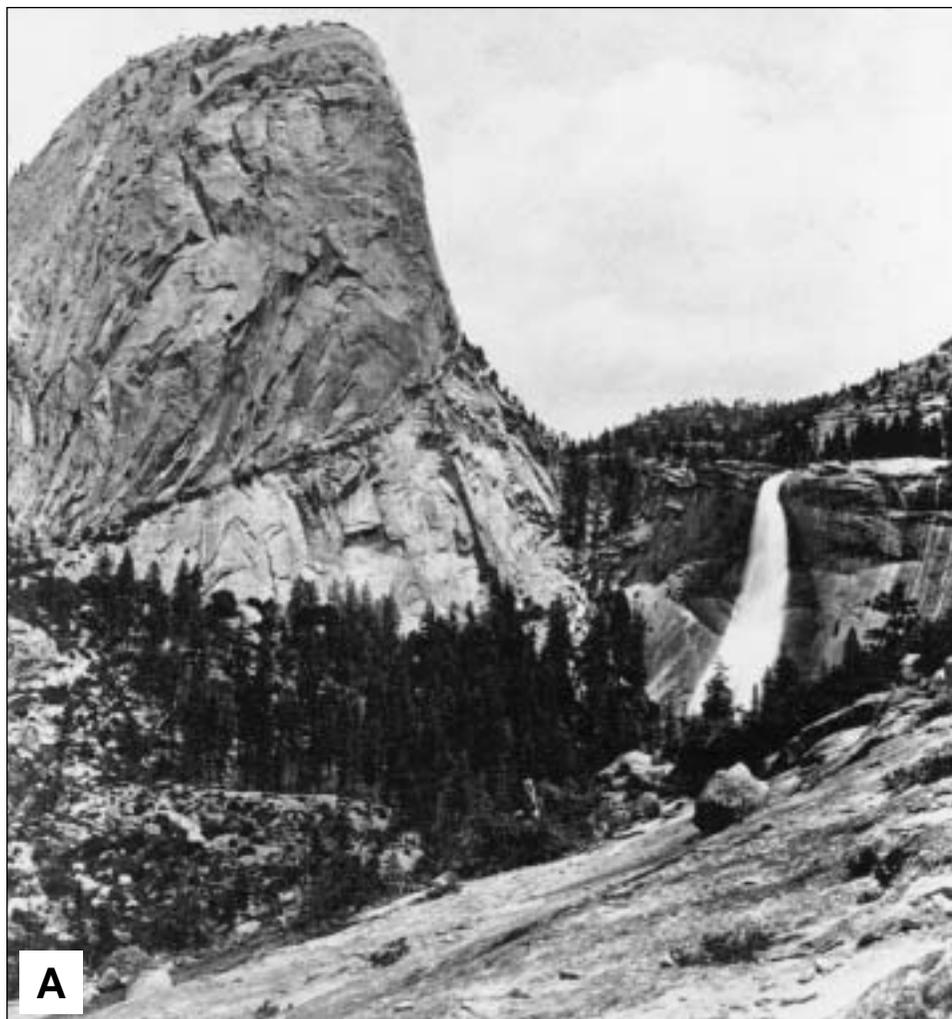
Figure 15. Photograph of Liberty Cap showing rockfall from southwest side triggered by 1872 Owen's Valley earthquake. A: Photograph of Nevada Falls and Liberty Cap by John Soule before construction of Snow's Hotel and 1872 earthquake (1870; Yosemite Research Library YRL-2700). B: Rockfall deposit (dotted lines) triggered by 1872 earthquake behind Snow's Hotel (photograph taken by Carleton Watkins (1878) (Yosemite Museum catalog 571). Release area is indicated by dashed lines. Both photographs published with permission of National Park Service, Yosemite Museum.

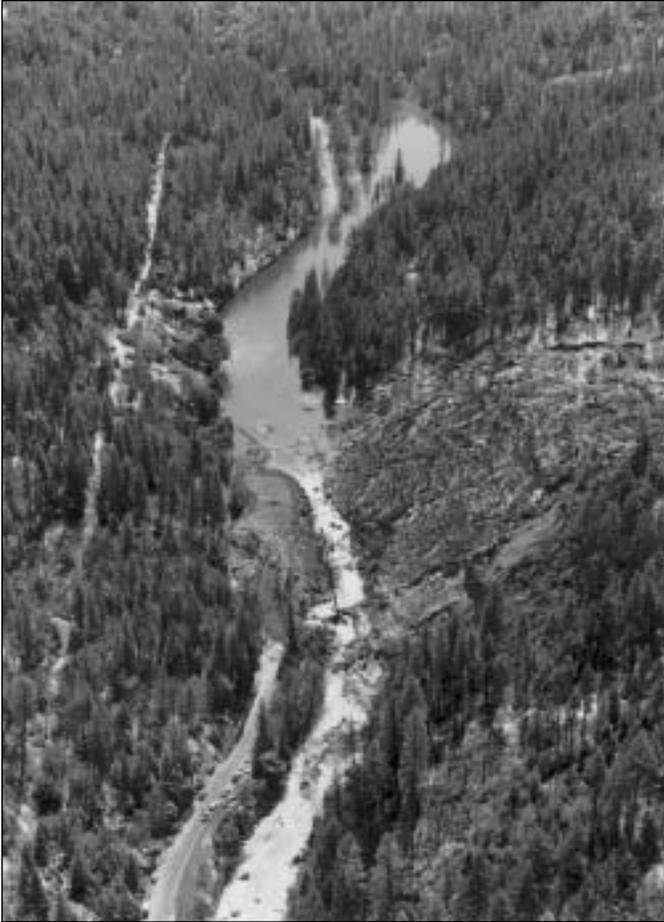
Figure 17. Photograph of rockslide covering Highway 50 and backing up Pony Express Lake. South Fork of American River is draining over breached landslide dam (published with permission of California Department of Transportation, photo C-9021-4).

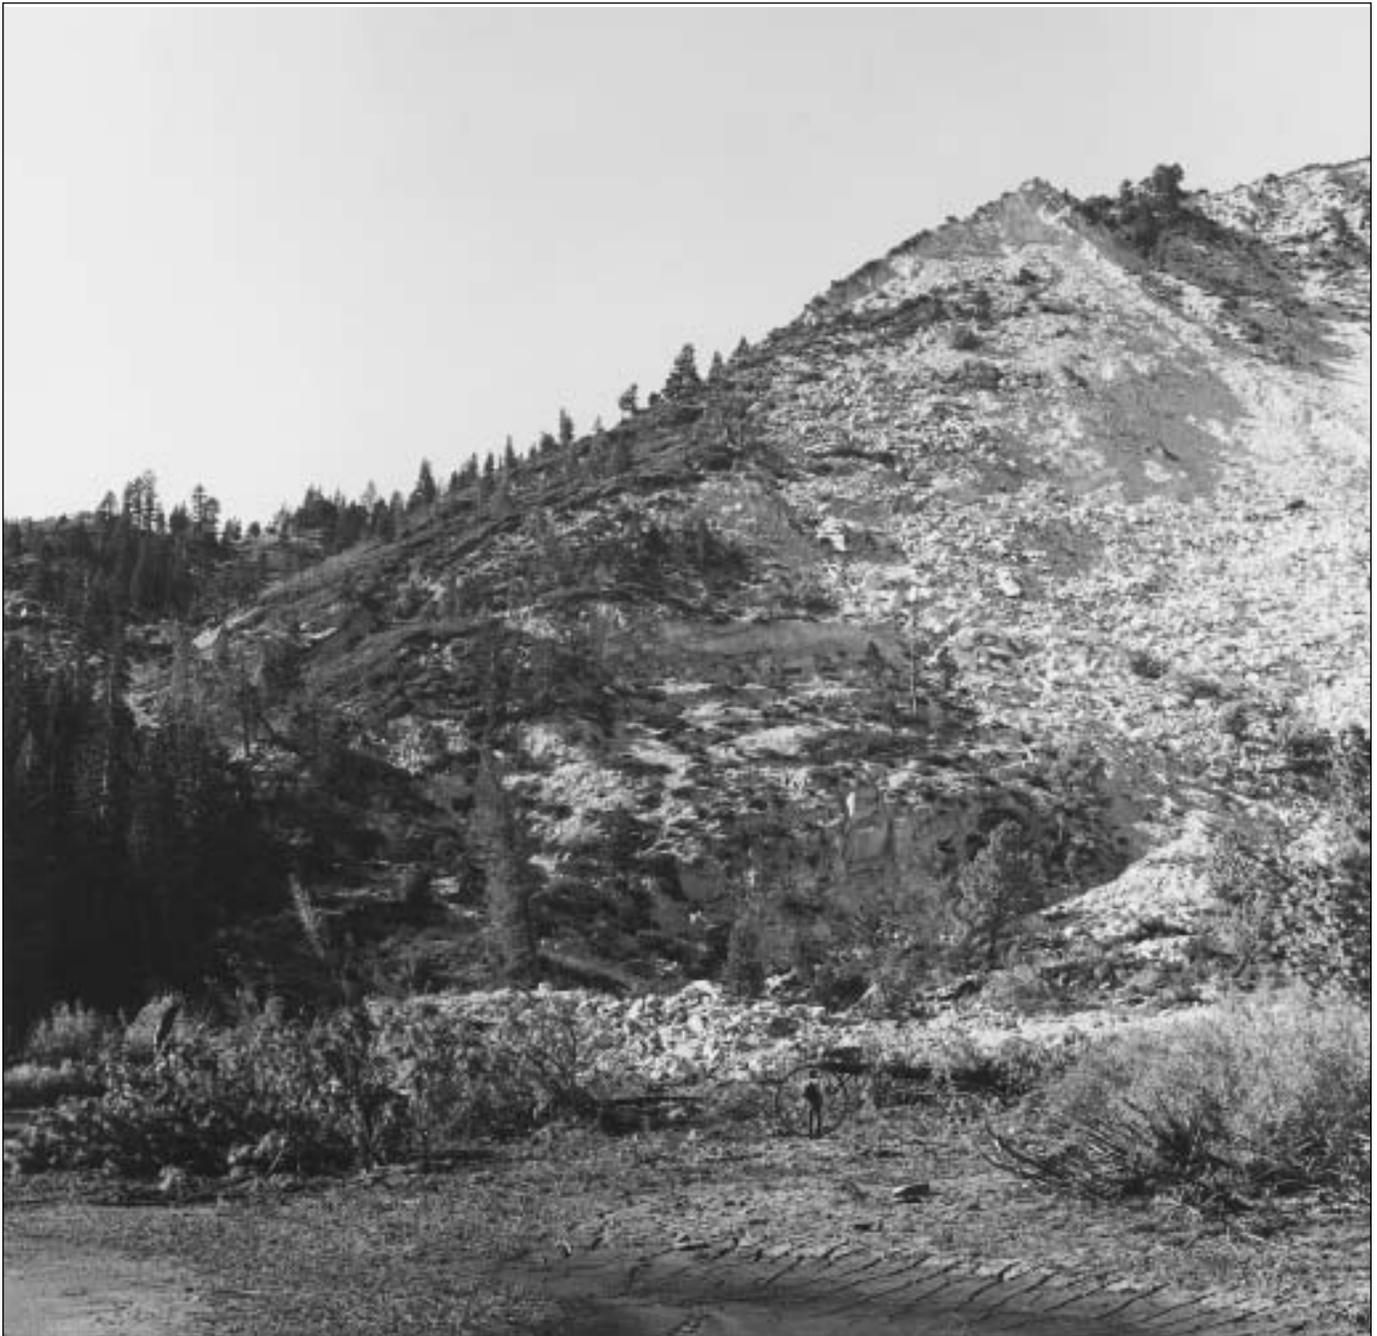
Figure 19. Photograph of Slide Mountain, Nevada, rockslide. Scarp at top right with person (circled) in foreground for scale (photograph by Steve Ellen, 1983).

Price Lake, displaced most of the lake water, which overtopped and breached a low dam (Fig. 19). The water then breached the dam of Lower Price Lake and sent a torrent down the gorge of Ophir Creek. In the steep canyon the rapidly moving water picked up fine and coarse rocky debris. Emerging from the canyon 6 km downstream, the debris flow spread out and deposited over the alluvial fan of Ophir Creek in the Washoe Valley,

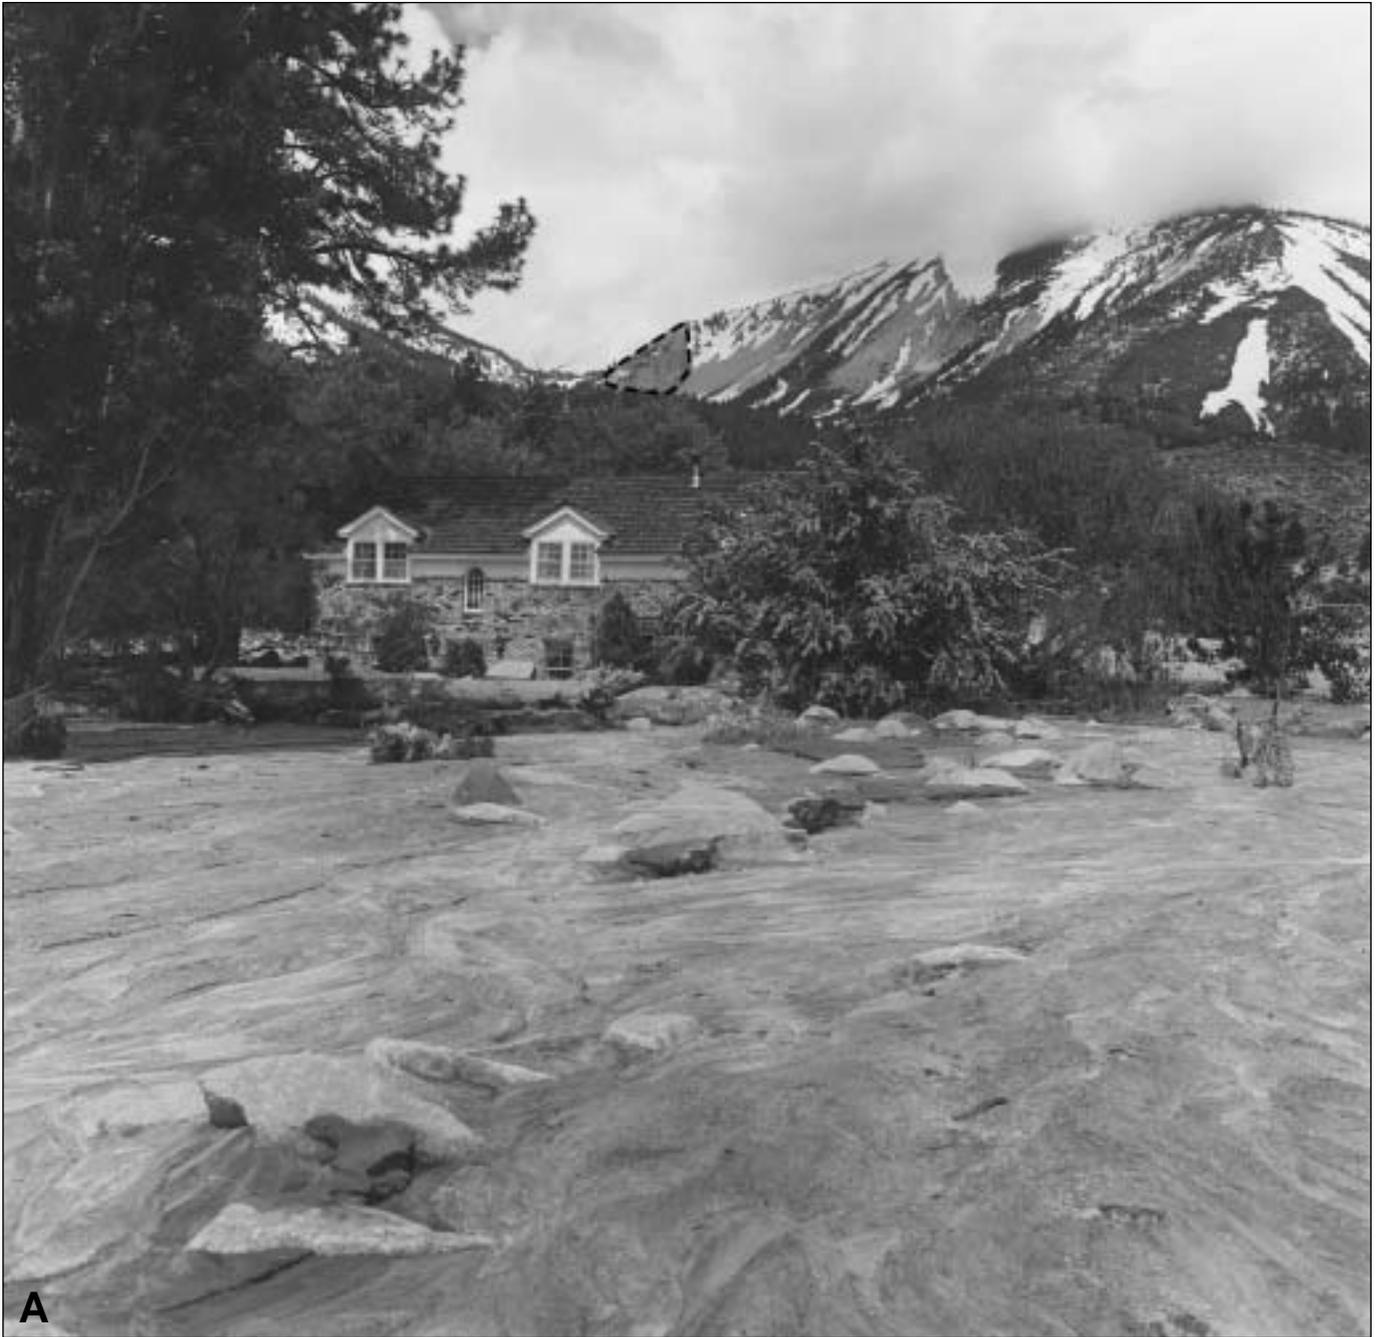
Figure 20. Photographs of debris flow on Ophir Creek fan triggered by rockslide on Slide Mountain, Nevada. A: Debris-flow deposition on fan; recent rockslide scar on Slide Mountain is visible in distance (dashed line). B: House partially buried and bus overturned (right) by debris flow on fan of Ophir Creek (photographs by Steve Ellen, 1983).

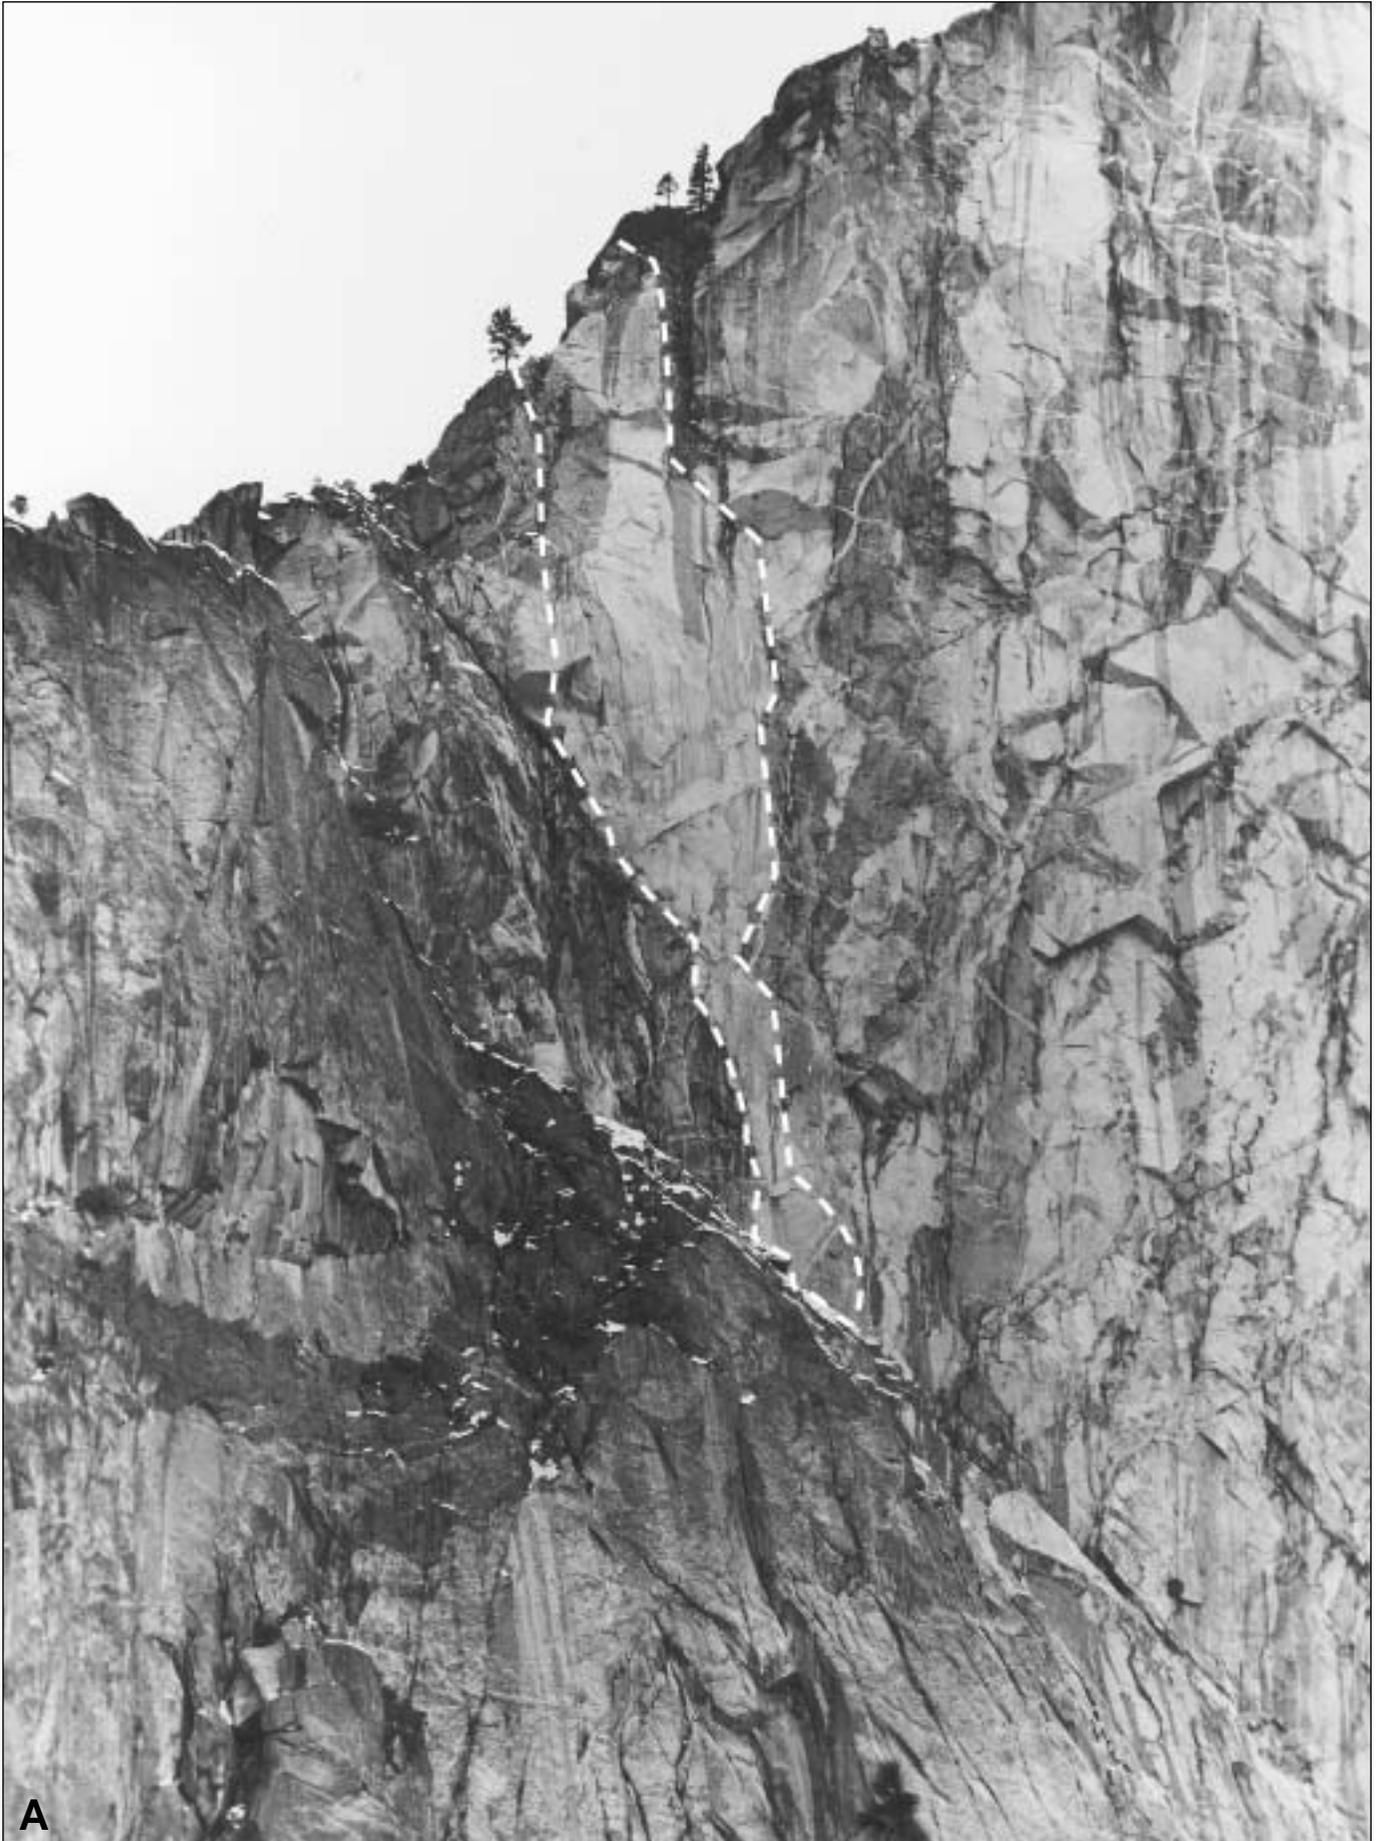
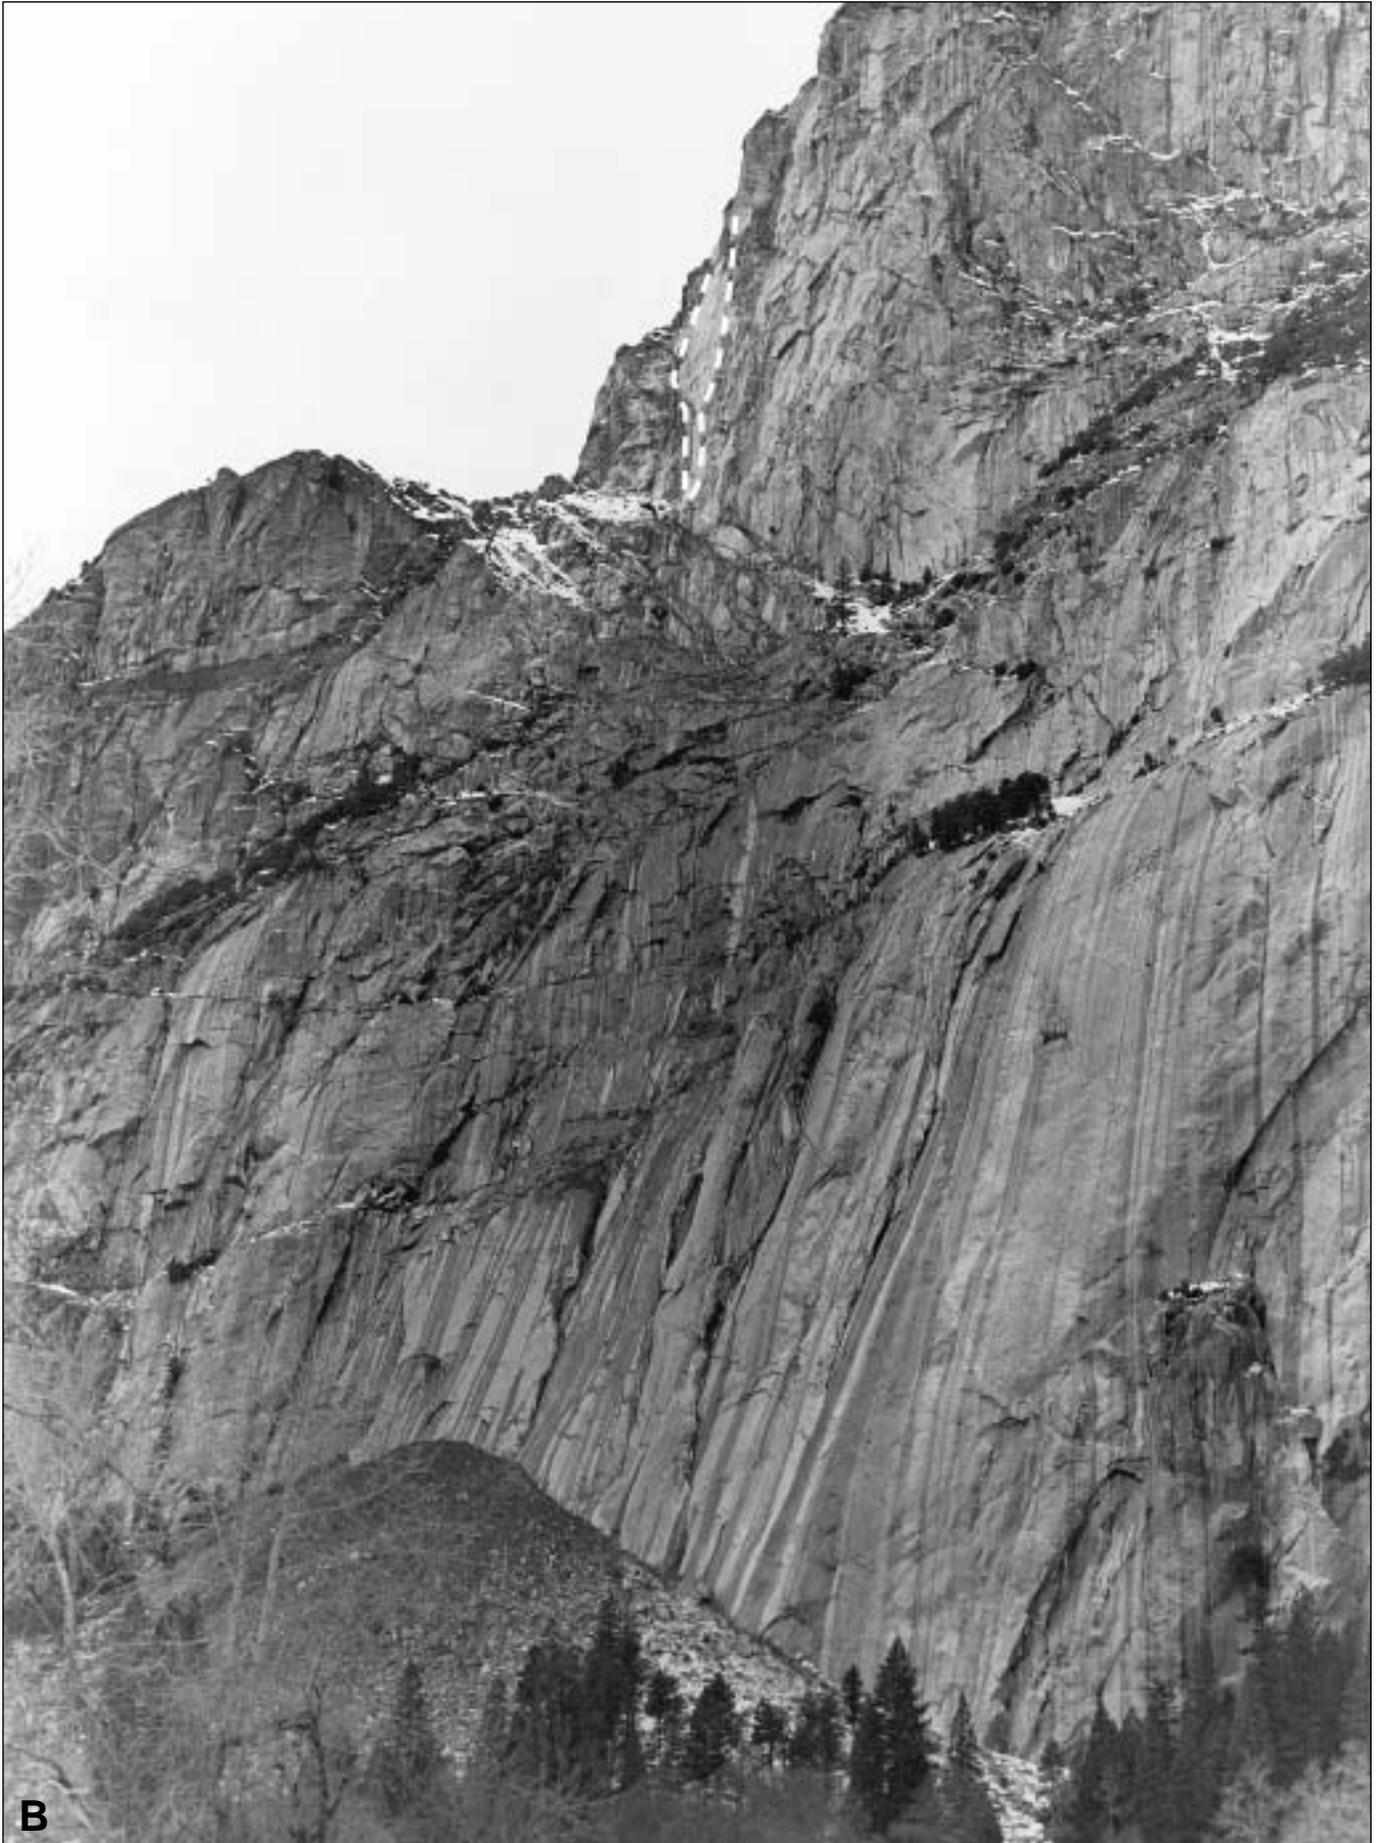
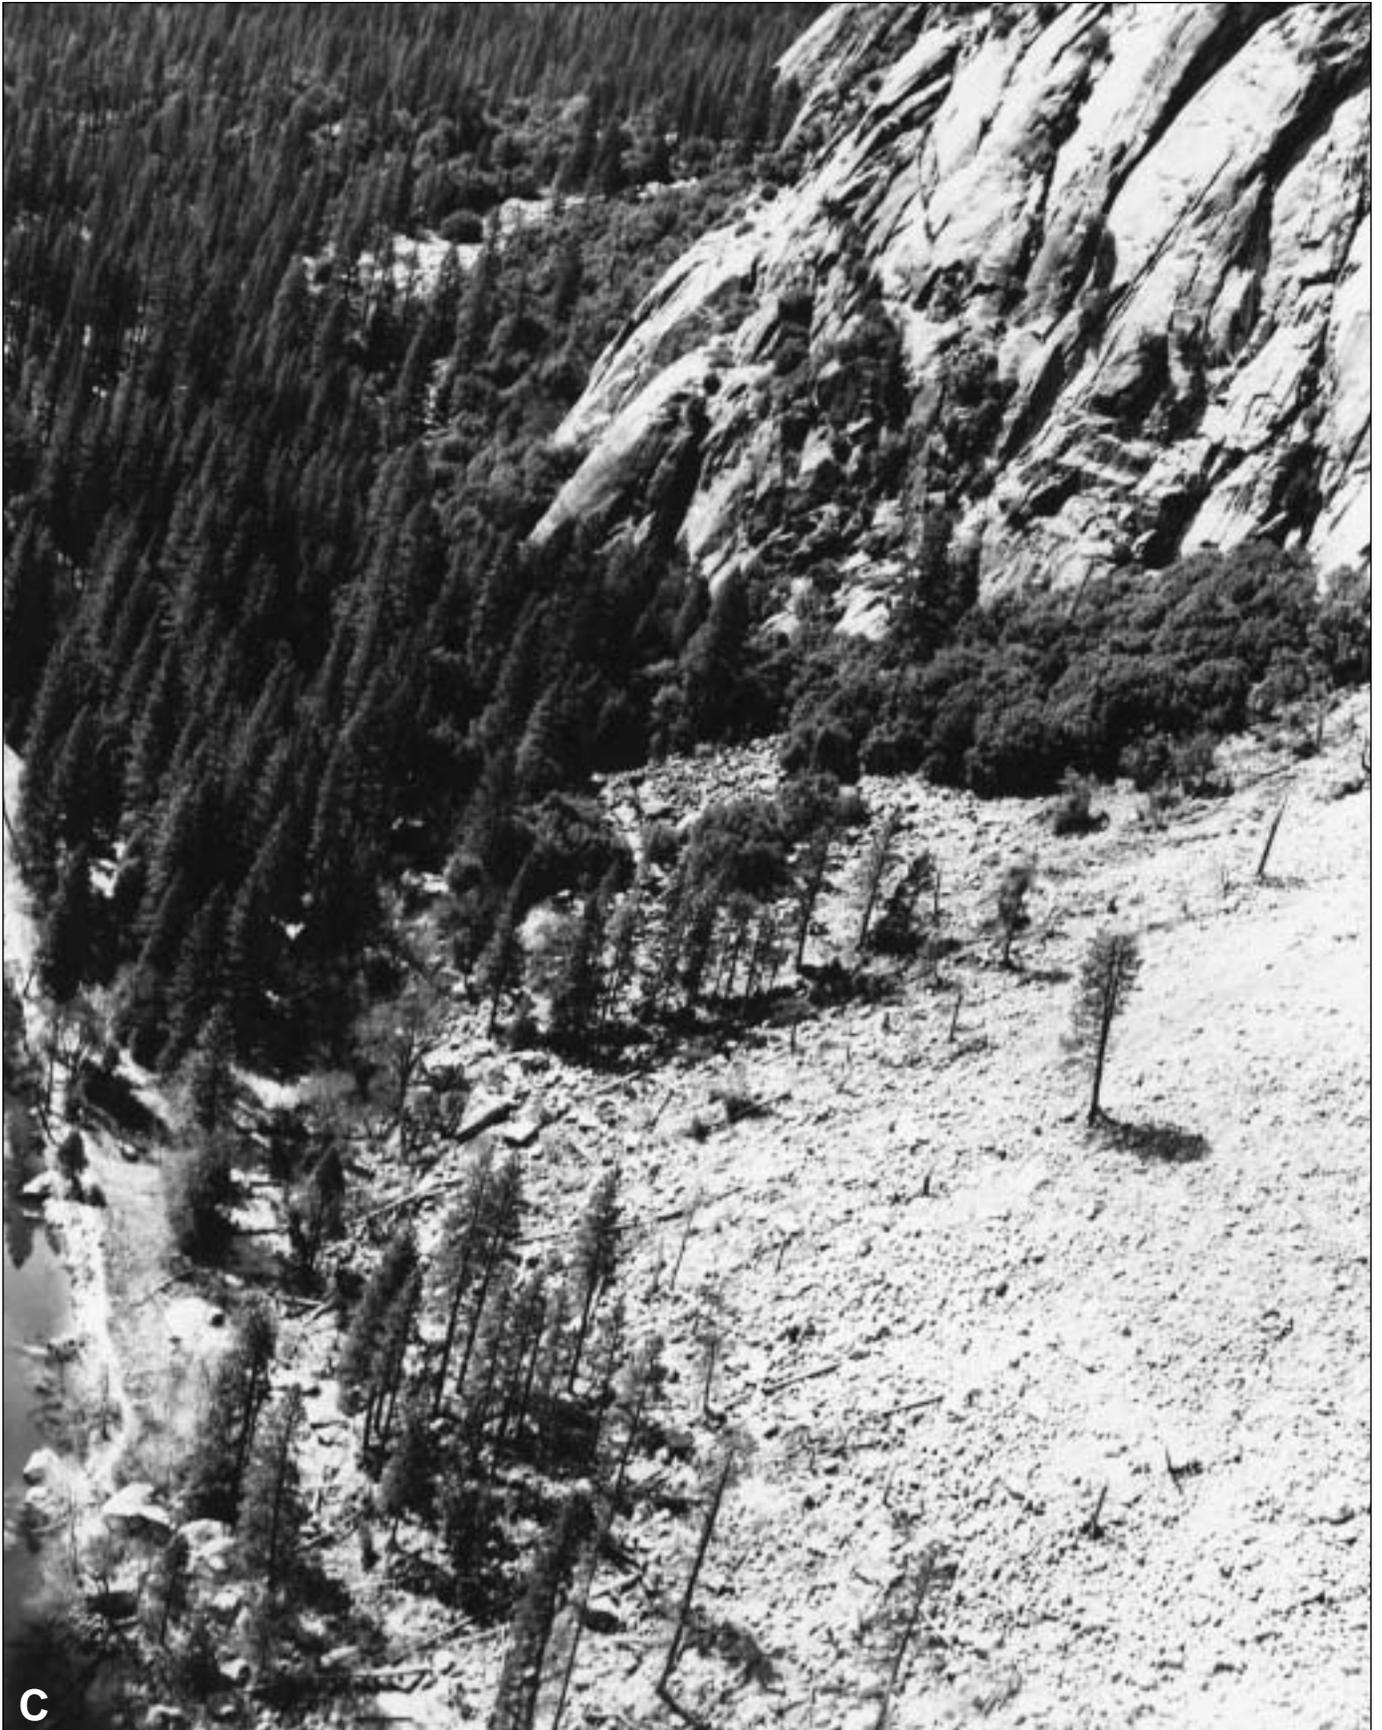
Figure 22. Photographs of Middle Brother rockfall. A: Release point (dashed line) of March 10, 1987, rockfall. Pine trees above and to left of release point provide approximate scale. (National Park Service photo 92-013-28 taken February 19, 1992. B: Release point (dashed line) and rockfall deposit on talus at base of Middle Brother. (National Park Service photo 92-013-4 taken February 19, 1992. C: Talus from March 10, 1987, rockfall covering Northside Drive and reaching Merced River at left (National Park Service photo 87-004 taken March 11, 1987).
